**ARTC**

**SJ23-0631-RPT-V1**

**Euroa Goods Shed  
Building Inspection Report**

**25 August 2023**

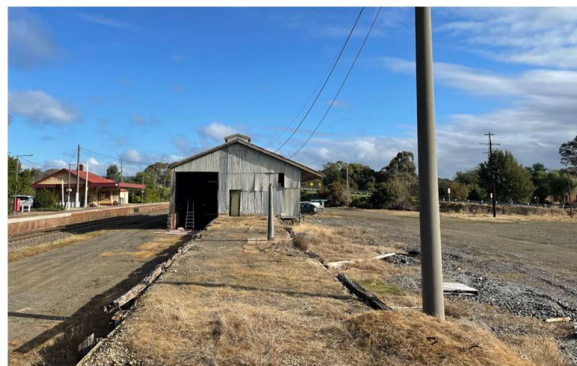
*Image 3-2A – Shed is publicly accessible (there is no barrier to entry, such as a door, fence or gate)*

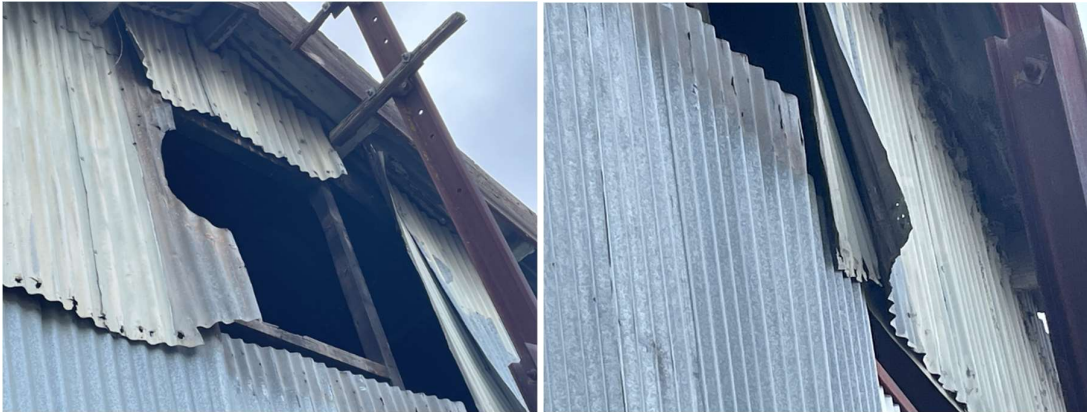
The corrugated steel sheeting forming the wall cladding, is dislodged in many locations throughout with large openings and voids present. There are areas of the wall cladding which are loose due to apparent failure of fixings and these present a safety hazard due to the potential to become fully dislodged and fall.

*Images 3-4 & 3-5 – Failed wall sheeting on the Up End, and warped disconnected wall sheeting*

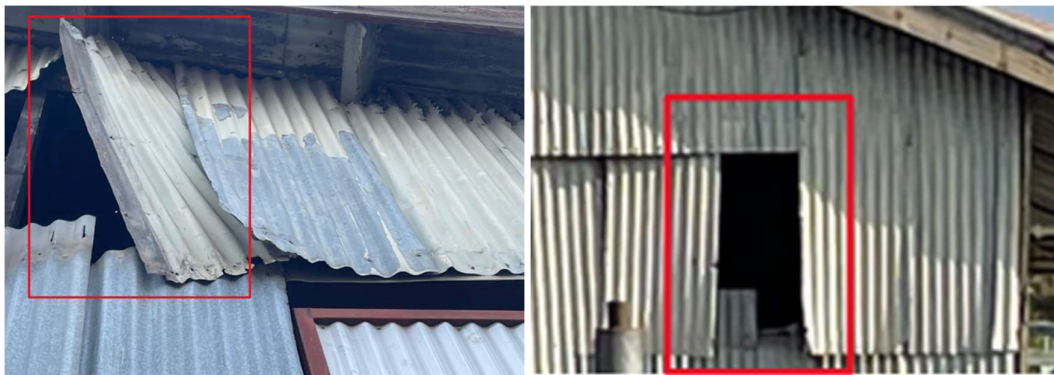
*Images 3-6 & 3-7 – Precarious façade sheeting on Up End(Left image), and Down End (Right image)*

The wall cladding in it's current condition poses a significant safety hazard due to risk of full disconnection occurring. For this reason, an exclusion zone is required to be set up to prevent pedestrian access. Due to the risk of the wall cladding sheeting falling laterally or getting blown in the wind the exclusion zone should be erected several meters away from the building line.

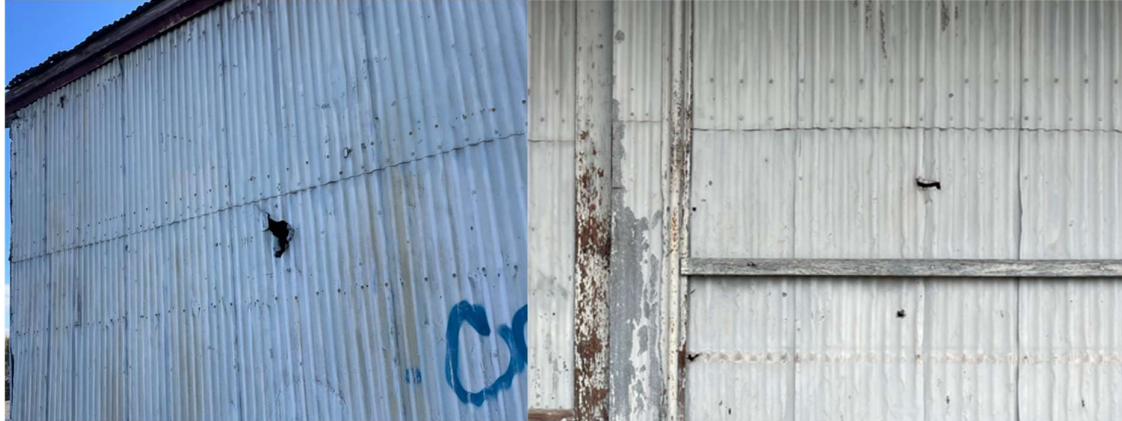
The Up Side and Down Side façade sheeting was generally in better condition however these areas did contain numerous perforations and missing rivets.

*Images 3-8A & 3-8B – Typical wall cladding condition on Down Side and Up Side elevations*

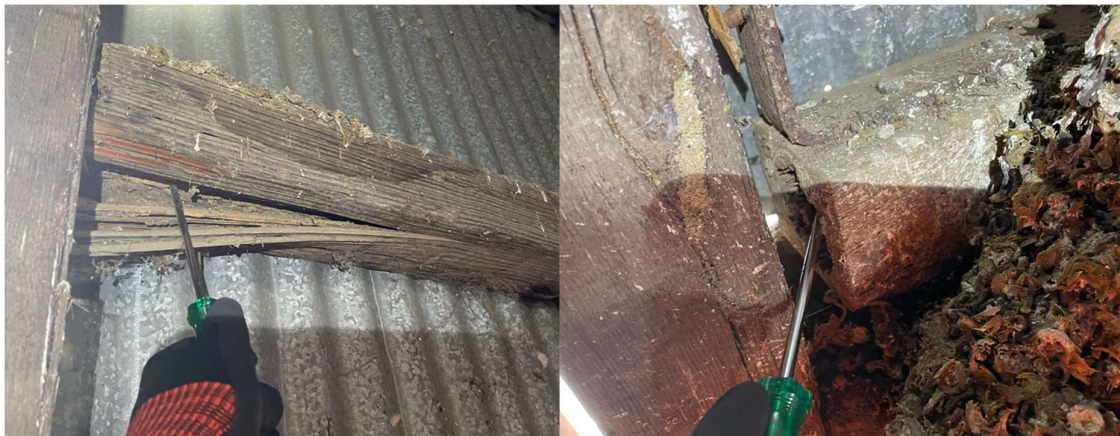
The installation of new fixings would present a problem as many of the internal timber 'girts' which support the corrugated steel cladding are themselves rotten beyond repair and in need of replacement (as shown below)

*Image 3-9A&3-9B – Deteriorated timber 'girts' Up End*

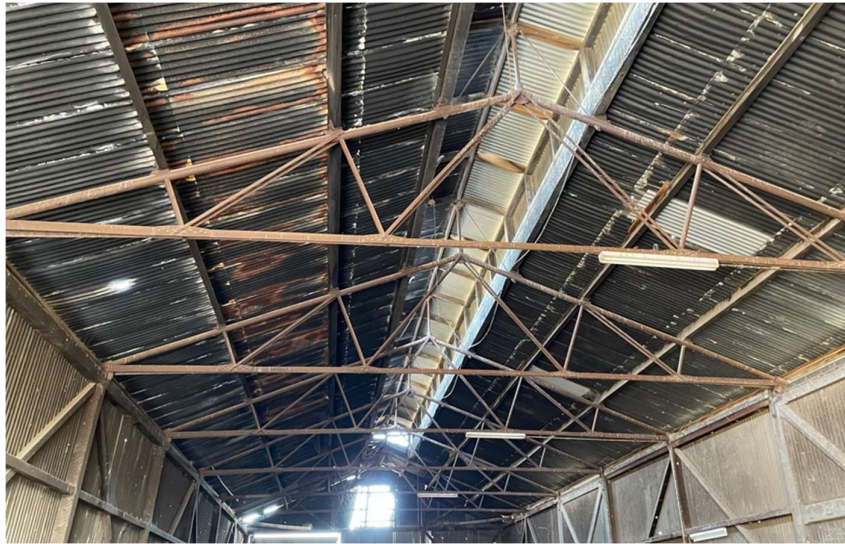
*Images 3-10 – Steel roof trusses, generally in good condition*

Generally, the steel roof trusses appeared to be in reasonable condition. The protective coating was generally intact, and no significant evidence of corrosion was observed.

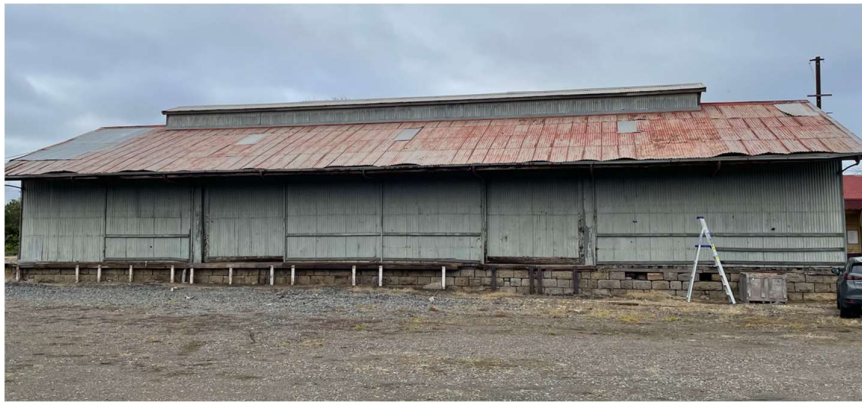
The corrugated steel roof sheeting was generally in poor condition throughout, exhibiting warping, deformation, disconnection, and surface deterioration. Numerous areas of the roof sheeting have been replaced, however there remains a section of roof which is missing sheeting.

*Images 3-14 – General condition of roof sheeting, view from Down Side*

The roof sheeting poses a safety hazard due to risk of disconnection. For this reason an exclusion zone is required to be set up to prevent pedestrian access. Due to the risk of the roof sheeting falling laterally or getting blown in the wind the exclusion zone should be erected several meters away from the building line.

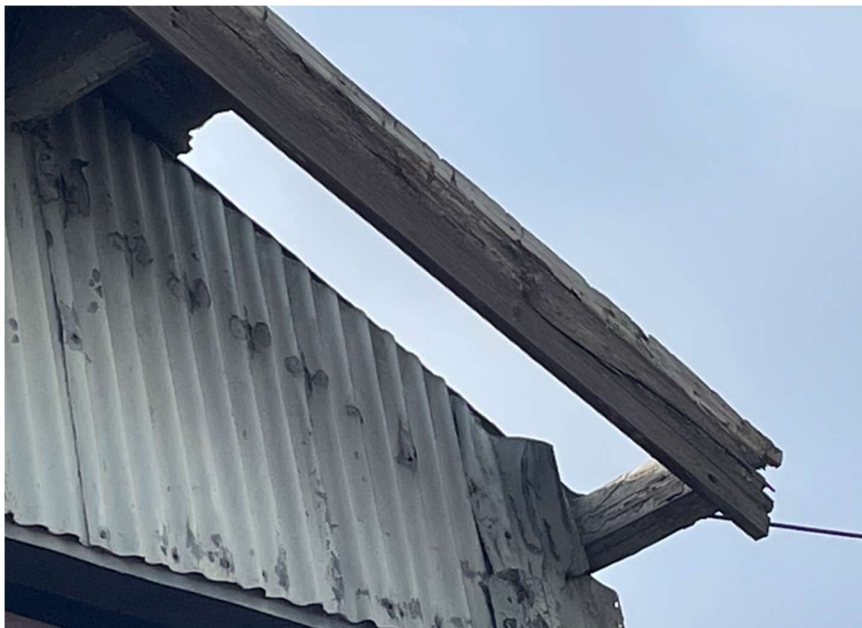
*Images 3-15 – Missing roof sheeting at Up End, Up Side corner*

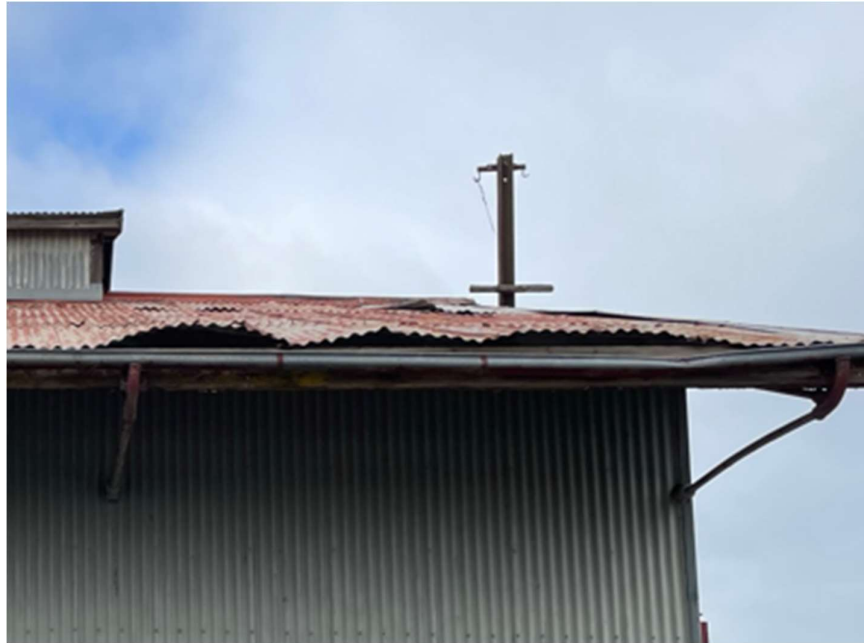
*Images 3-16 – Disconnected, warped roof sheeting*

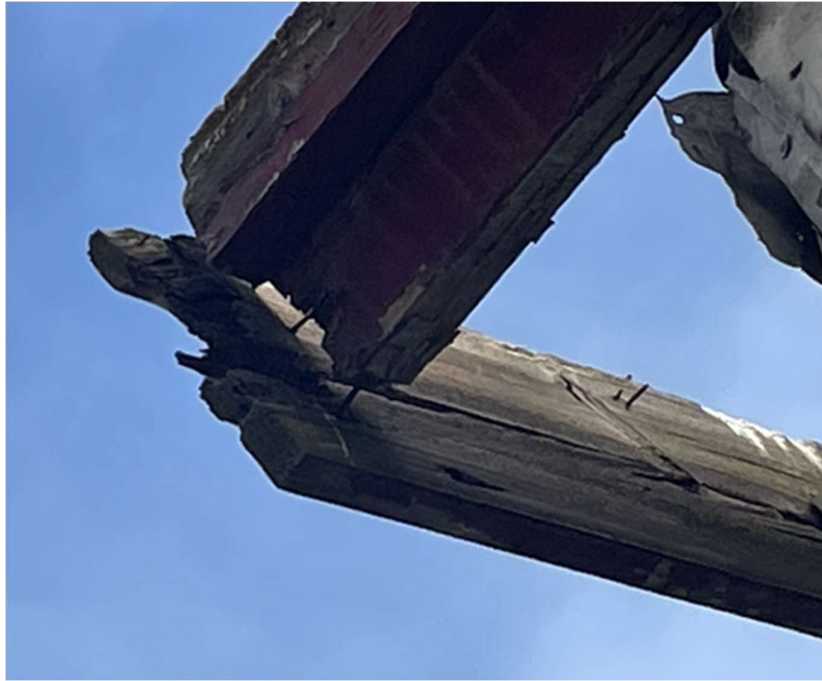
Generally, the fascia is weathered and the protective paint coating has disintegrated. There are large areas of the fascia which are rotten beyond repair, particularly on the Up End and Down End.

*Images 3-17 – Failed fascia at Up End, Up Side corner*

The gutter and fascia pose a safety hazard due to their instability and risk of disconnection. For this reason, an exclusion zone is required to be set up to prevent pedestrian access. Due to the risk of the gutter or fascia falling laterally, the exclusion zone should be erected several meters away from the building line.

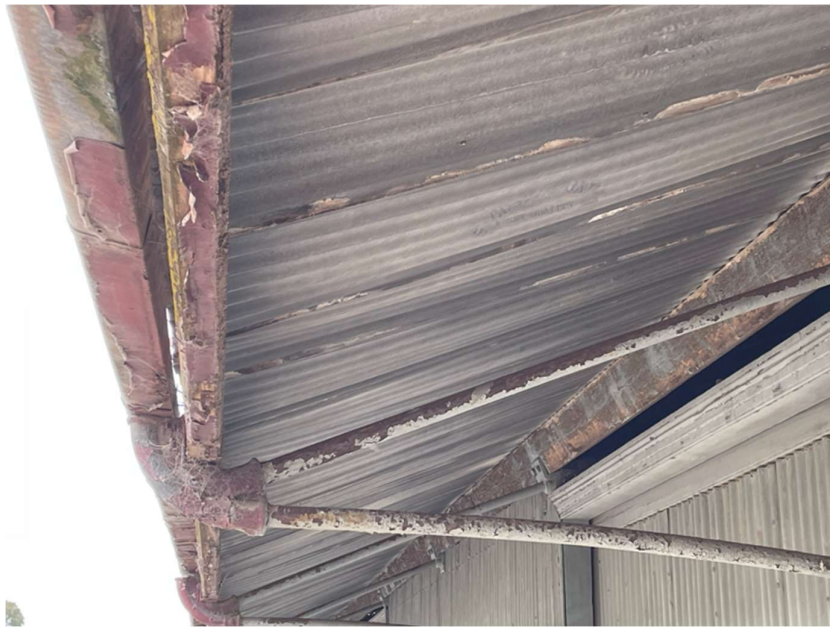
*Images 3-18 – Typical condition of fascia*

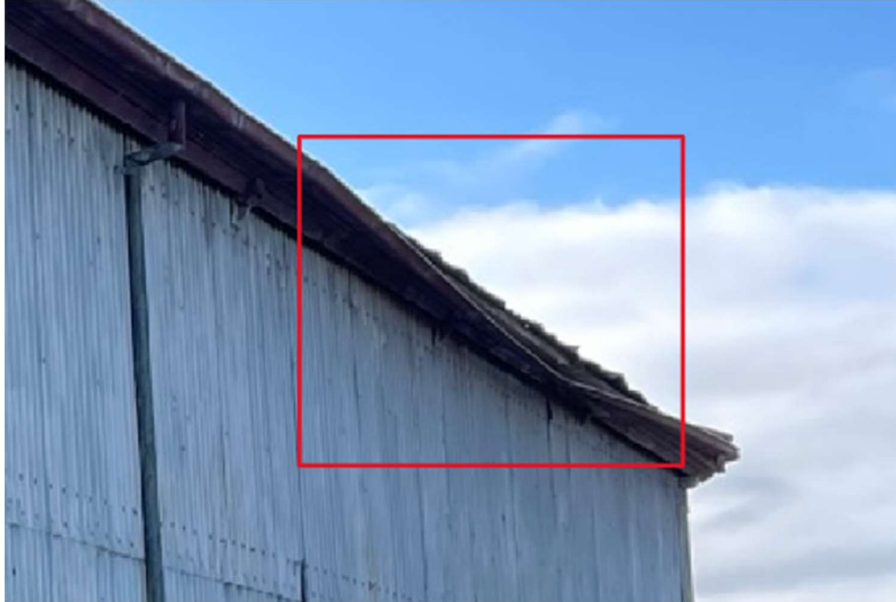
The gutter is generally in poor condition, exhibiting surface coating deterioration, loose fixings, and disconnection.

*Images 3-19 – Failed gutter on Up Side*

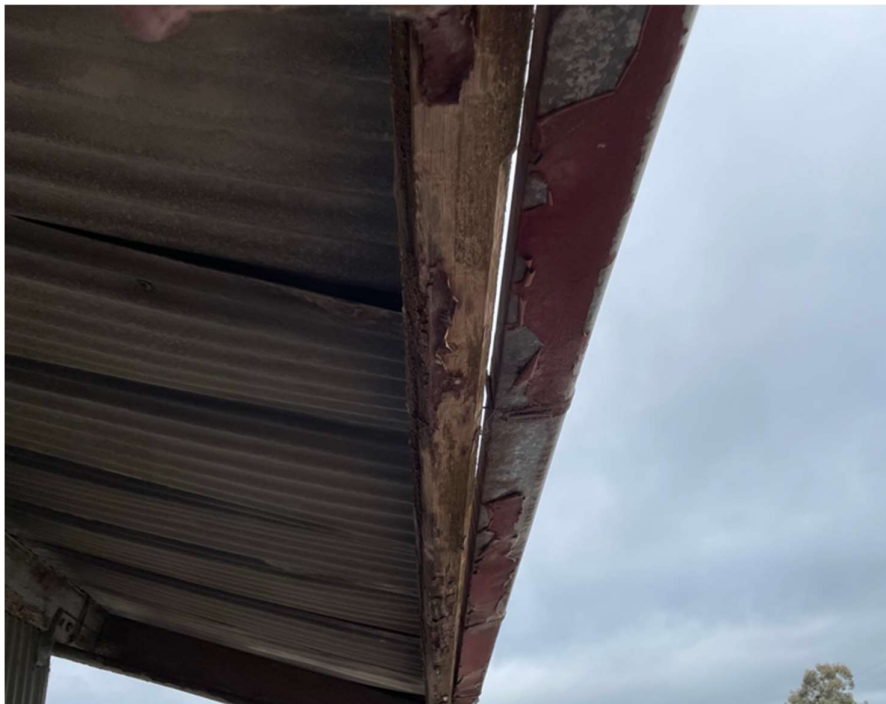
*Images 3-20 – Typical condition of gutter*

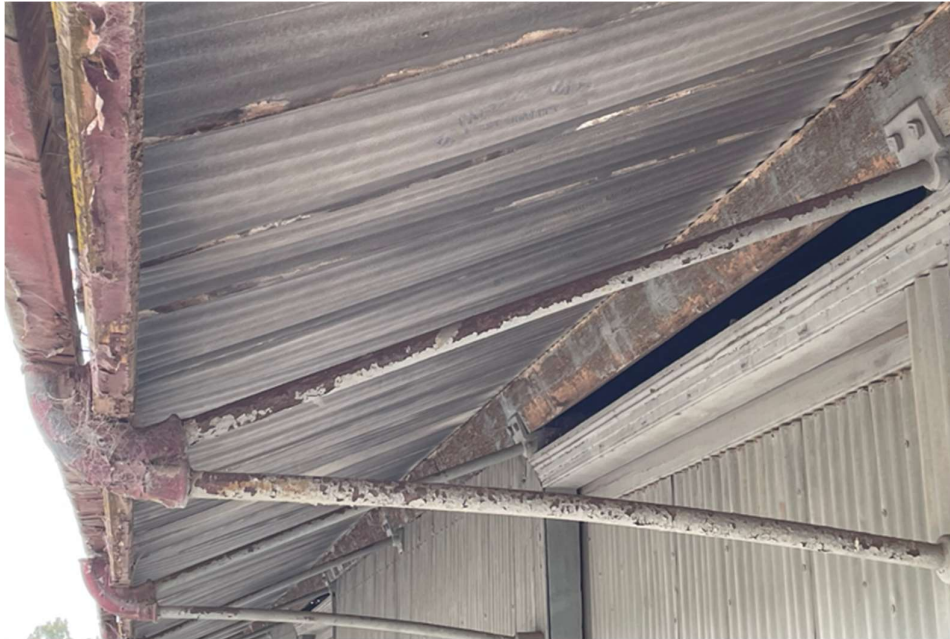
The 'strut and ties' exhibited moderate corrosion and visible compression induced out-of-plane movement (precursor to buckling).

*Images 3-21 – Typical condition of fascia supports (strut and ties)*

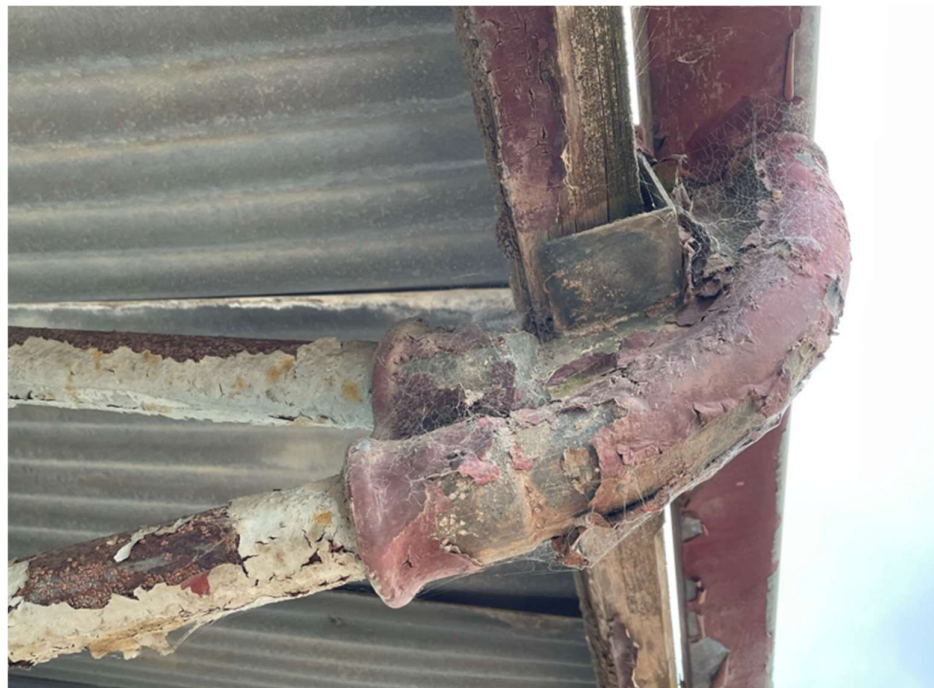
*Images 3-22 – Typical condition of fascia supports at connection to gutter*

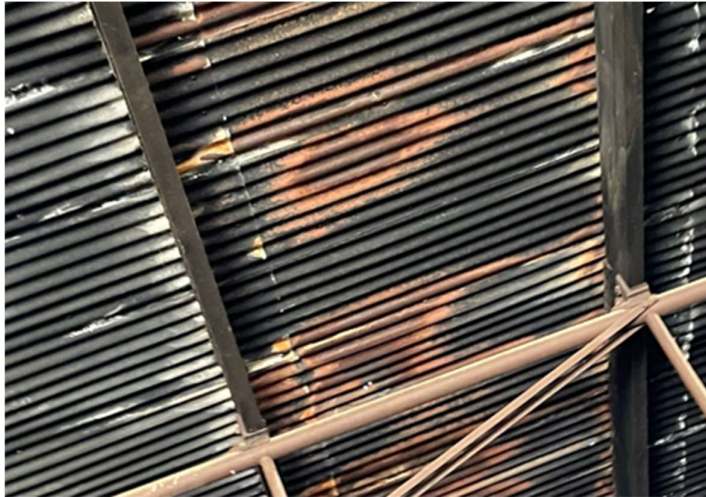
Generally, the purlins appeared aged and water-stained, however, no visible signs of splitting or rot could be confirmed, though water staining did indicate a likelihood that prolonged exposure to moisture could have induced some hidden rot to the top surface abutting the roof sheets.

*Image 3-23 – Typical condition of purlins*

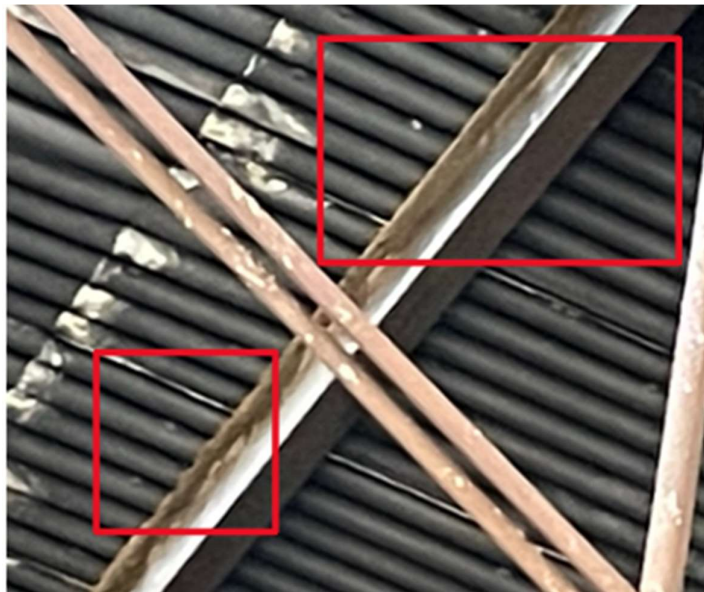
*Image 3-24 – Water staining on the upper portion of purlin*

Based on our visual assessment of the severity of the water staining, it is inferred that the purlins have likely endured a degree of rot and will therefore likely have a reduced structural capacity, however, this cannot be quantified accurately without a more detailed intrusive inspection which would involve the removal of roof sheeting.

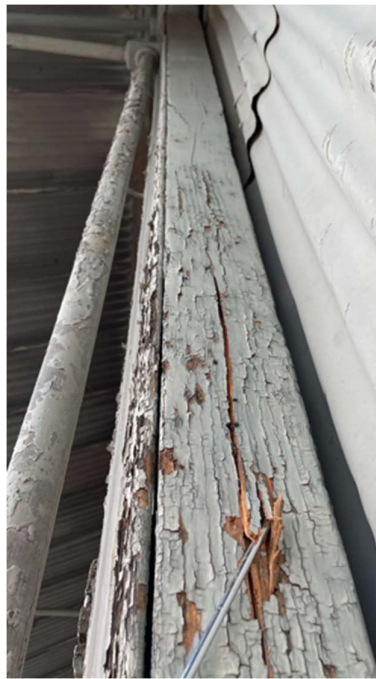
Generally, the columns were in an aged but fair condition, with deterioration of protective coatings, and minor to moderate splitting.

*Image 3-25 – Typical condition of timber columns*

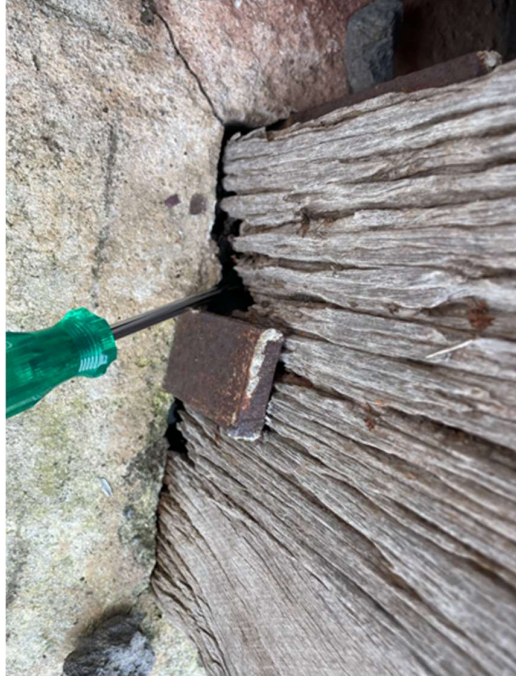
*Image 3-26 – Rotten column at footing connection, Up End , Up side corner*

The suspected termite induced decay and rot, and severe splitting have reduced the column section capacity significantly and it is considered unlikely that these columns would retain sufficient capacity to comply with the design loads of the current Australian Standards.

Rectification would involve widespread drilling to confirm the extent of the decayed/deteriorated area, followed by temporary propping and bracing installed to ensure The Shed remains stable during extraction and replacement of adversely affected full or partial columns.

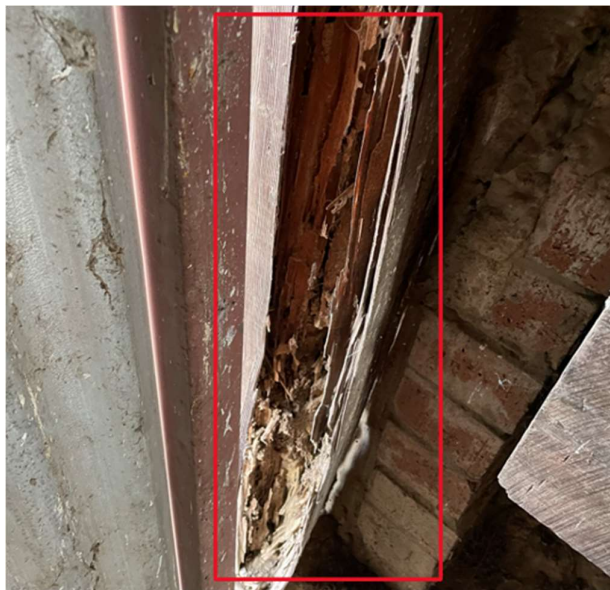
*Image 3-27 – Suspected termite affected column, Up end, central*

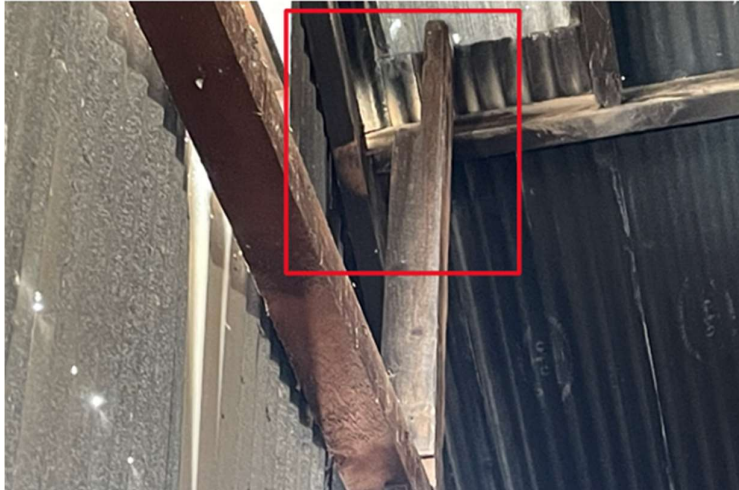
*Image 3-28 – Column has disconnected from roof truss and purlin, and is leaning inwards pulling the wall beam*

The severity of the column defects poses a significant risk to the global stability of The Shed. The inward leaning column at the Up-End has the potential to destabilize and collapse bringing with it a portion of the roof framework and wall framework and cladding.

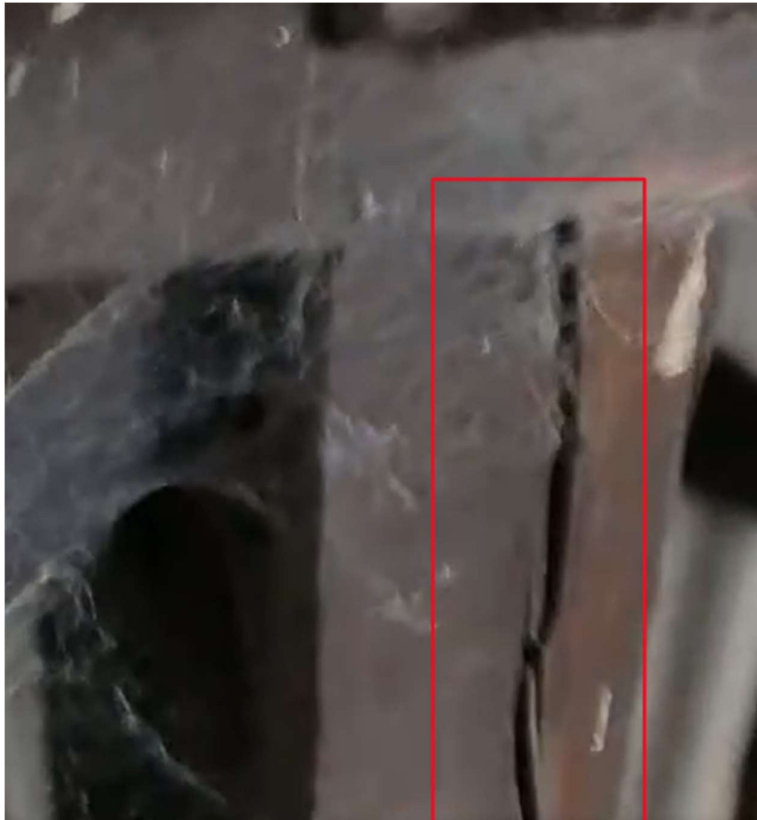
*Image 3-29 – Severe split in column propagating from connection to steel roof truss Up Side*

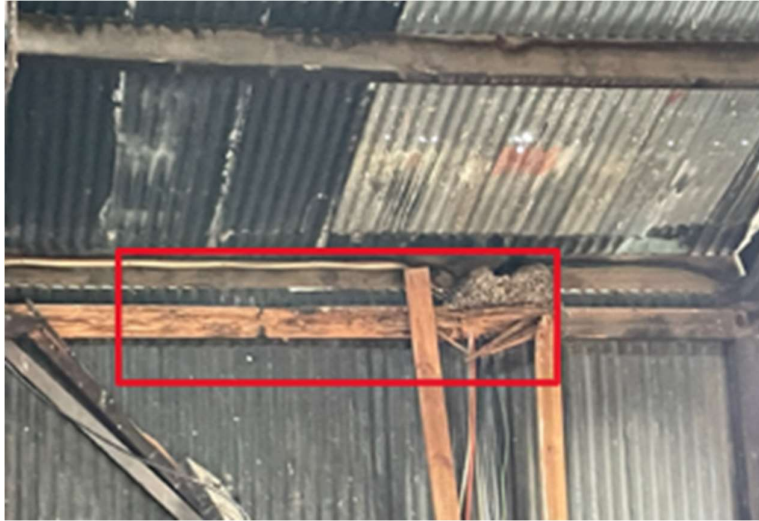
*Image 3-32 – Failed timber beam at Down Side, Down End*

The suspected termite induced decay and rot, and severe splitting have reduced the beam's section capacity significantly and it is considered unlikely that these beams would retain sufficient capacity to comply with the design loads of the current Australian Standards.

Rectification would involve temporary propping works to ensure The Shed remains stable during extraction, and replacement of adversely affected beam segments.

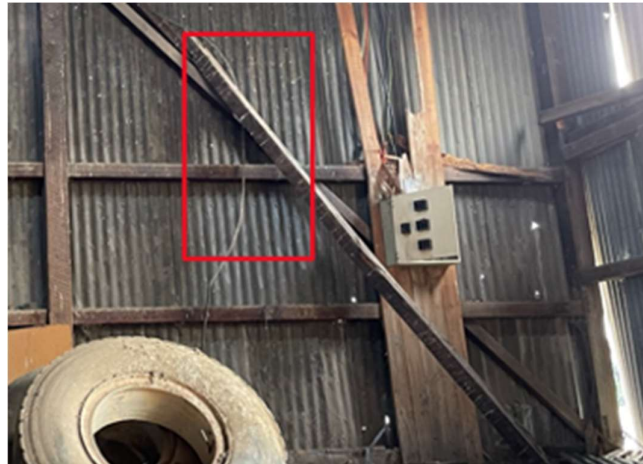
*Image 3-33 – Collapsed roof bracing. Down Side, Down End*

The failed bracing, leaves the structure vulnerable to lateral instability, which could potentially result in the structure falling laterally during high winds.

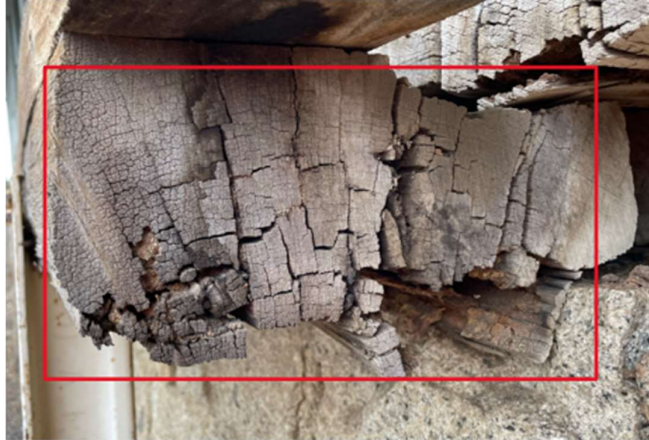
*Image 3-34 – Severely split beam end, Down Side, central*

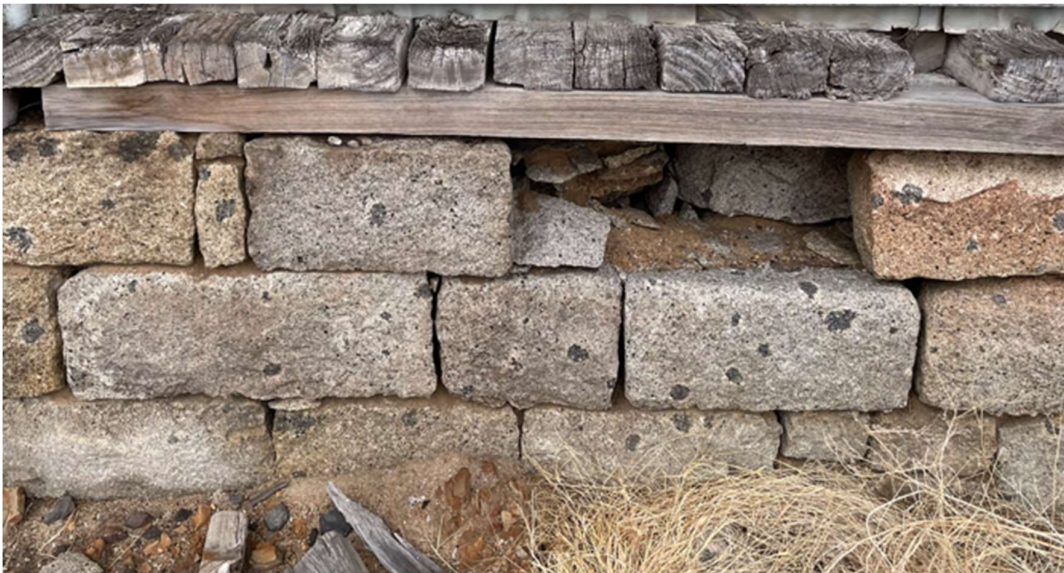
*Image 3-36 – Deteriorated stone upstand, Down Side*

However, we would recommend undertaking testing on the stone elements if they were to be used as a future structural load bearing element.

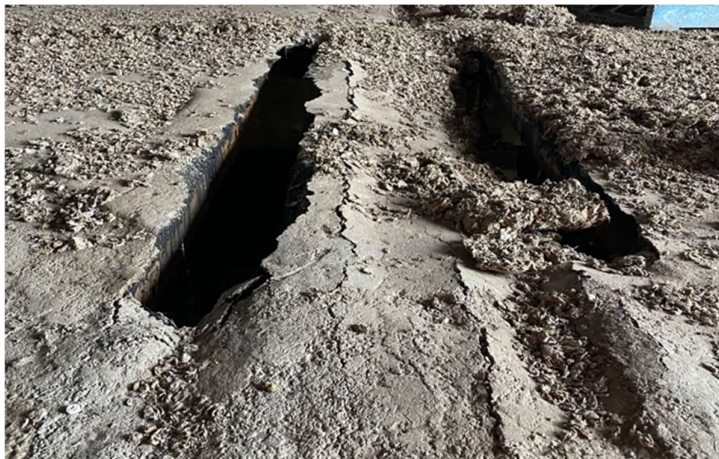
*Image 3-38 – Failed timber deck poses a serious risk of injury*

The deck planks pose a safety hazard due to their instability and risk of further collapse if accessed. For this reason an exclusion zone is required to be set up to prevent pedestrian access.

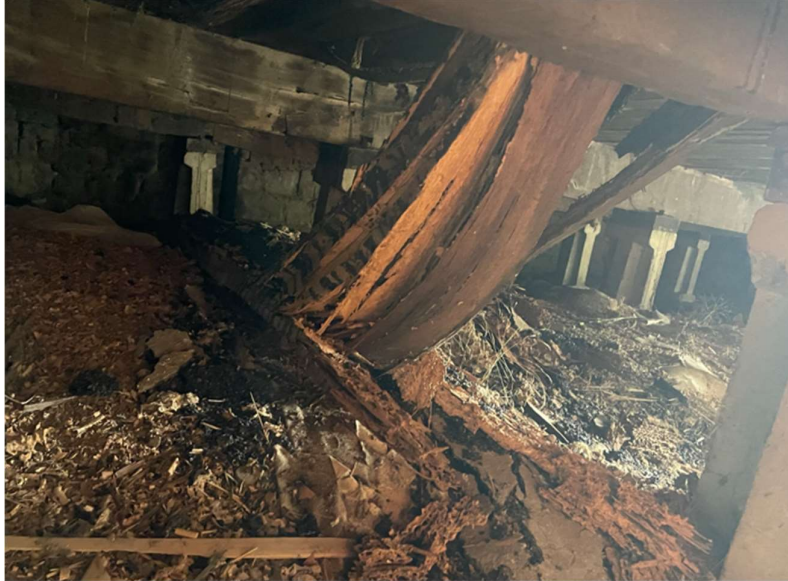
*Image 3-39 – Failed timber deck poses a serious risk of injury*

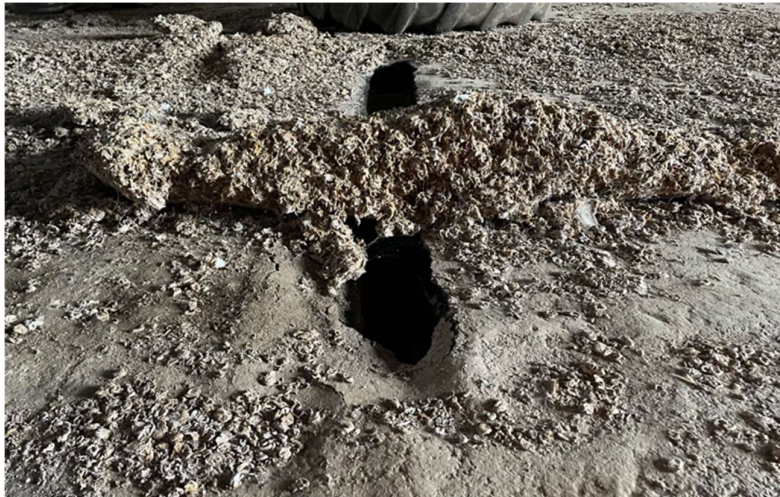
*Image 3-40 – Failed timber deck poses a serious risk of injury*

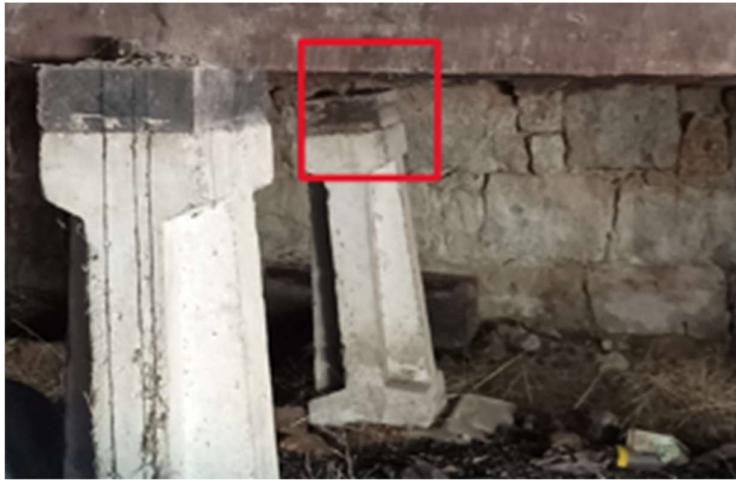
Generally the concrete stumps were in fair condition, however three of these have settled, rotated and disconnected from the timber bears which they were designed to support.

*Image 3-41 – Concrete stump rotated and disconnected from bearer*

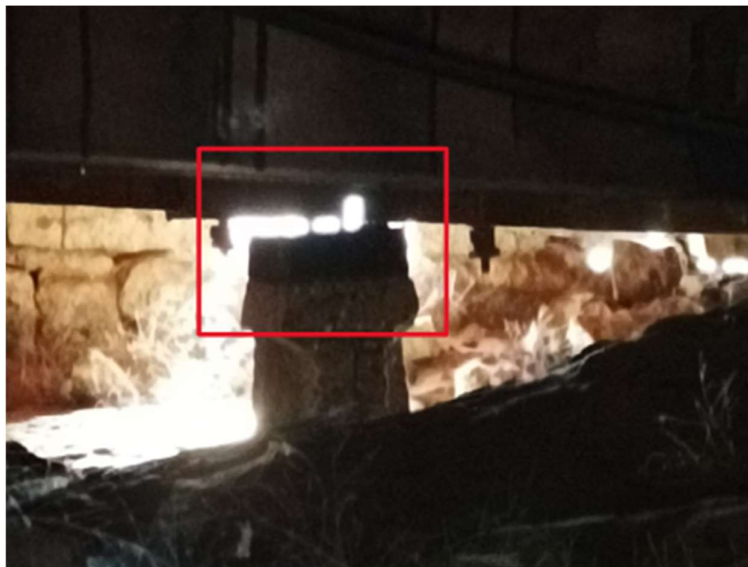
*Image 3-42 – Concrete stump rotated and disconnected from bearer*

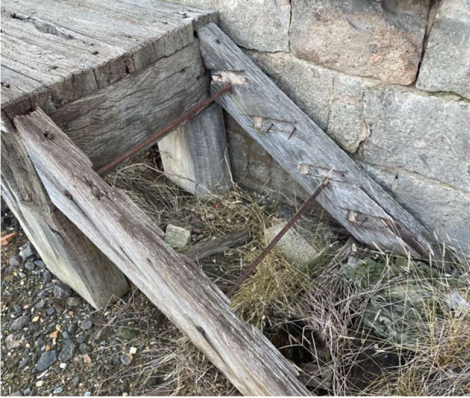
REF	DEFECT DESCRIPTION	PHOTO
<b>FACADE</b>		
1	External timber stairway has decayed and the treads are missing in full.

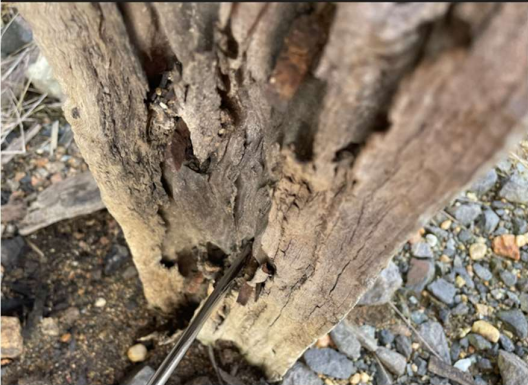
2	External timber landing stub column is severely rotten.

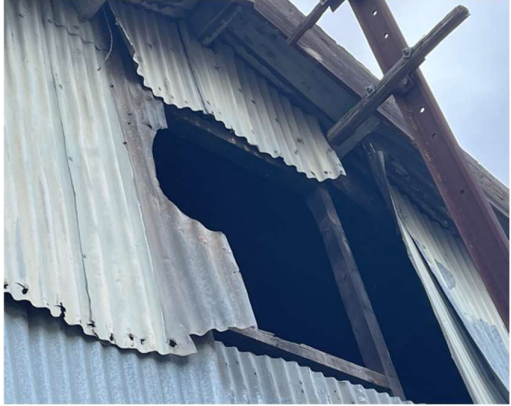
REF	DEFECT DESCRIPTION	PHOTO
3	Corrugated steel wall cladding is missing, adjacent wall cladding is loose and at risk of falling without further warning. Up End.

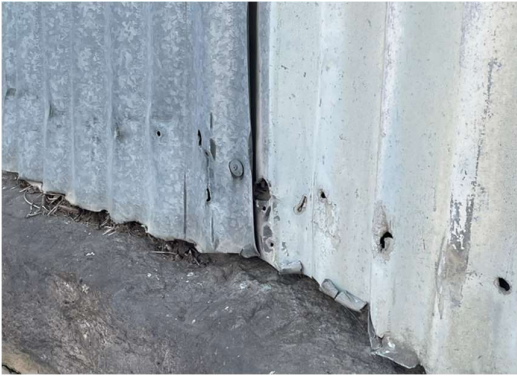
4	Corrugated steel wall cladding rivets are missing. Up End.

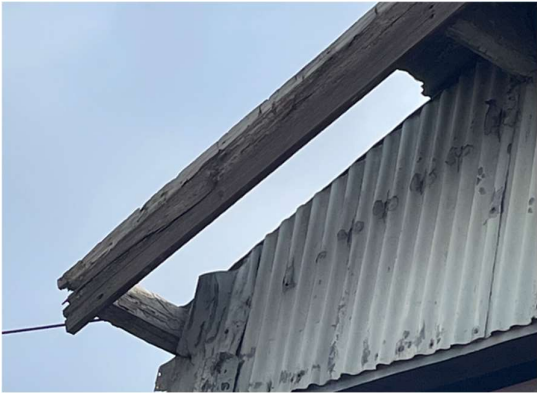
5	Roof sheeting has disconnected from the eaves and fallen. Up End, Up Side.

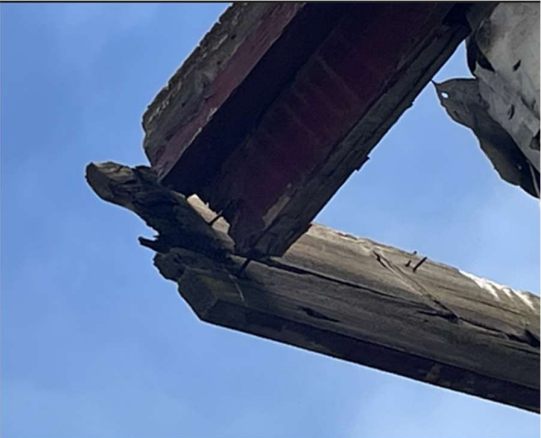
REF	DEFECT DESCRIPTION	PHOTO
6	Timber fascia is severely rotten and is disconnected from adjacent fascia. Up End, Up side.

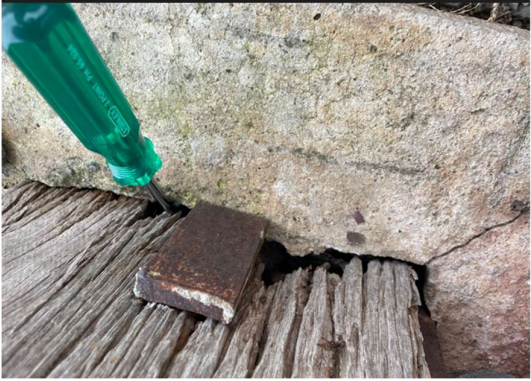
7	Timber column is rotten at base. Up end, Up side.

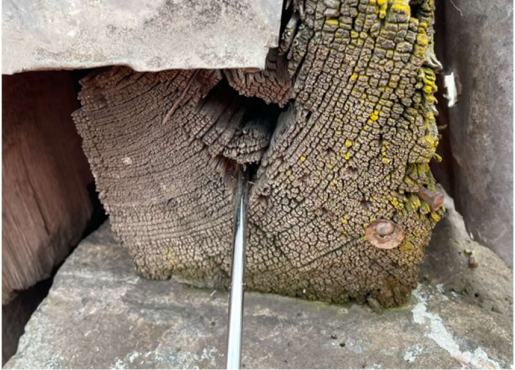
8	Rotten timber wall plate beam end. Up End, Up Side.

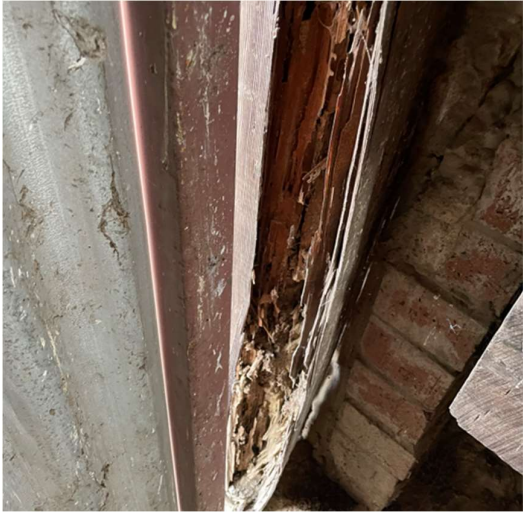
REF	DEFECT DESCRIPTION	PHOTO
9	Failed timber column. Up End, central.

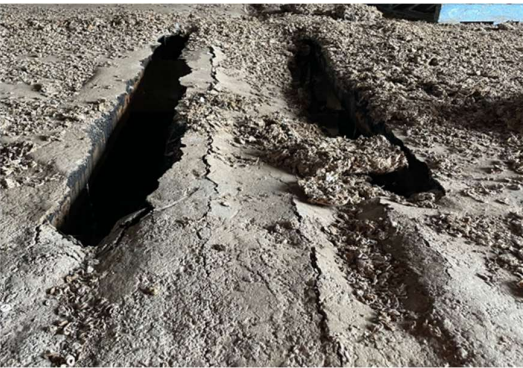
10	Failed timber deck planks, (5) of.

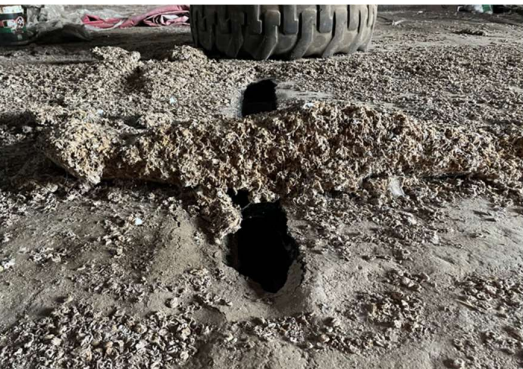
11	Failed timber deck planks, (3) of.

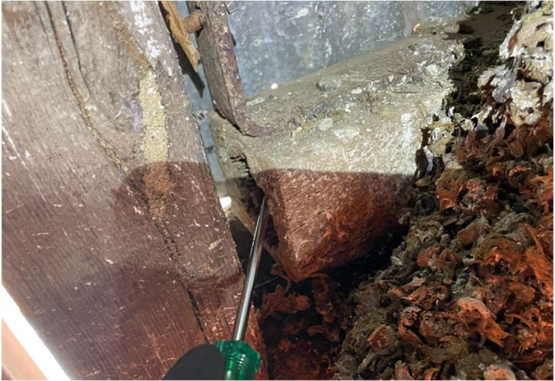
REF	DEFECT DESCRIPTION	PHOTO
12	Rotten timber girt. Up End.

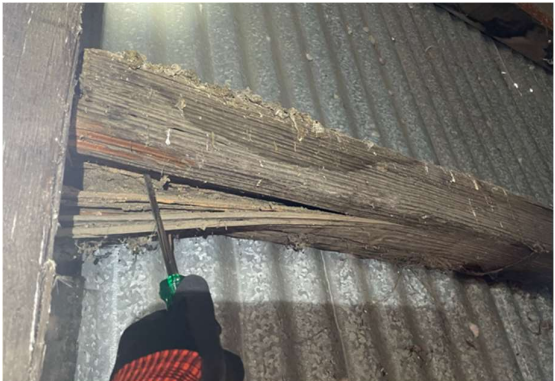
13	Rotten timber girt. Up End.

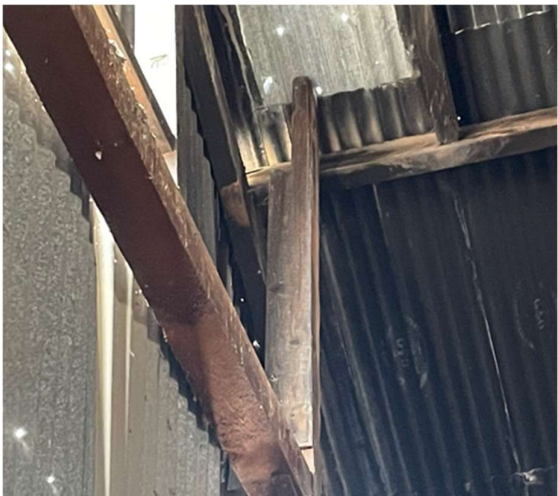
14	Timber column disconnection and inward lean. Up End.

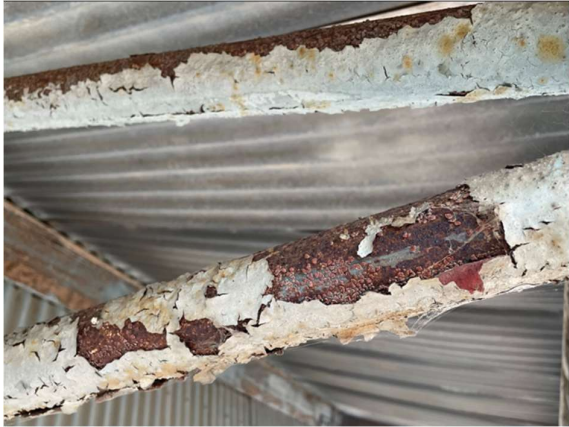
REF	DEFECT DESCRIPTION	PHOTO
15	Paint deterioration and corrosion on cantilevered roof (strut-tie) supports. (Typical).

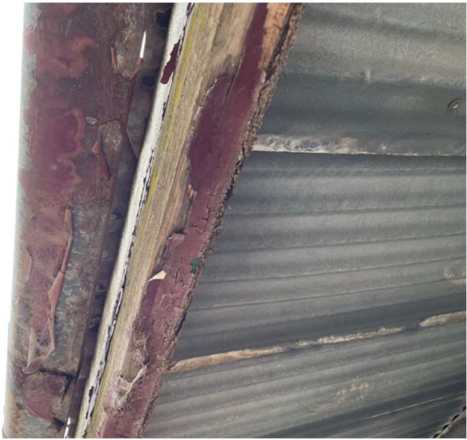
16	Paint deterioration on steel gutter and fascia. (Typical)

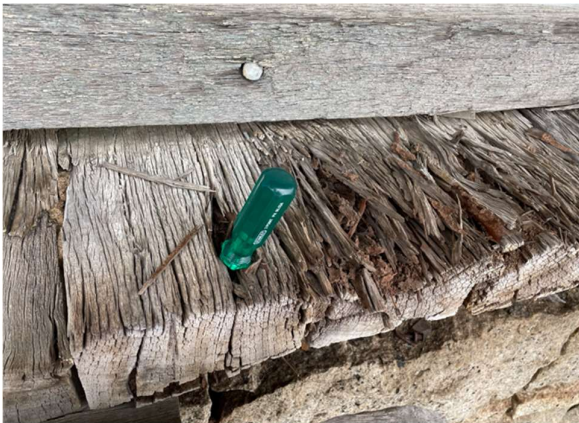
17	Rotten external timber deck planks. 30% of total quantity of external deck planks are in this condition.

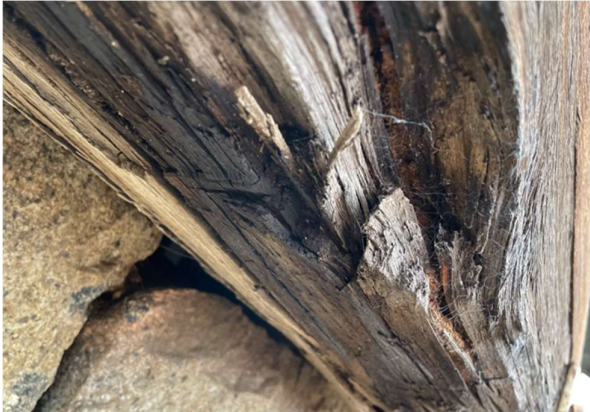
REF	DEFECT DESCRIPTION	PHOTO
18	External loading timber beam is rotten and has section loss. Down Side, entrance door.

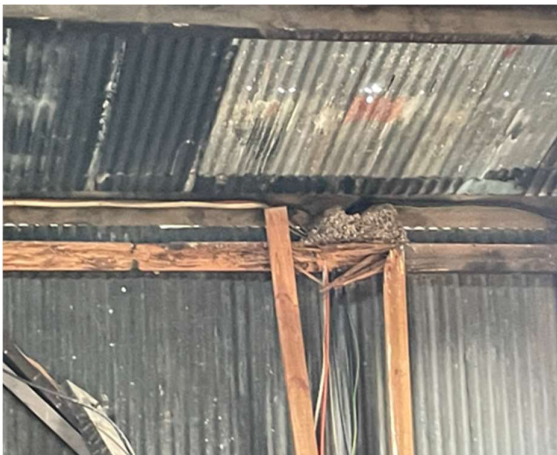
19	Collapsed timber beam. Down Side, Down End.

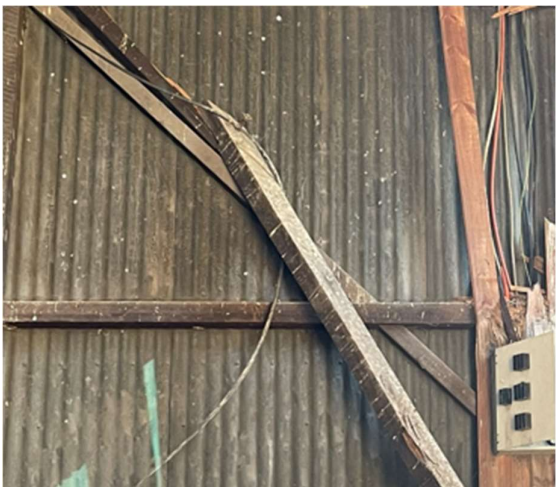
20	Collapsed timber roof bracing. Down Side, Down End.

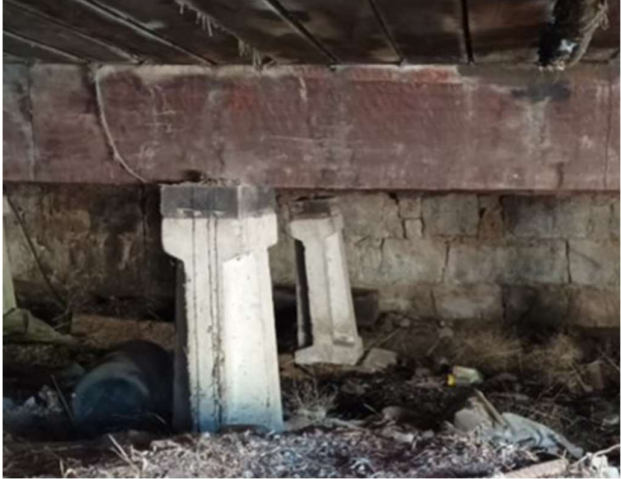
REF	DEFECT DESCRIPTION	PHOTO
23	Concrete stumps have settled, rotated, and disconnected from the timber bearers above.

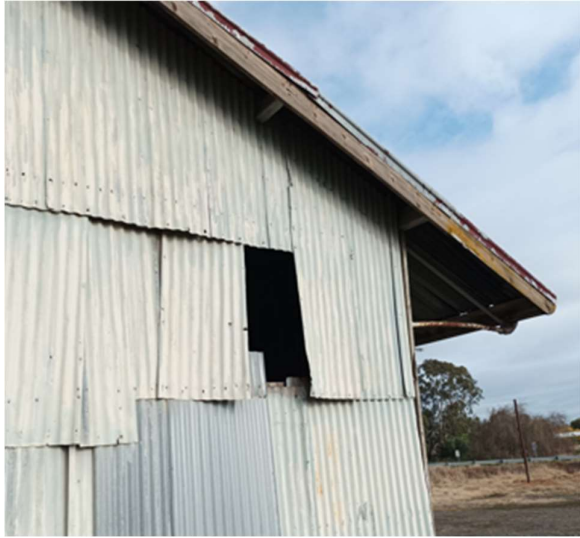
A photograph showing a cross-section of a building's foundation. A thick, dark brown timber bearer is positioned horizontally. Below it, two concrete stumps are visible. The stumps appear to have shifted and are no longer in contact with the timber bearer, indicating structural failure. The ground around the stumps is uneven and contains some debris.
24	Corrugated steel wall cladding has disconnected and fallen. Down End.

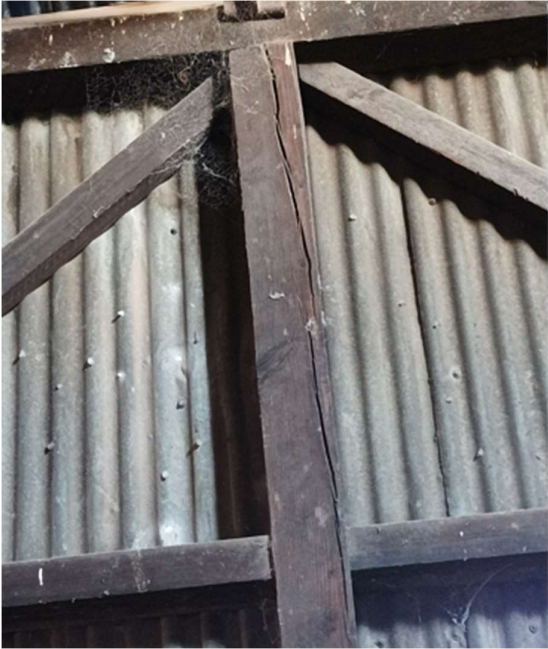
REF	DEFECT DESCRIPTION	PHOTO
29	Split in timber loadbearing column Up Side.

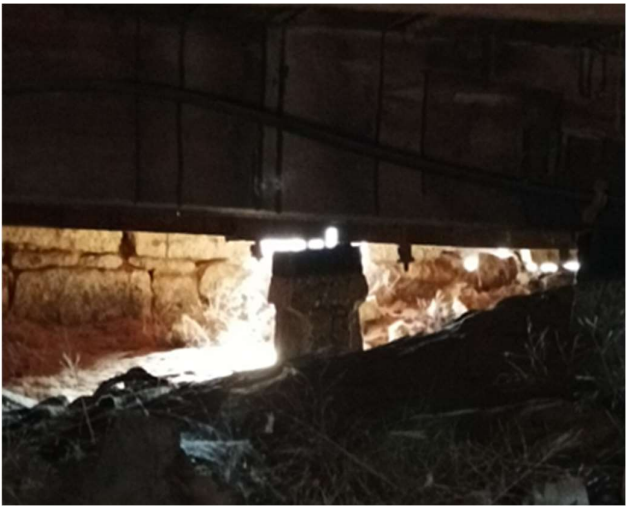
30	Concrete stump has disconnected from bearer.
