SJ23-0631-RPT-V1

**Benalla Signal Hut
Building Inspection Report**

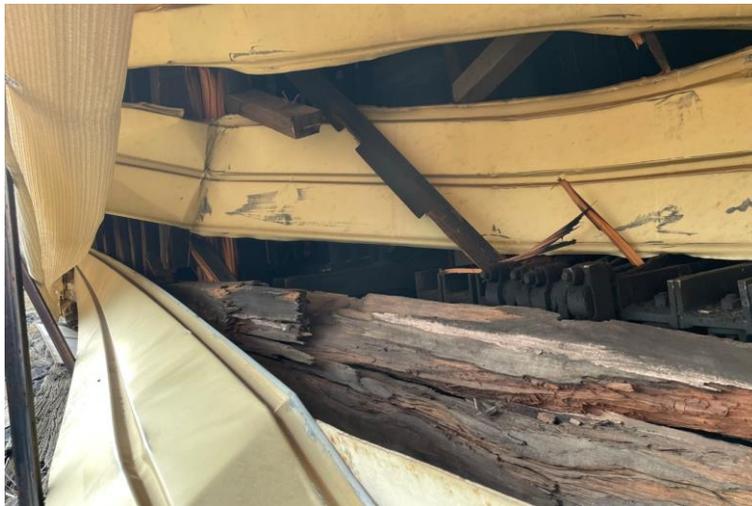
Figure 3-5: Section of external cladding that has been damaged beyond repair.

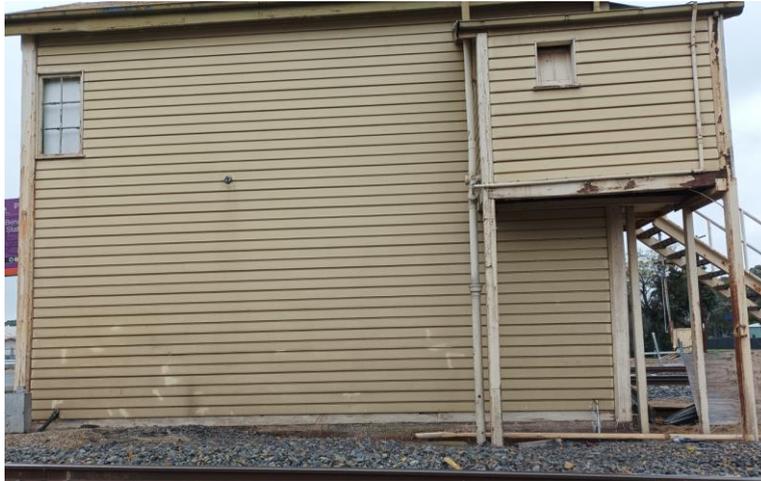
Figure 3-6: General condition of steel weatherboard cladding

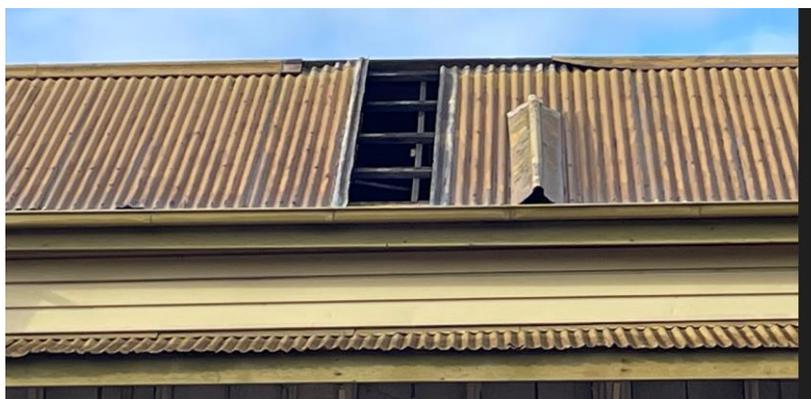
Figure 3-8: Section of roof sheeting missing and section of the roof ridge on top of the roof

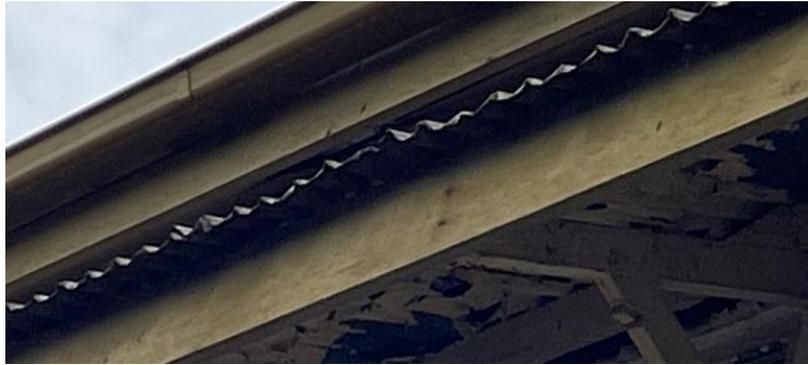
Figure 3-9: Deformed section of the roof sheeting on the lower portion of the roof

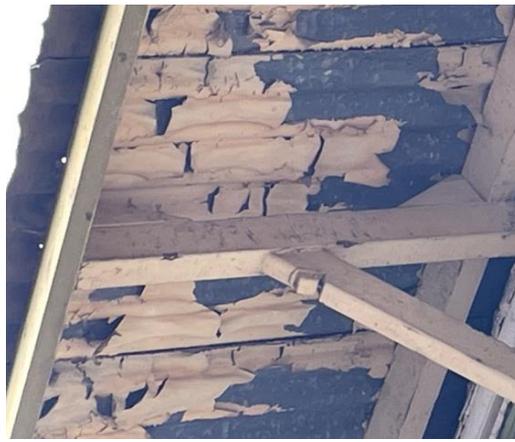
Figure 3-10: Deterioration of protective coating system on roof sheeting

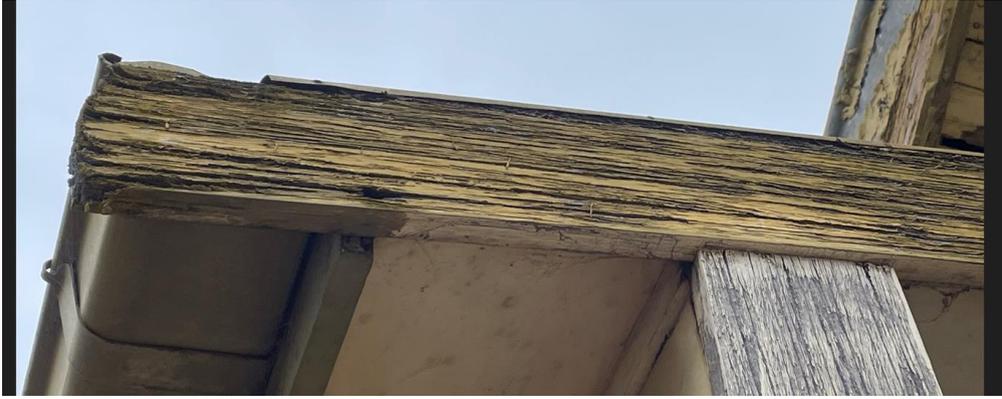
Figure 3-11: Significant splitting and deterioration of the fascia member

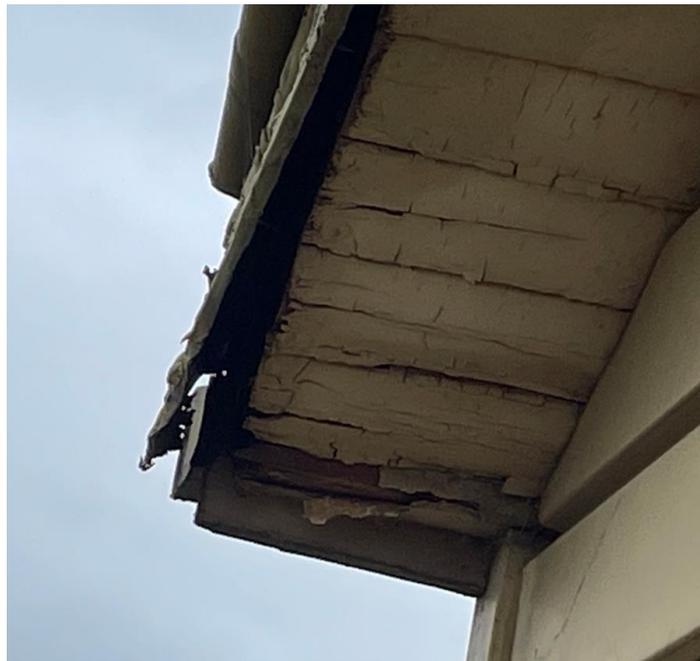
Figure 3-12: Disconnected fascia member and deterioration of the roof lining

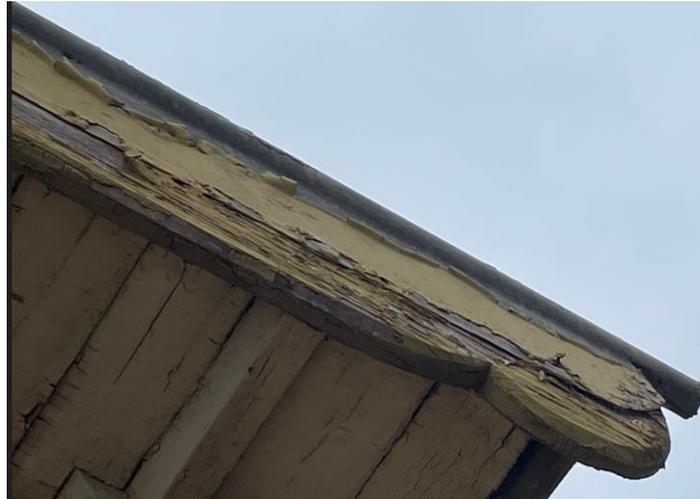
Figure 3-13: Deteriorated fascia member

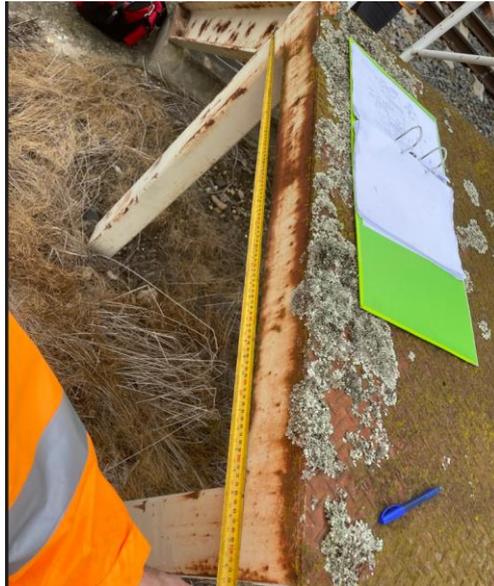
Figure 3-14: General surface corrosion on one of the PFC members of the external staircase

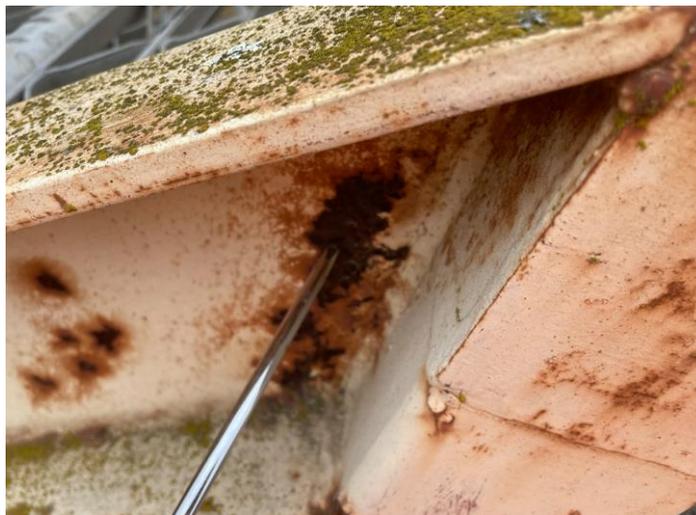
Figure 3-15: Pitting corrosion on one of the PFC members on the external staircase

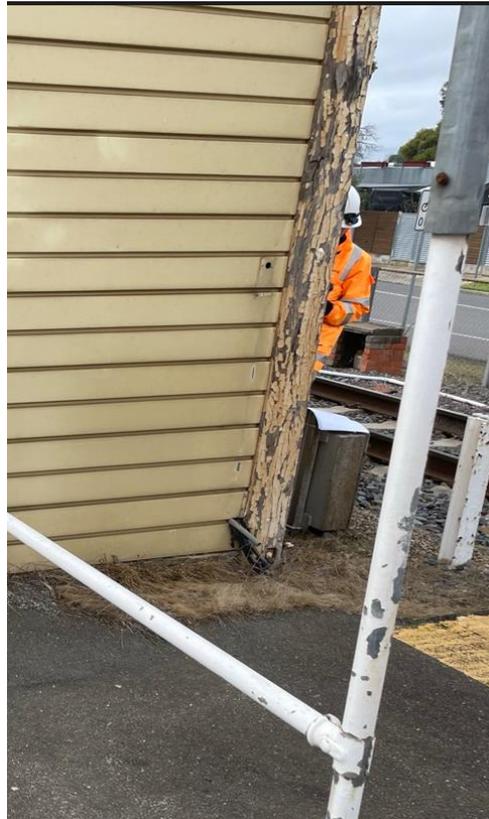
Figure 3-16: Severe splitting and deterioration of protective coating system on south-west column

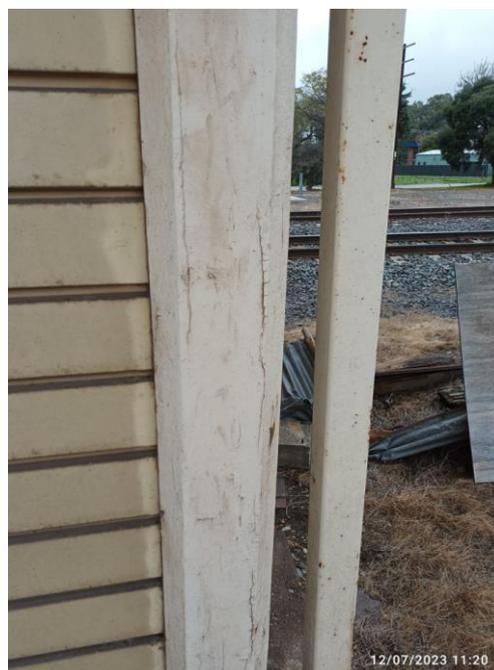
Figure 3-17: General photo of main column on the south-east corner of the building

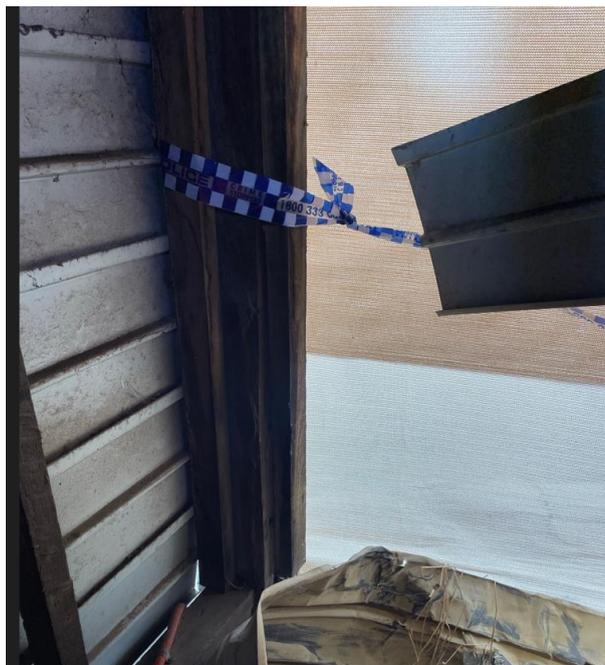
Figure 3-18: Main column impacted by the accidental impact load

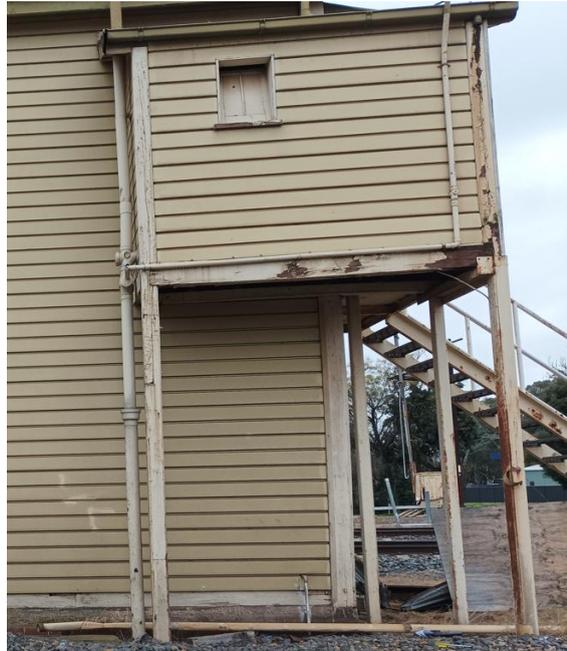
Figure 3-19: Non horizontal external beam supporting first floor toilet

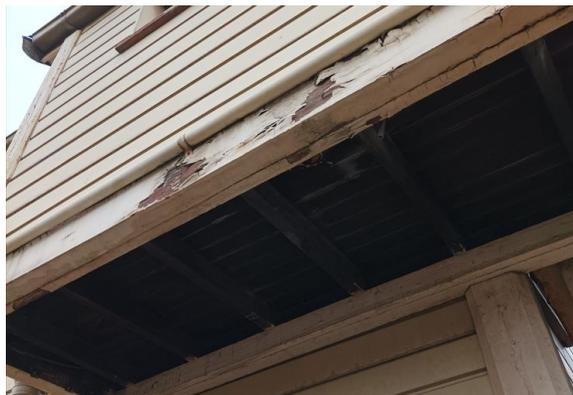
Figure 3-20: Split in external beam supporting first floor toilet

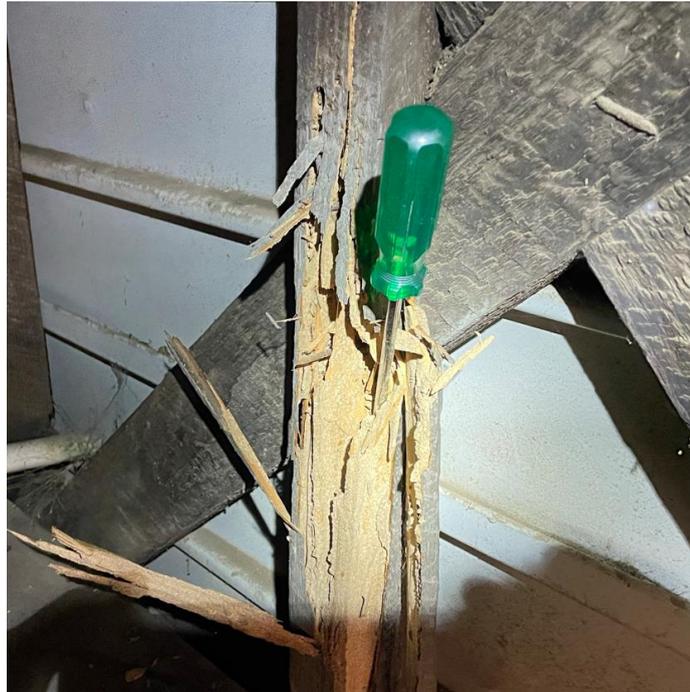
Figure 3-21: Structurally failed member due to the possible presence of termites

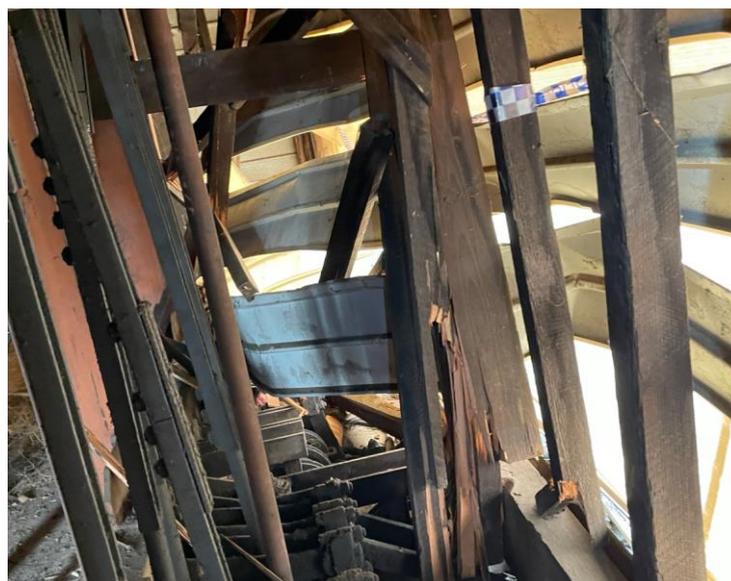
Figure 3-22: Structurally failed column and mullions due to impact collision

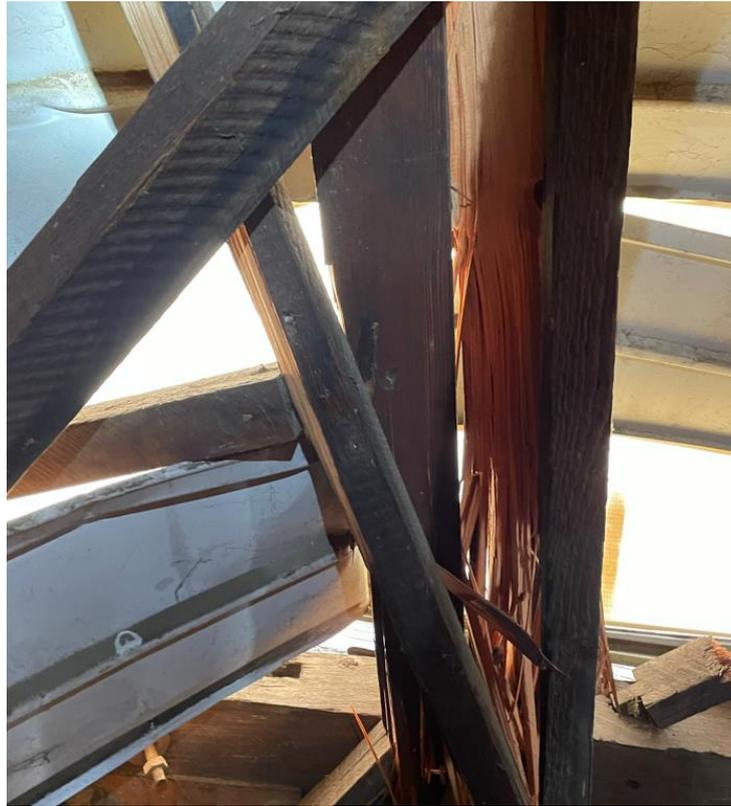
Figure 3-23: Structurally failed column due to impact collision

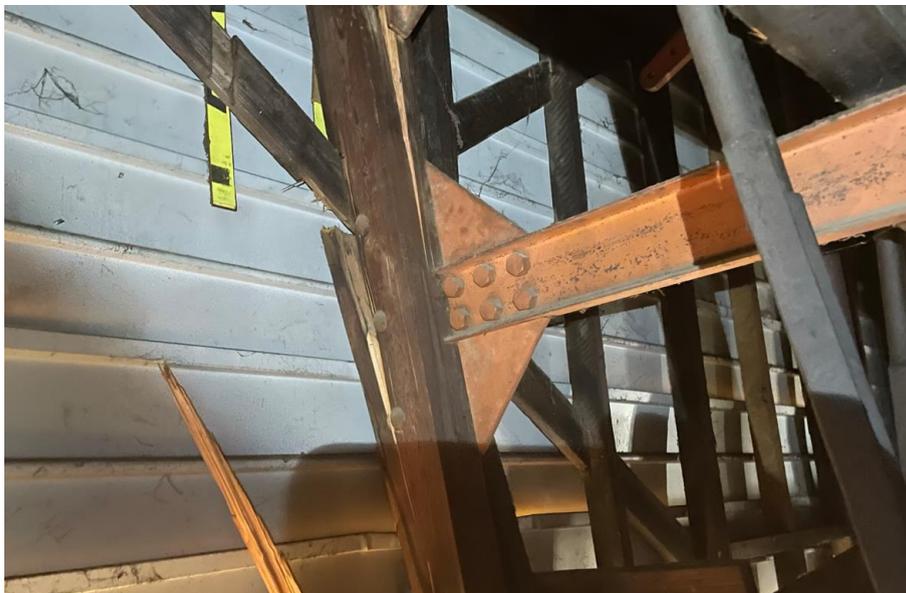
Figure 3-24 Structurally failed members due to impact collision

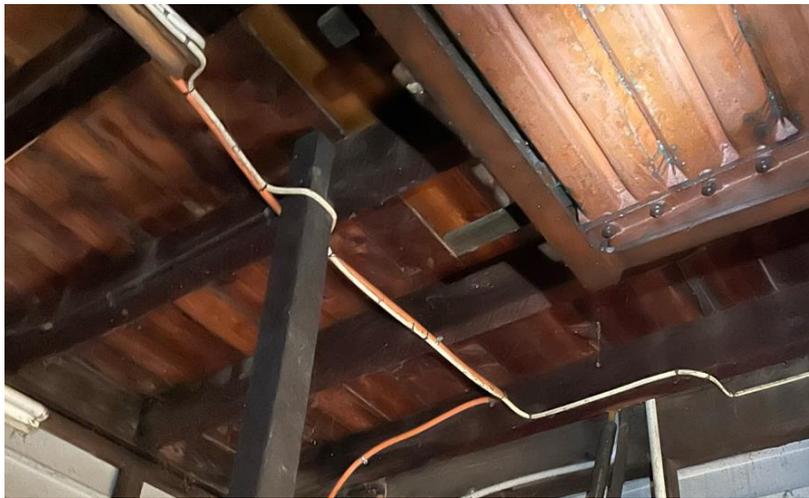
Figure 3-25: Underside of timber beams and deck flooring of the first floor

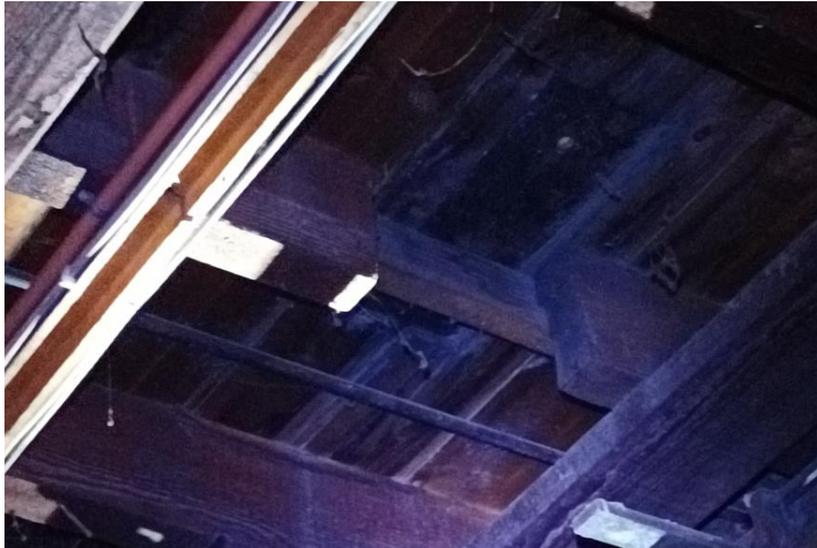
Figure 3-26: Missing middle section of timber beam of first floor

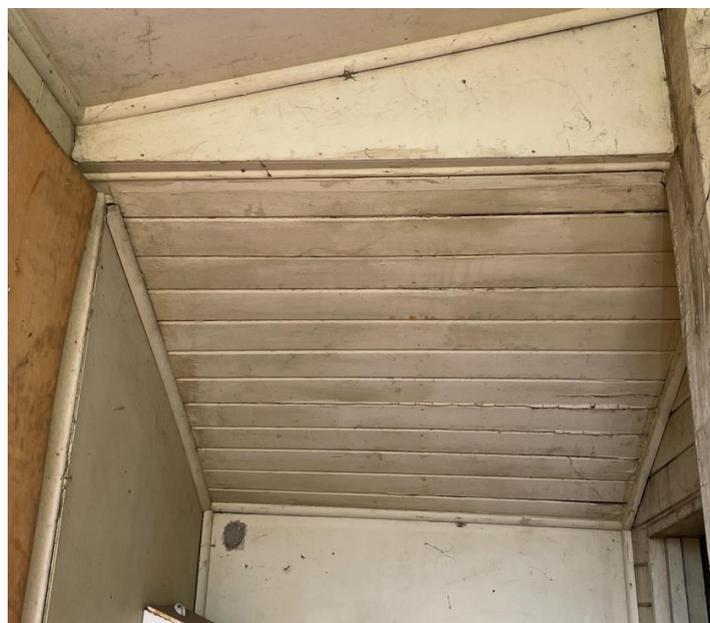
Figure 3-27: Timber ceiling adjacent to first floor toilet

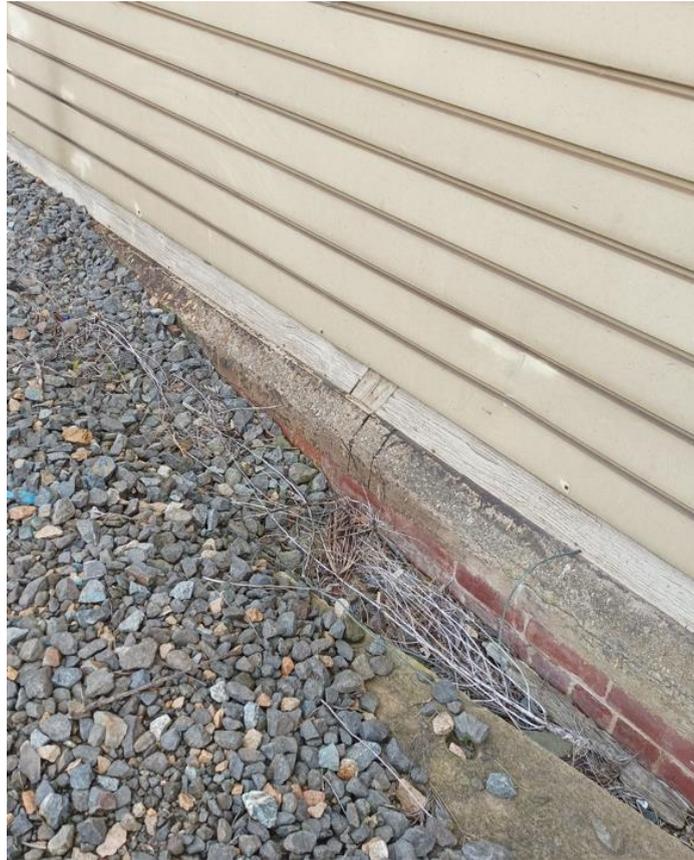
Figure 3-31: General photo of concrete footing on masonry bricks

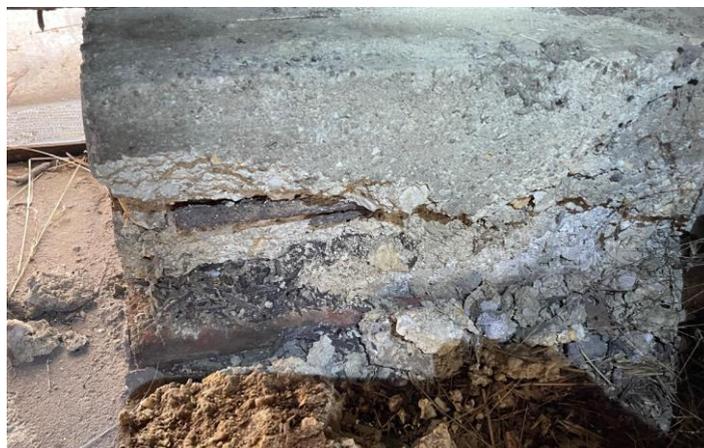
Figure 3-32: Missing piece of the concrete footing

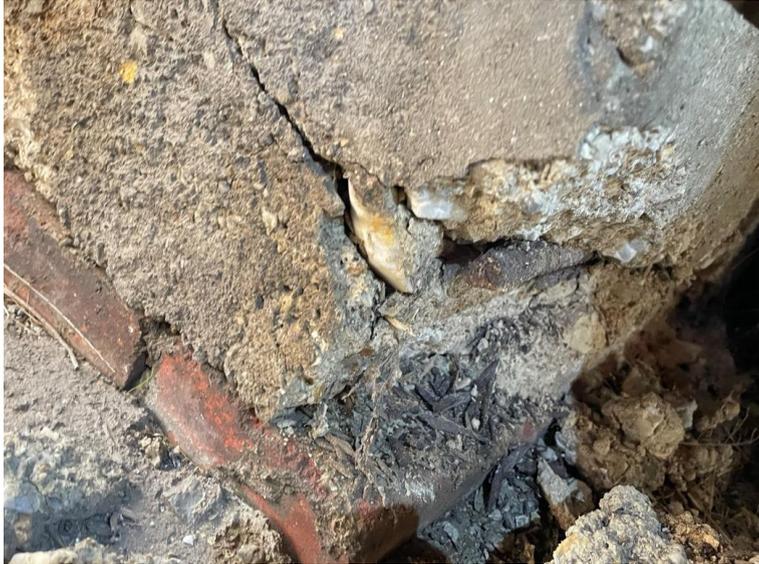
Figure 3-33: Cracked piece of concrete upstand with exposed rebar

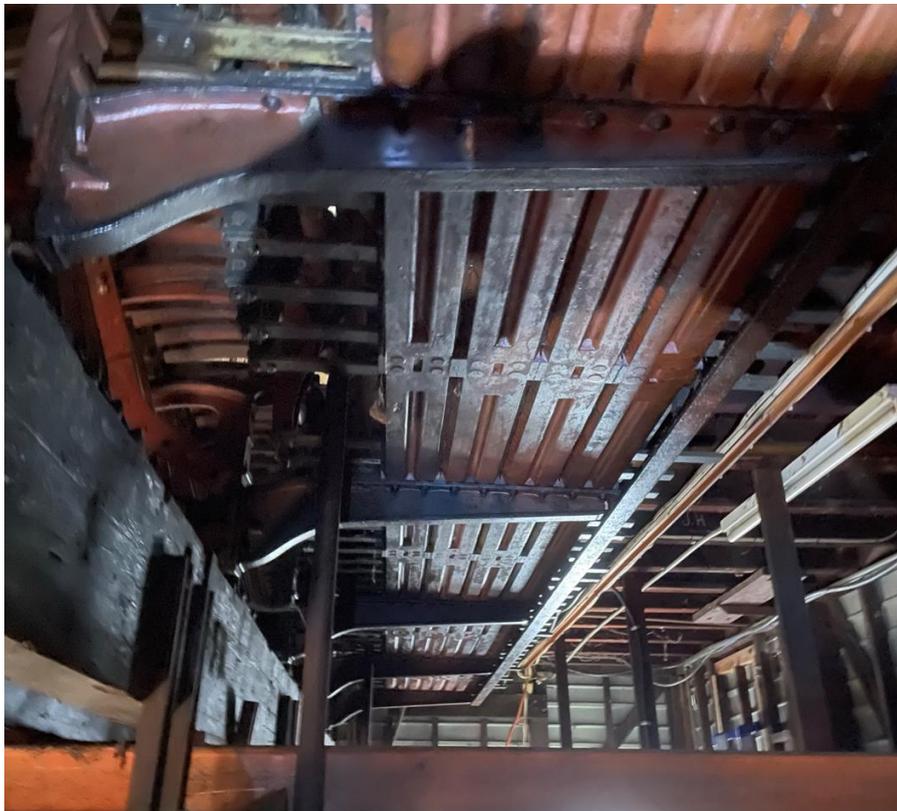
Figure 3-34: Signalling lever frame and associated equipment

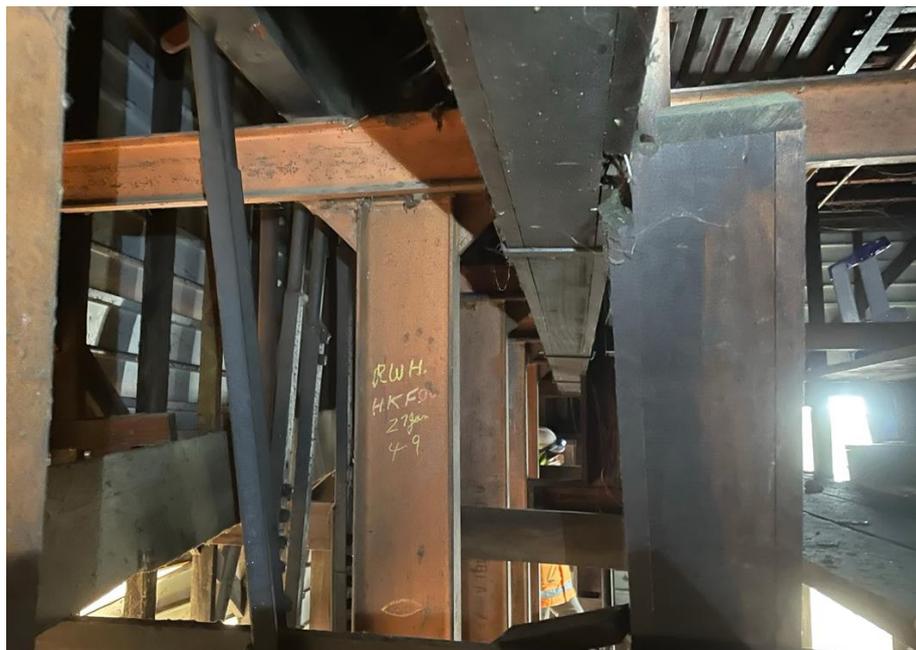
Figure 3-41: Internal steel lever frame supports

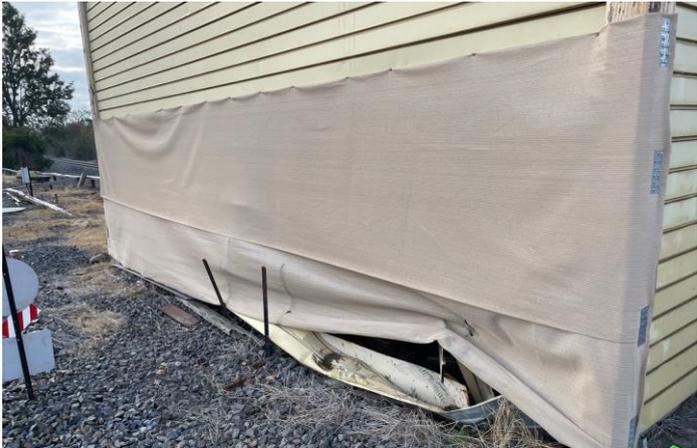
2	Steel wall cladding that has been damaged beyond repair by impact damage

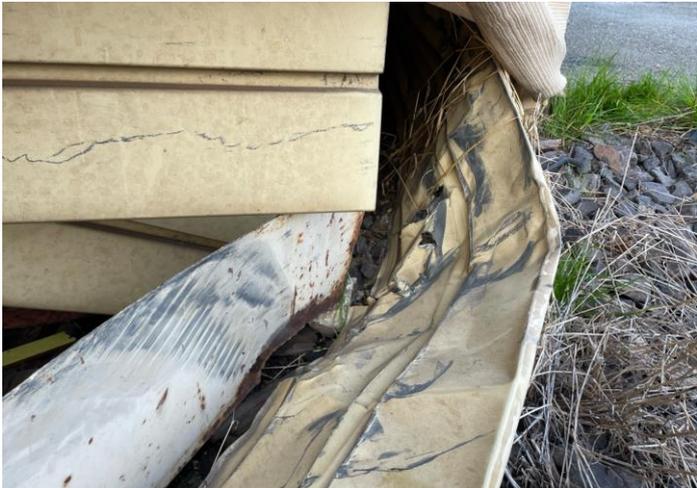
REF	DEFECT DESCRIPTION	PHOTO
3	Steel wall cladding and internal timber wall members damaged beyond repair by impact damage

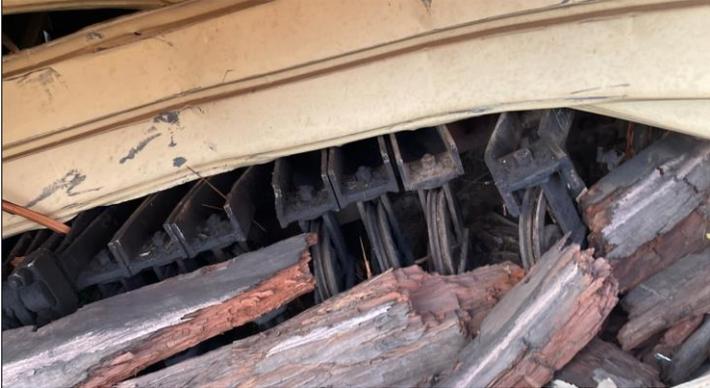
A close-up photograph showing significant damage to the interior wall structure. The top part of the image shows a horizontal steel beam with yellowish cladding. Below it, several dark, charred timber members are visible, some of which are broken and splintered. The damage appears to be the result of a severe impact.
4	Steel wall cladding and internal timber wall members damaged beyond repair by impact damage

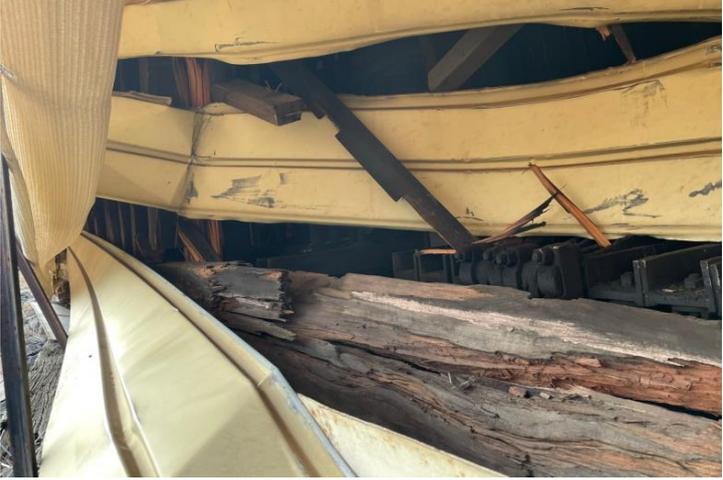
A photograph showing a wider view of the interior wall damage. The yellowish steel cladding is severely distorted and broken. Large sections of timber wall members are exposed, showing extensive charring and structural failure. The damage is extensive and appears to be beyond repair.

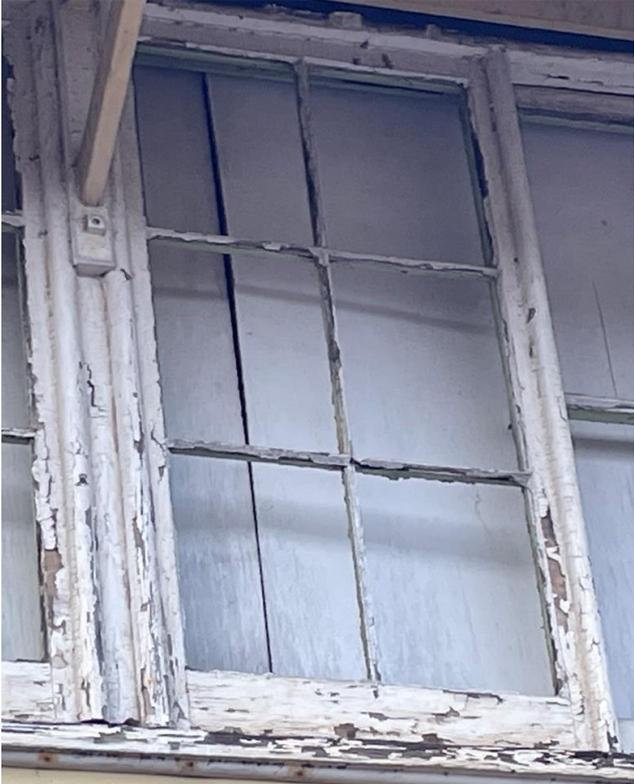
6	Splitting and deterioration of protective coating of timber framed windows on north elevation of structure

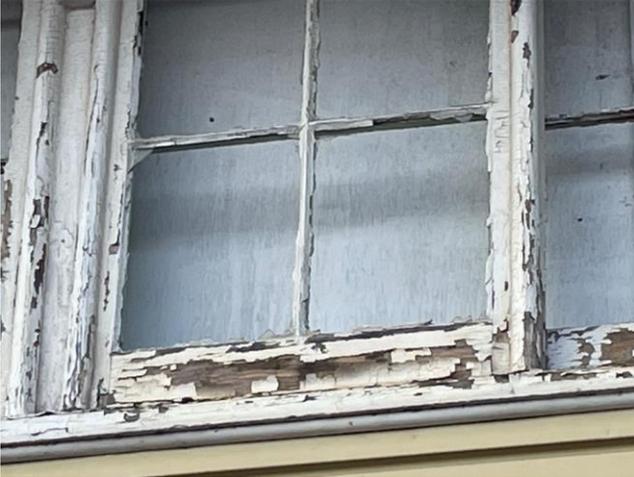
REF	DEFECT DESCRIPTION	PHOTO
7	Splitting and deterioration of protective coating of timber framed windows on north elevation of structure

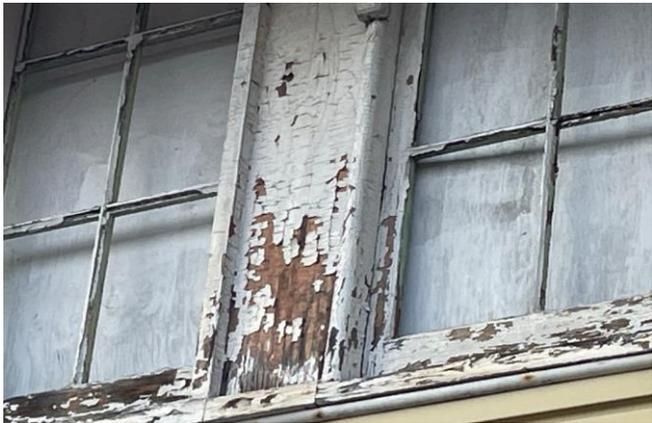
COLUMNS		
8	Severe splitting and deterioration of protective coating system on main timber column on south-west corner of structure

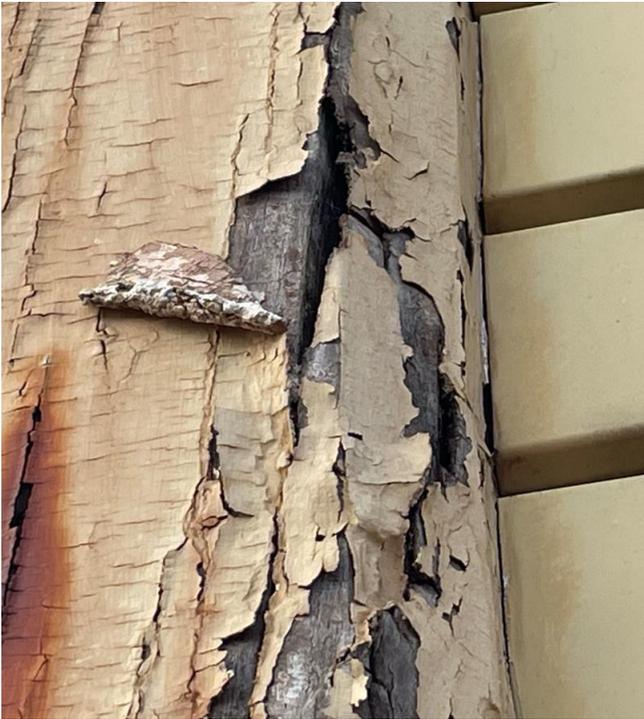
REF	DEFECT DESCRIPTION	PHOTO
9	Splitting of timber column and deterioration of protective coating system on south-west corner of structure

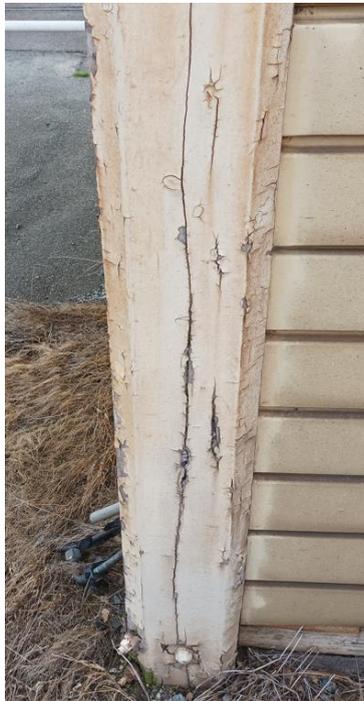
10	Splitting of timber column and deterioration of protective coating system on south-west corner of structure

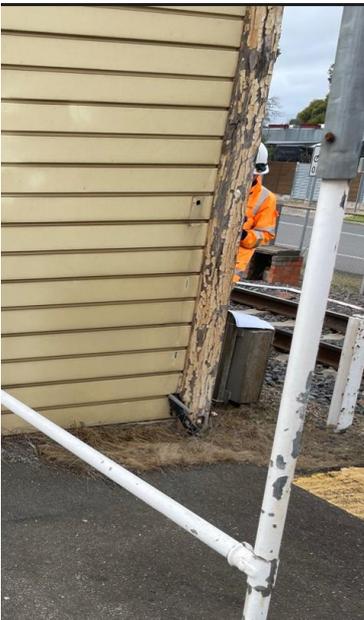
REF	DEFECT DESCRIPTION	PHOTO
11	Main timber column member on the north-west corner of the structure affected by the impact damage

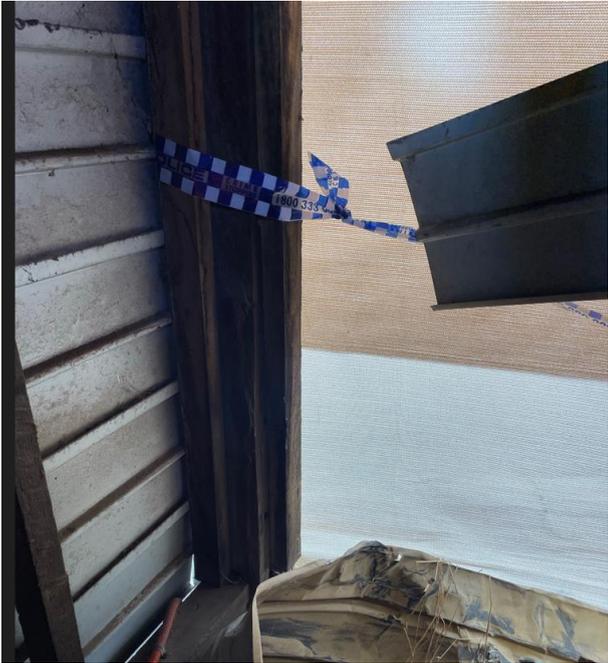
12	Column on northern elevation has been destroyed, presumably by vehicle impact.

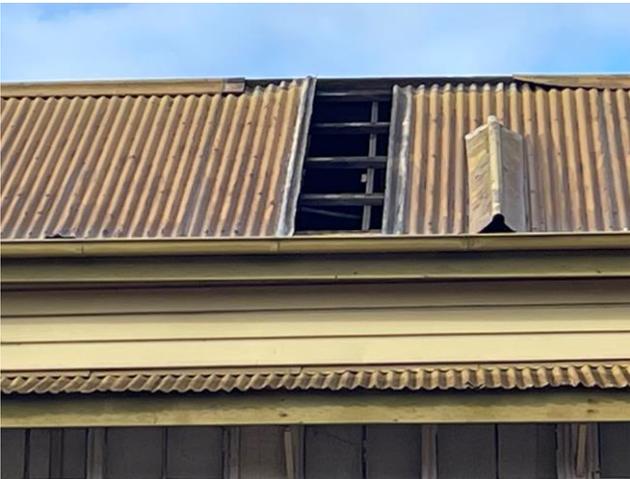
14	Deformed corrugated steel roof sheeting on the lower portion of the roof

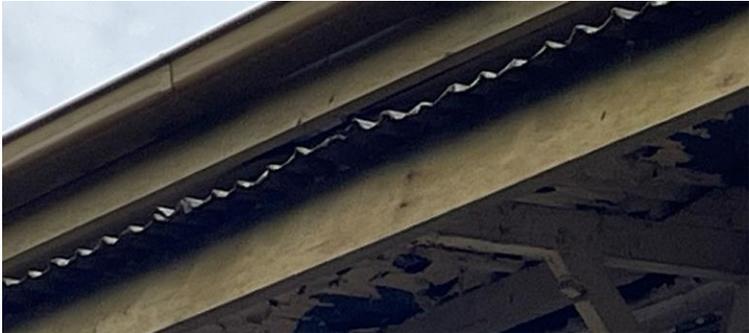
15	Deterioration of the protective coating on the underside of the lower portion of the roof

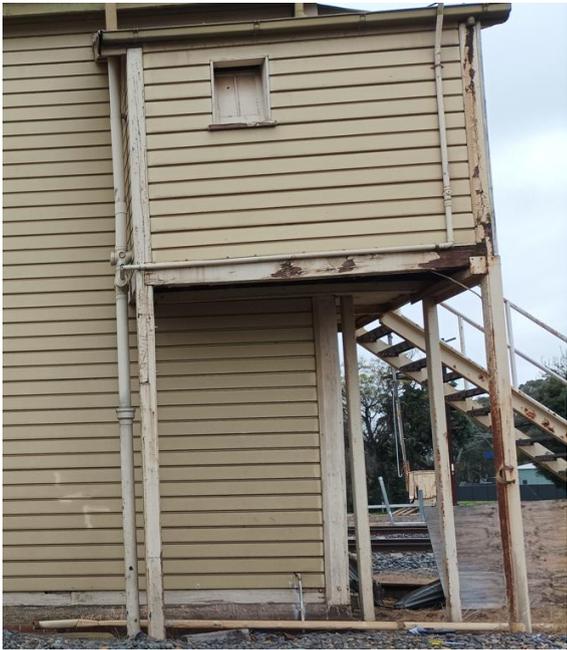
17	Severe splitting in the external timber beams supporting the first floor toilet and deterioration of the protective coating system

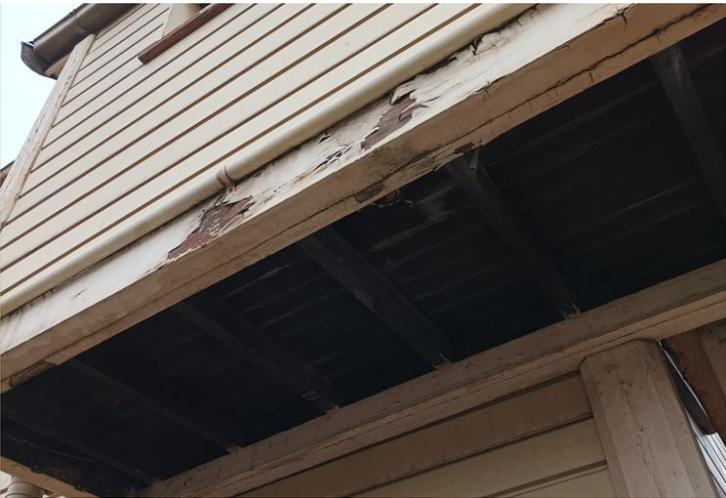
FASCIA, GUTTER AND ROOF SOFFIT		
18	Significant splitting and deterioration of the timber fascia member

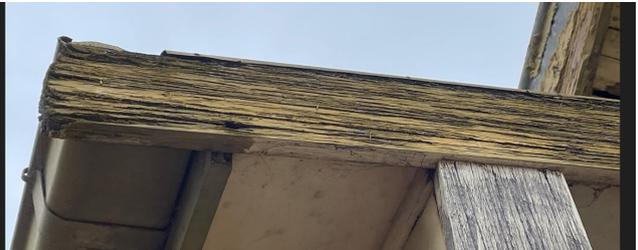
REF	DEFECT DESCRIPTION	PHOTO
19	<p>Disconnected timber fascia member and, splitting and deterioration of the protective coating system of the roof soffit members</p>

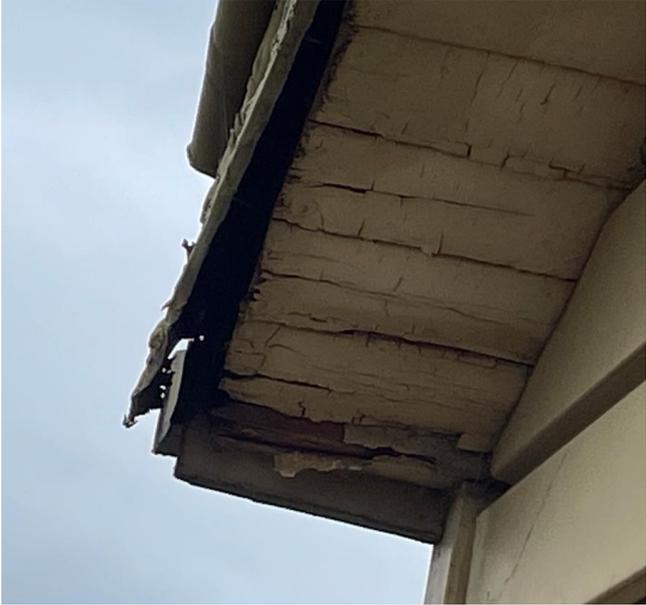
20	<p>Splitting and deterioration of the protective coating system</p>

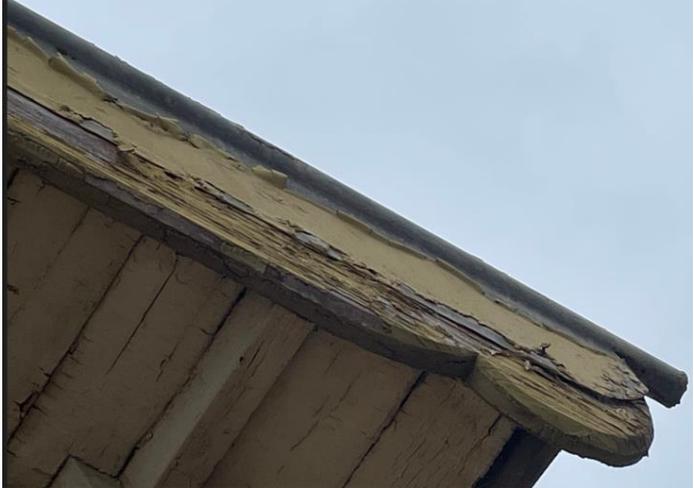
EXTERNAL STAIRCASE AND STEEL COLUMNS

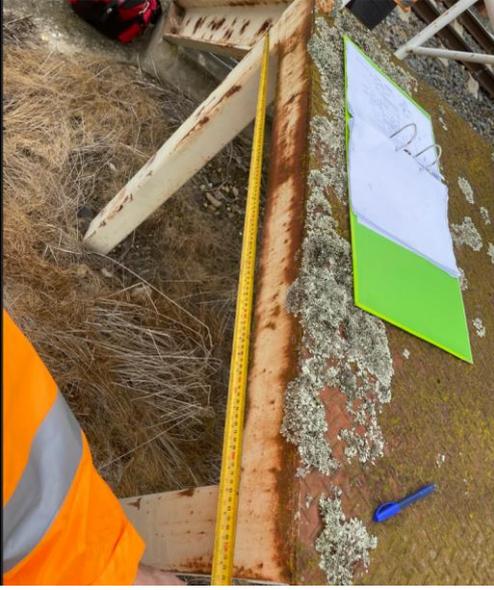
22	Pitting corrosion located on PFC member of external staircase where stair thread was connected to member

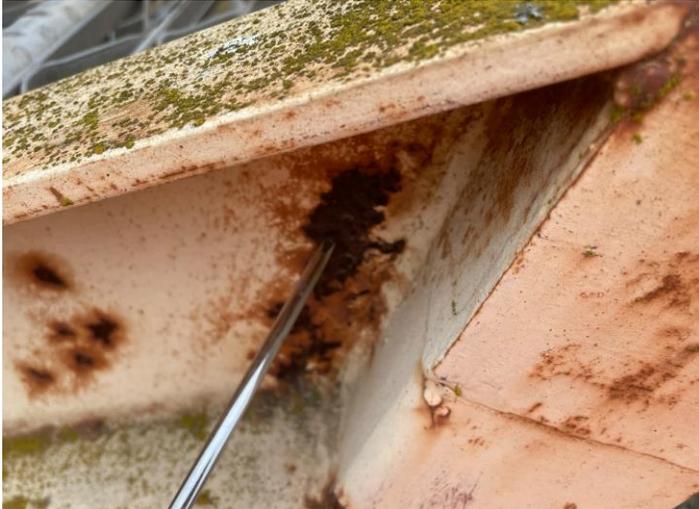
REF	DEFECT DESCRIPTION	PHOTO
23	Surface corrosion of external SHS column section supporting first floor toilet

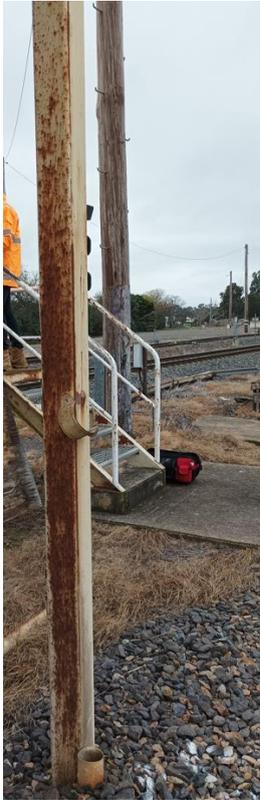
24	Fallen drainage pipe

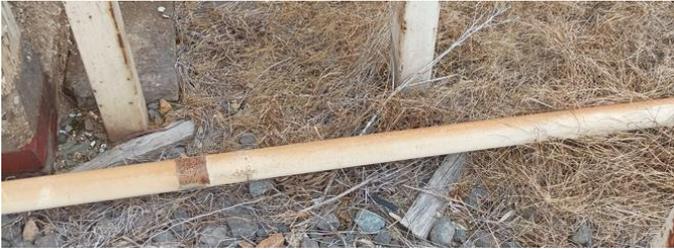
25	Delamination of the connection between the PFC member and the steel platform on the external stairs landing due to corrosion expansion of the steel.

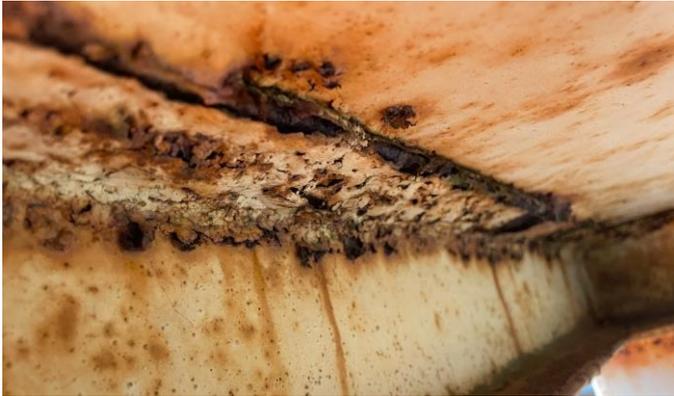
REF	DEFECT DESCRIPTION	PHOTO
26	Surface corrosion and grime present on external staircase landing

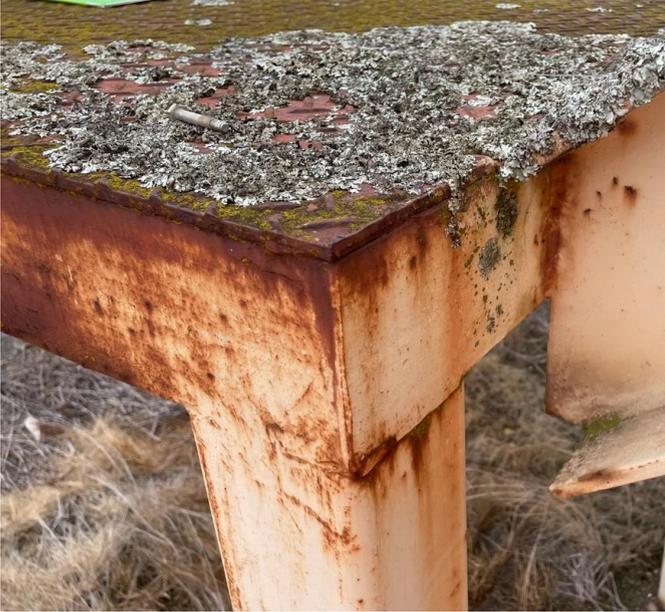
27	Pitting corrosion observed on at the underside of the steel platform landing

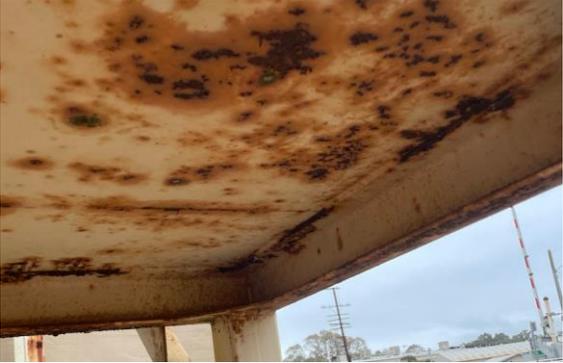
REF	DEFECT DESCRIPTION	PHOTO
28	Surface corrosion of one of the SHS column section supporting the steel staircase

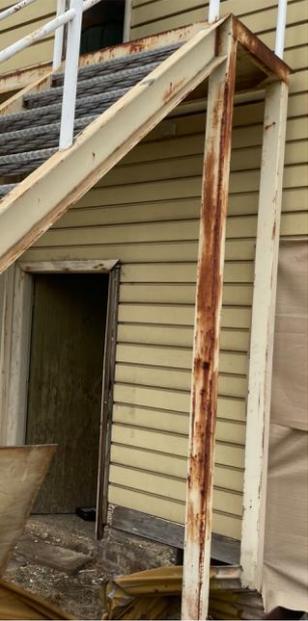
29	Pitting corrosion observed on PFC member

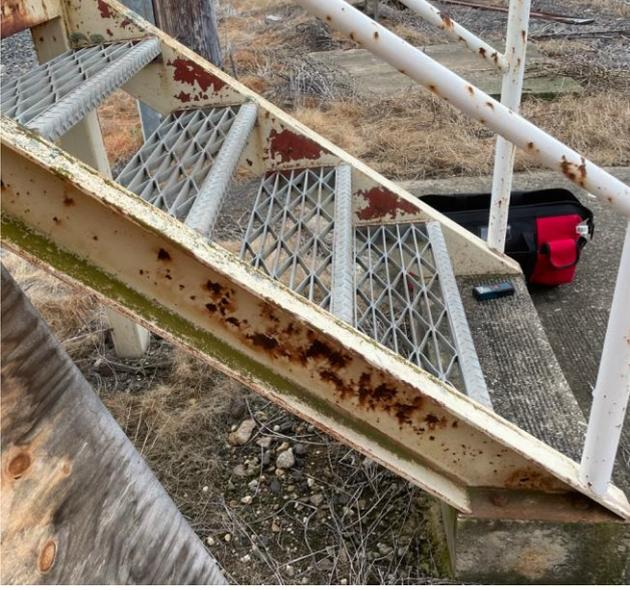
3.3.2 INTERNAL DEFECTS

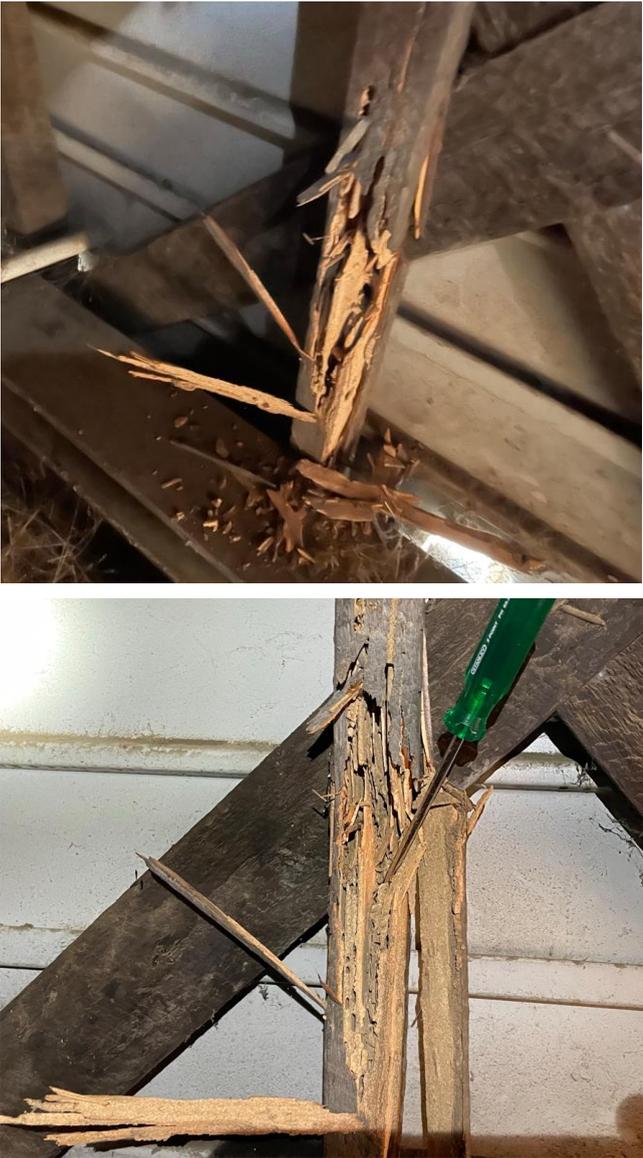
REF	DEFECT DESCRIPTION	PHOTO
31	Severe split in internal column stud member

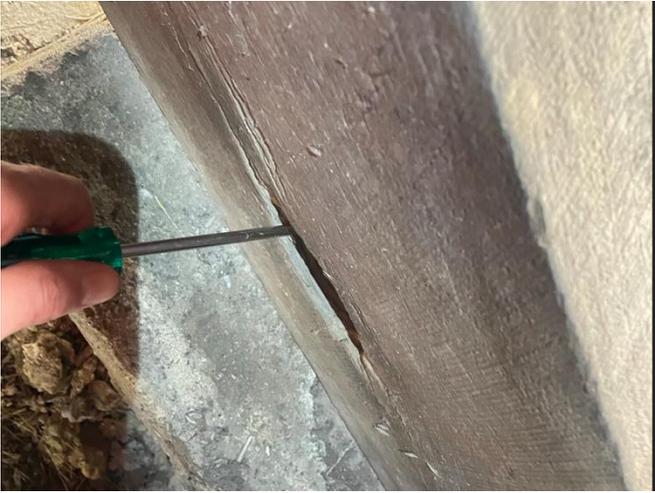
32	Splitting in internal column stud member

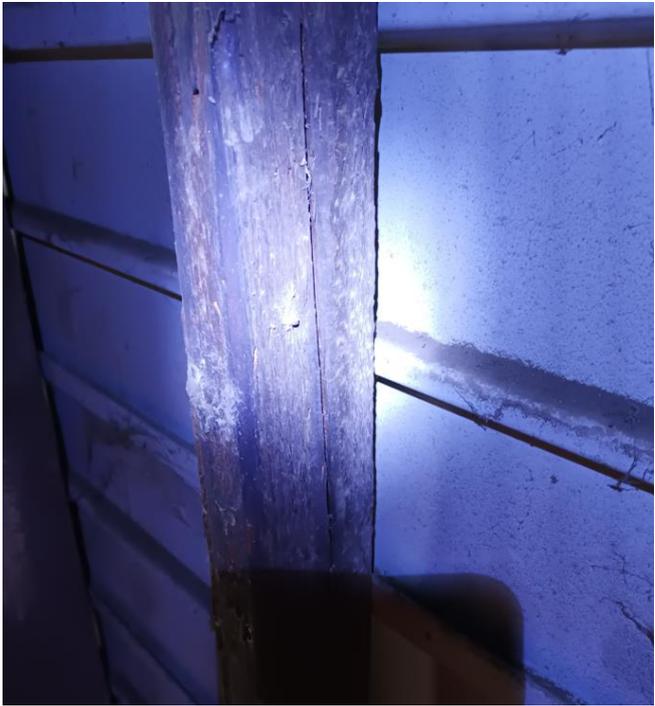
REF	DEFECT DESCRIPTION	PHOTO
33	Severely deformed cladding on the north elevation of the structure due to vehicle impact

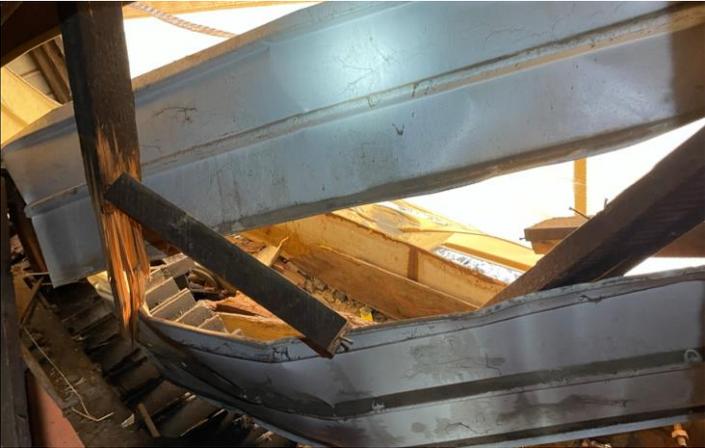
A photograph showing a close-up of a metal beam that has been severely deformed and bent downwards. The beam is surrounded by other structural elements, including wooden studs and other metal beams, indicating significant damage to the building's exterior cladding.
34	Failure of timber studs on the north elevation of the structure due to vehicle impact
