SJ23-0631-RPT-V1

**Benalla Signal Hut
Building Inspection Report**

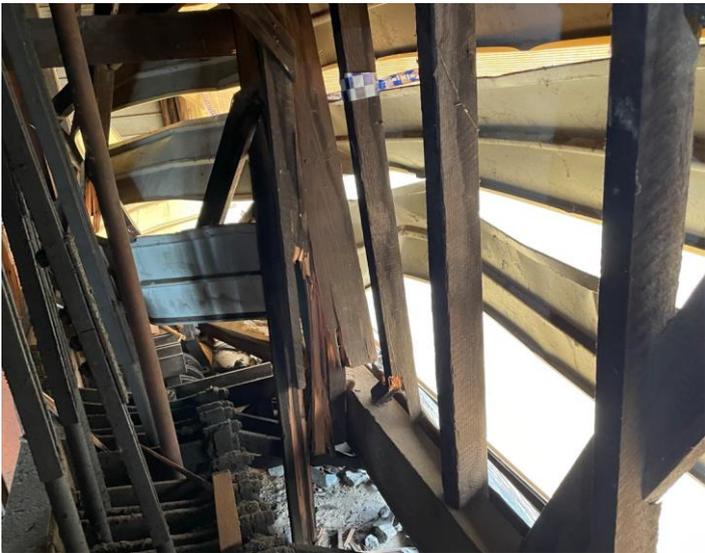
A photograph showing a close-up of a timber stud that has failed and is leaning precariously. The stud is surrounded by other structural elements, including metal beams and other timber studs, indicating significant damage to the building's exterior cladding.
35	Displaced timber beam due to structurally failed timber studs on the north elevation of the structure due to vehicle impact

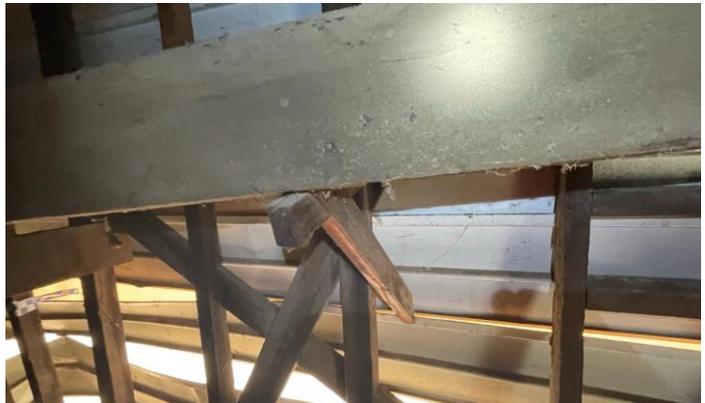
A photograph showing a close-up of a timber beam that has been displaced and is leaning precariously. The beam is surrounded by other structural elements, including metal beams and other timber studs, indicating significant damage to the building's exterior cladding.

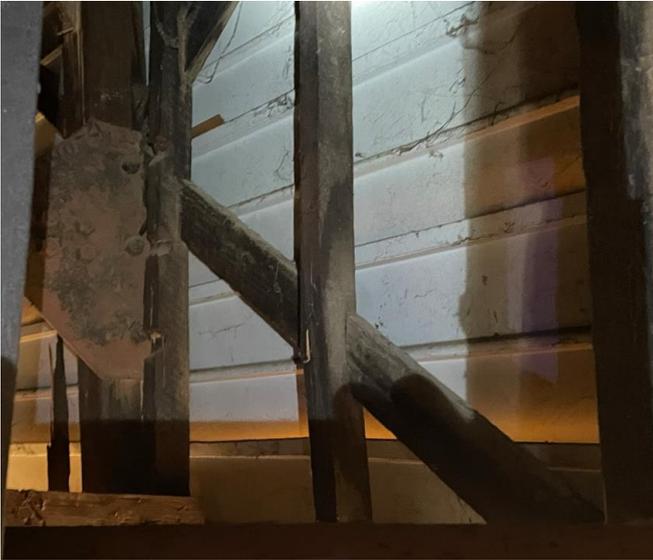
A photograph showing a vertical timber stud that has failed and is leaning away from its original position. The stud is surrounded by other structural members and a wall with horizontal siding. The failure is clearly visible as a gap and a sharp bend in the timber.
37	Failure of timber stud on the north elevation of the structure due to vehicle impact.

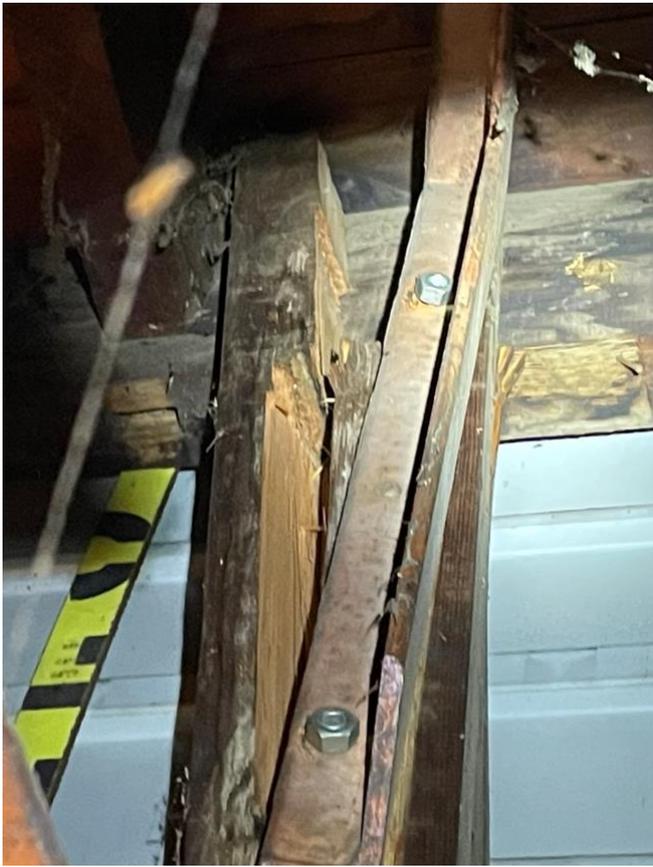
A close-up photograph of a timber stud that has split and failed. A metal bracket with two bolts is attached to the stud, but the timber has cracked and separated from the bracket. A yellow and black striped safety barrier is visible in the lower-left corner of the frame.

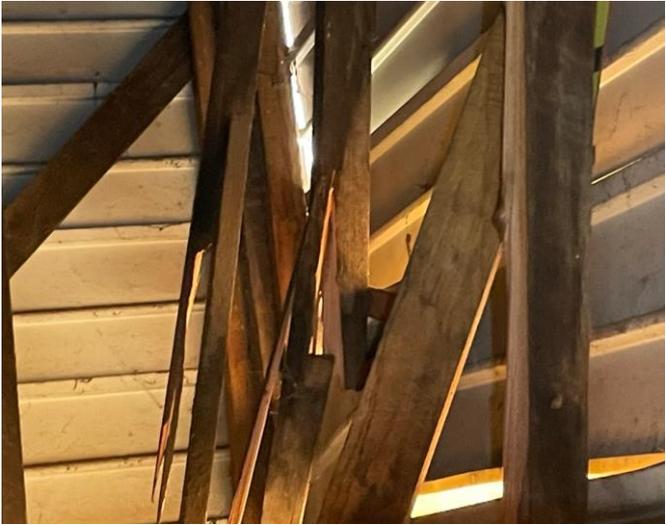
INTERNAL TIMBER FLOORING AND CEILING		
39	Missing portion of one of the timber floor beams at the underside of the first floor.

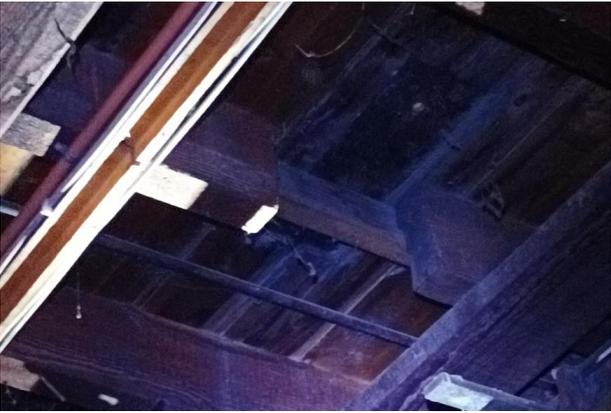
40	Minor splitting and deterioration of the protective coating system for timber ceiling adjacent to toilet.

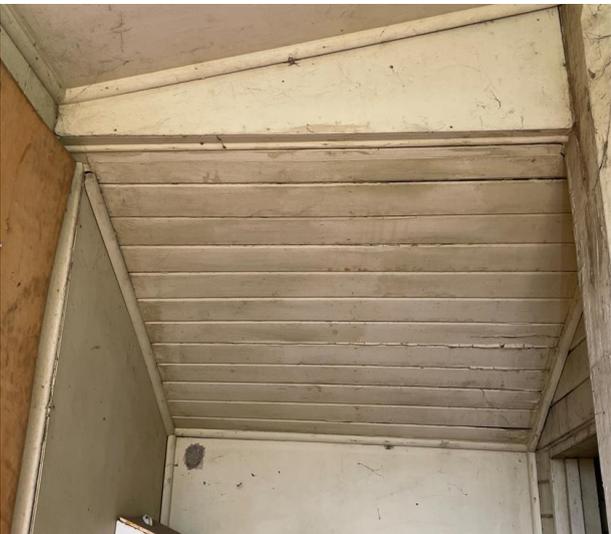
REF	DEFECT DESCRIPTION	PHOTO
MASONRY AND CONCRETE UPSTAND		
41	Concrete missing from concrete and masonry upstand alongside corroded reinforcement on the Down Side elevation of the structure

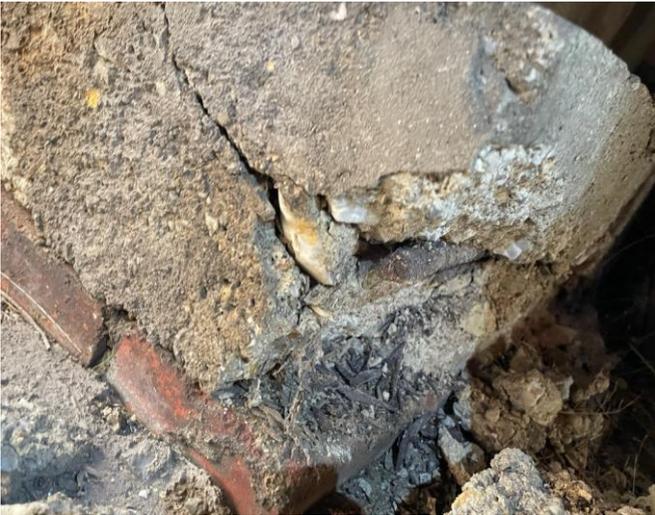
3.4 ACCESS TO THE PUBLIC AND ADJACENT RAILWAY LINE
