## Appendix A – Figures

Figure 7 Environmental overlays

**Environmental Overlays**

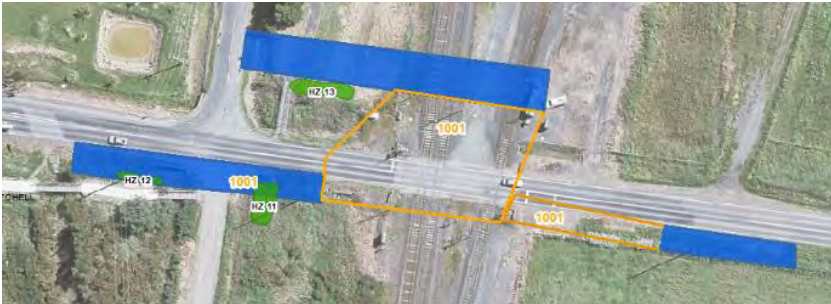
Investigation Area ID	Field assessment conducted?	Change to project area?	Field assessment proposed?	Desktop assessment notes	Image snip for illustration Key: <ul style="list-style-type: none"> <li>• Blue fill – original project area (field assessment unless otherwise stated)</li> <li>• Orange outline – additional project area (desktop assessment)</li> <li>• Green fill – mapped native vegetation</li> <li>• Green dot – mapped scattered tree</li> <li>• Black outline/dot – value mapped through desktop not field assessment</li> </ul>
<b>Mitchell</b>					
1001	Yes	Yes	No	Additional area contains existing rail infrastructure, paved roads, and roadside verge with exotic pasture grasses. No further field assessment proposed.

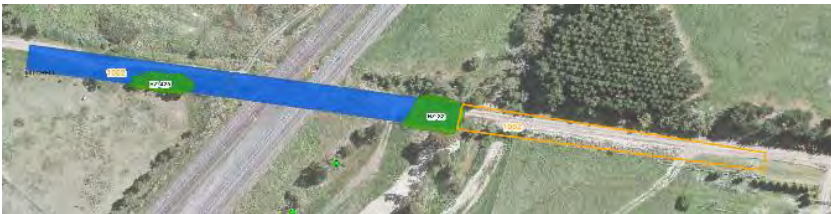
1002	Yes	Yes	No	Additional area contains some individual scattered native shrubs amongst blackberry and exotic grasses but not considered to be a patch of remnant native vegetation. No further field assessment proposed.

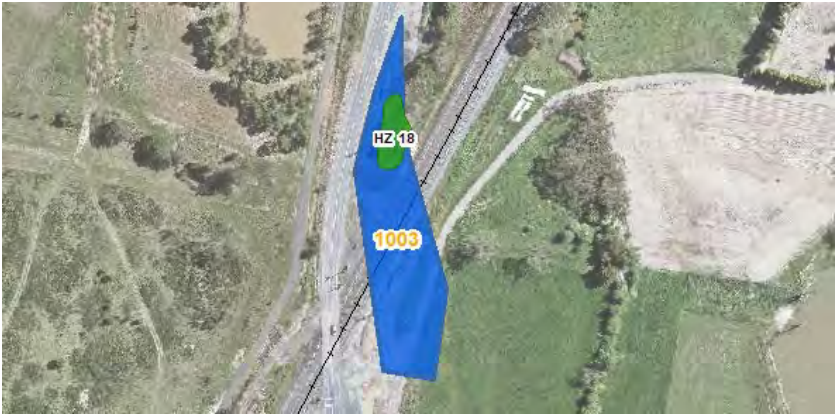
Investigation Area ID	Field assessment conducted?	Change to project area?	Field assessment proposed?	Desktop assessment notes	Image snip for illustration Key: <ul style="list-style-type: none"> <li>• Blue fill – original project area (field assessment unless otherwise stated)</li> <li>• Orange outline – additional project area (desktop assessment)</li> <li>• Green fill – mapped native vegetation</li> <li>• Green dot – mapped scattered tree</li> <li>• Black outline/dot – value mapped through desktop not field assessment</li> </ul>
1003	Yes	No	No	No additional project area, therefore, no further field assessment is proposed.

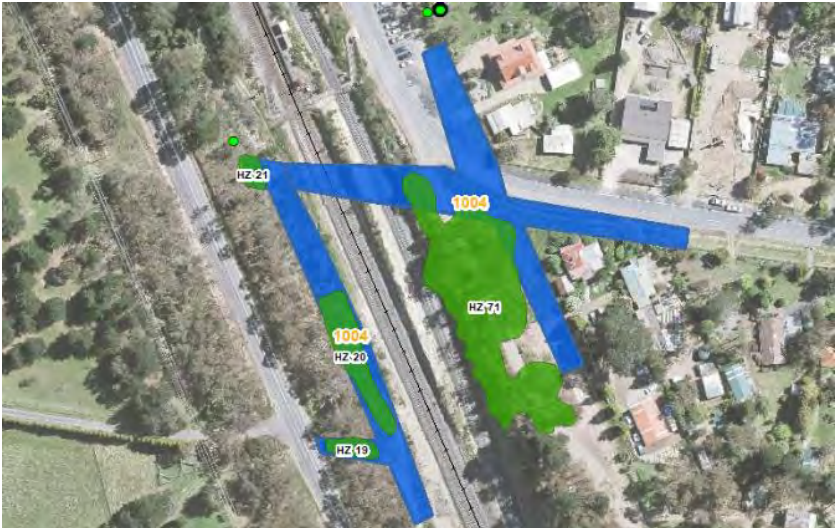
1004	Yes	No	No	No additional project area, therefore, no further field assessment is proposed.

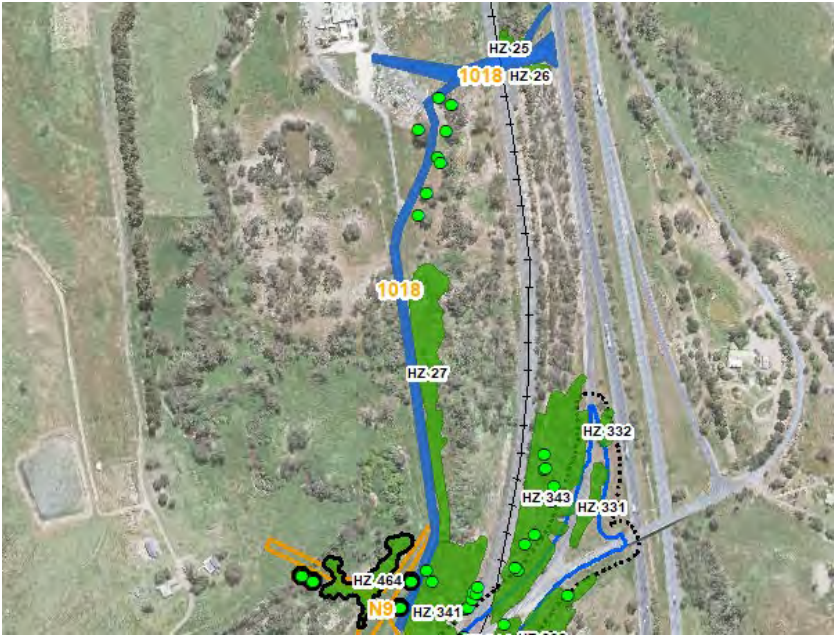
An aerial photograph showing a project area outlined in blue. The area includes a road and surrounding vegetation. Labels include HZ 25, HZ 26, HZ 27, HZ 331, HZ 332, HZ 343, HZ 464, HZ 341, and N9. A green area labeled 1018 is shown, indicating mapped native vegetation.

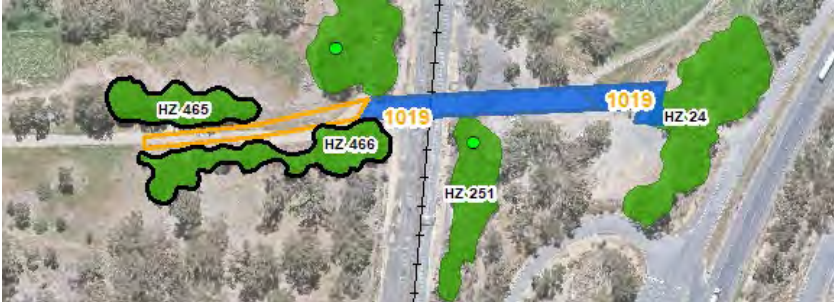
1019	Yes	Yes	Yes	Desktop mapped native vegetation was included in the existing conditions and impact assessment. Further field assessment is proposed.

An aerial photograph showing a project area outlined in blue. The area includes a road and surrounding vegetation. Labels include HZ 465, HZ 466, HZ 251, HZ 24, and 1019. A green area labeled 1019 is shown, indicating mapped native vegetation.

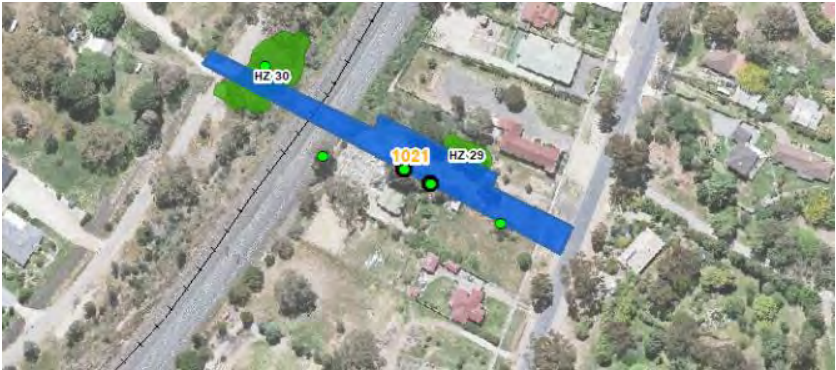
1021	Yes	No	Yes	No access was available to the private property adjacent to the project area. The trees mapped via desktop were contained within the private property behind a fence and were included because their TPZs may be impacted. Further field assessment is proposed.

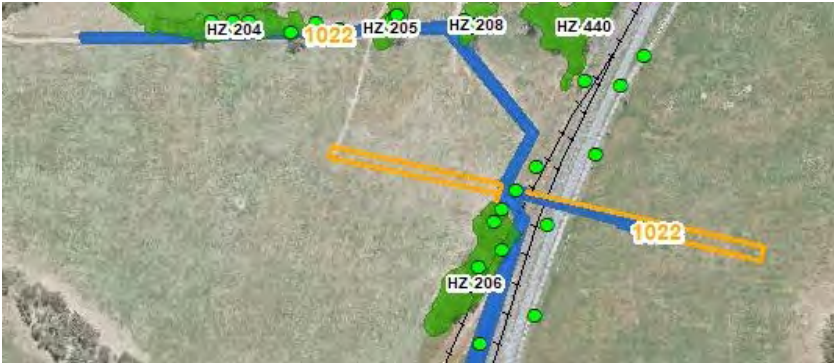
Investigation Area ID	Field assessment conducted?	Change to project area?	Field assessment proposed?	Desktop assessment notes	Image snip for illustration Key: <ul style="list-style-type: none"> <li>• Blue fill – original project area (field assessment unless otherwise stated)</li> <li>• Orange outline – additional project area (desktop assessment)</li> <li>• Green fill – mapped native vegetation</li> <li>• Green dot – mapped scattered tree</li> <li>• Black outline/dot – value mapped through desktop not field assessment</li> </ul>
1022	Yes	Yes	Yes	Additional area contains potential treeless vegetation therefore further field assessment is proposed.

An aerial photograph showing a project area. A blue-shaded area follows a path through a field. An orange-outlined area branches off to the right. Green dots and green-filled areas represent native vegetation. Labels include HZ.204, HZ.205, HZ.208, HZ.440, and HZ.206. The investigation area number 1022 is shown in yellow text.

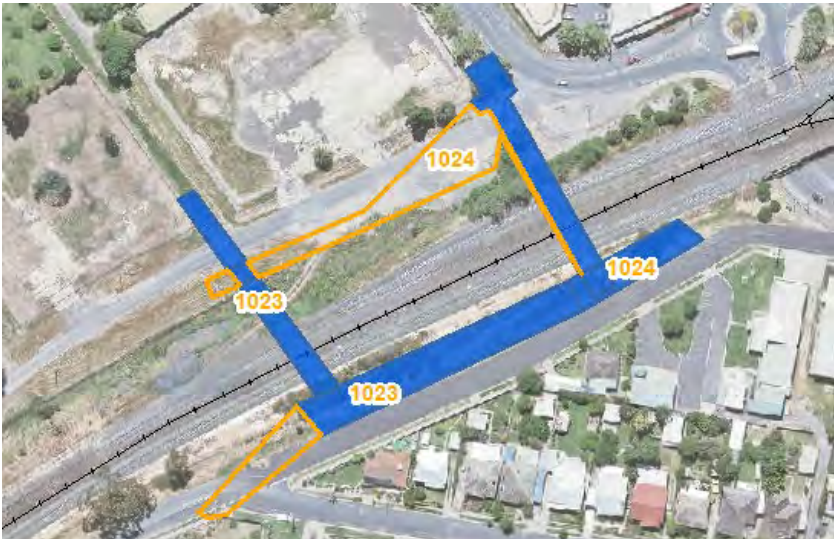
1023	Yes	Yes	No	Additional area is existing rail infrastructure, paved roads and footpaths, and exotic vegetation. No further field assessment is proposed.

An aerial photograph showing a project area. A blue-shaded area follows a path through an urban area. An orange-outlined area branches off to the right. Labels include 1023 and 1024. The investigation area number 1023 is shown in yellow text.

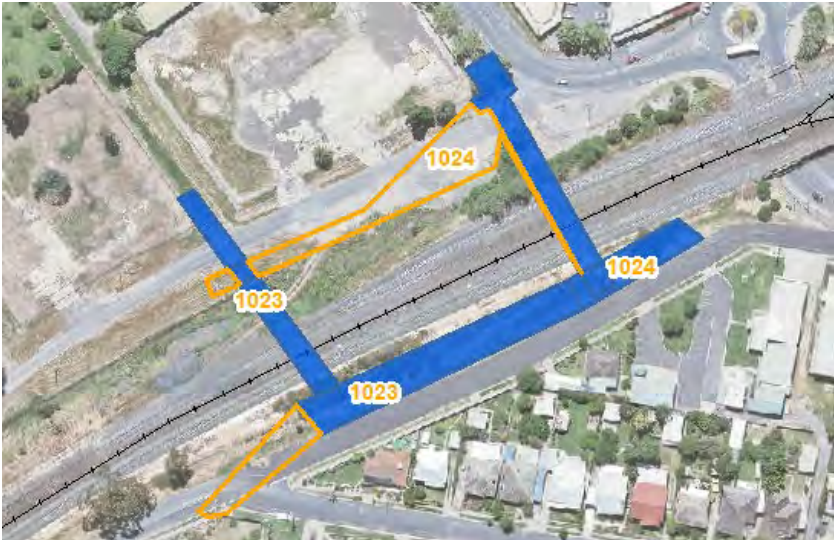
Investigation Area ID	Field assessment conducted?	Change to project area?	Field assessment proposed?	Desktop assessment notes	Image snip for illustration Key: <ul style="list-style-type: none"> <li>• Blue fill – original project area (field assessment unless otherwise stated)</li> <li>• Orange outline – additional project area (desktop assessment)</li> <li>• Green fill – mapped native vegetation</li> <li>• Green dot – mapped scattered tree</li> <li>• Black outline/dot – value mapped through desktop not field assessment</li> </ul>
1024	Yes	Yes	No	Additional area is existing rail infrastructure, paved roads and footpaths, and exotic vegetation. No further field assessment is proposed.

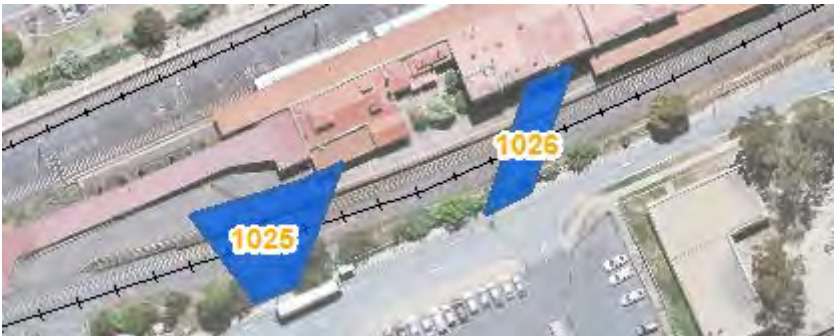
1025	Yes	No	No	No additional project area, therefore, no further field assessment is proposed.

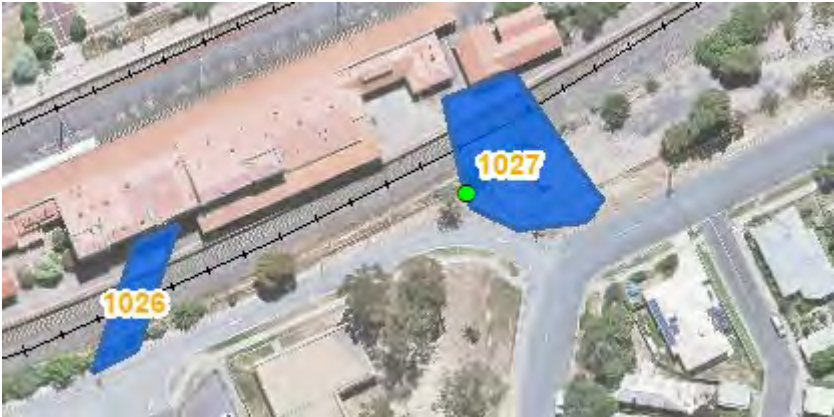
Investigation Area ID	Field assessment conducted?	Change to project area?	Field assessment proposed?	Desktop assessment notes	Image snip for illustration Key: <ul style="list-style-type: none"> <li>• Blue fill – original project area (field assessment unless otherwise stated)</li> <li>• Orange outline – additional project area (desktop assessment)</li> <li>• Green fill – mapped native vegetation</li> <li>• Green dot – mapped scattered tree</li> <li>• Black outline/dot – value mapped through desktop not field assessment</li> </ul>
1026	Yes	No	No	No additional project area, therefore, no further field assessment is proposed.

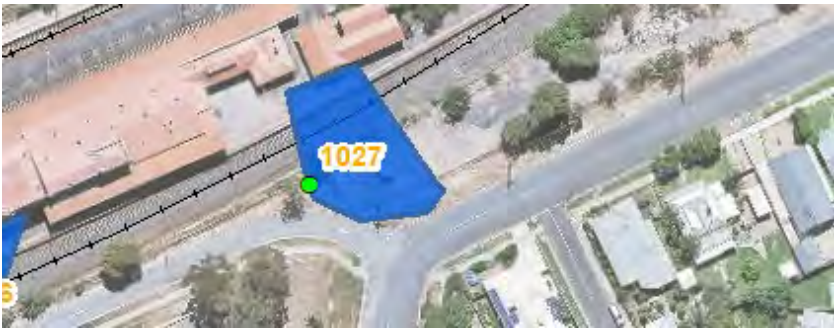
1027	Yes	No	No	No additional project area, therefore, no further field assessment is proposed.

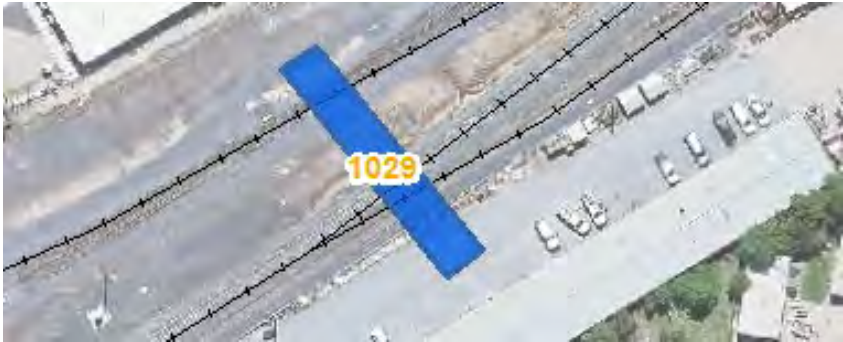
Investigation Area ID	Field assessment conducted?	Change to project area?	Field assessment proposed?	Desktop assessment notes	Image snip for illustration Key: <ul style="list-style-type: none"> <li>• Blue fill – original project area (field assessment unless otherwise stated)</li> <li>• Orange outline – additional project area (desktop assessment)</li> <li>• Green fill – mapped native vegetation</li> <li>• Green dot – mapped scattered tree</li> <li>• Black outline/dot – value mapped through desktop not field assessment</li> </ul>
1029	Yes	No	No	No additional project area, therefore, no further field assessment is proposed.

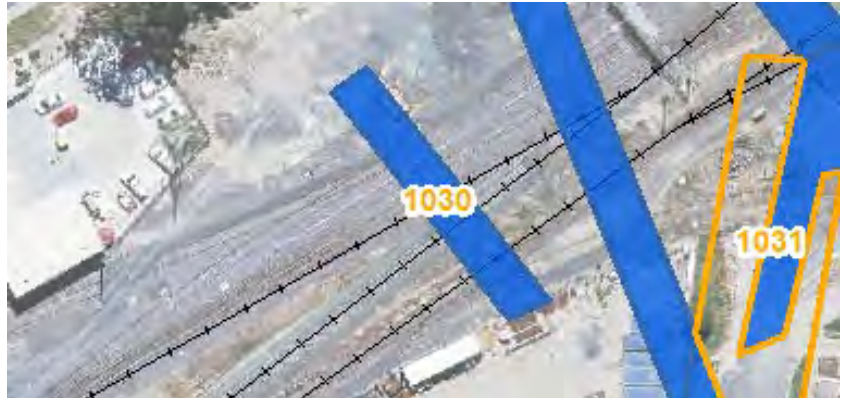
1030	Yes	No	No	No additional project area, therefore, no further field assessment is proposed.

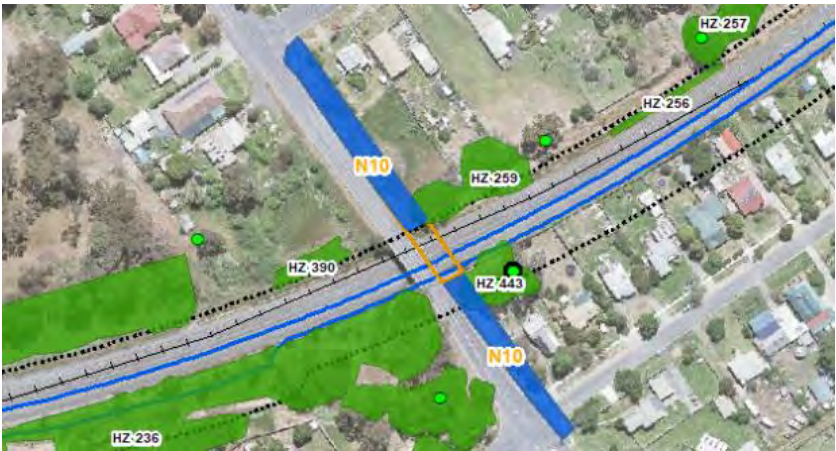
N10	Yes	Yes	Yes	No access was available to the private property adjacent to the project area; however, this did not limit the ability to include this as a Large Tree in a Patch by estimating DBH. Further field assessment is proposed.

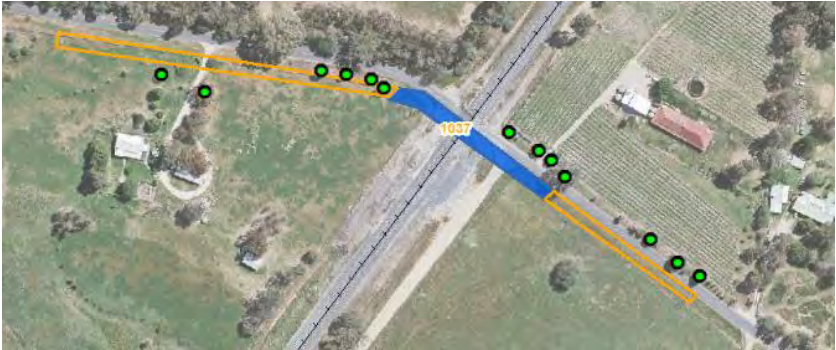
1037	Yes	Yes	Yes	Desktop mapped native vegetation was included in the existing conditions and impact assessment. Further field assessment is proposed.

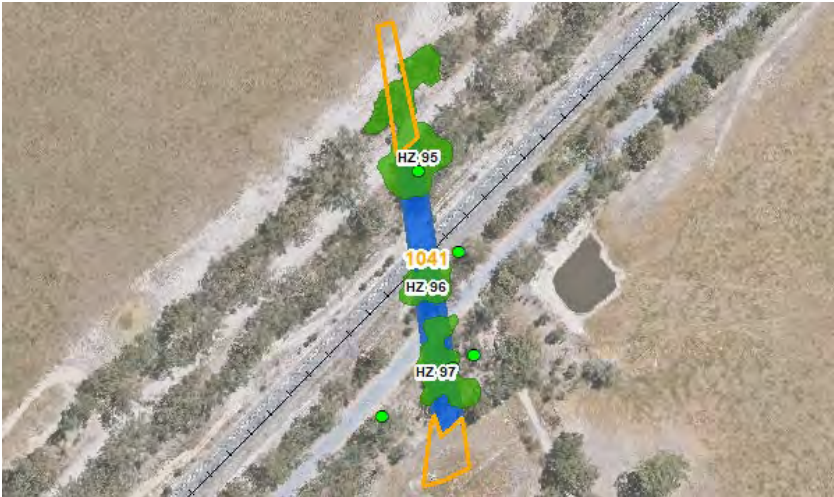
Investigation Area ID	Field assessment conducted?	Change to project area?	Field assessment proposed?	Desktop assessment notes	Image snip for illustration Key: <ul style="list-style-type: none"> <li>• Blue fill – original project area (field assessment unless otherwise stated)</li> <li>• Orange outline – additional project area (desktop assessment)</li> <li>• Green fill – mapped native vegetation</li> <li>• Green dot – mapped scattered tree</li> <li>• Black outline/dot – value mapped through desktop not field assessment</li> </ul>
1041	Yes	Yes	Yes	Patch of native vegetation mapped during field assessment of original project area was extended to cover additional area. Additional area also contains potential treeless vegetation. Further field assessment is proposed.

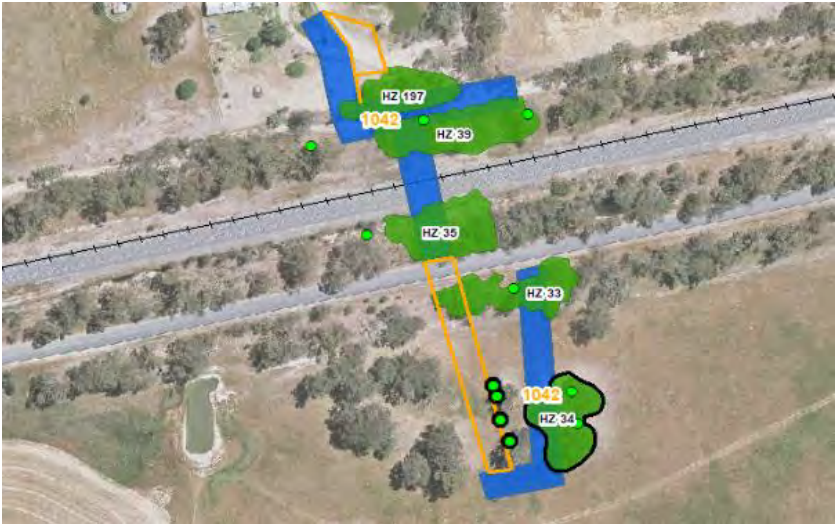
Investigation Area ID	Field assessment conducted?	Change to project area?	Field assessment proposed?	Desktop assessment notes	Image snip for illustration Key: <ul style="list-style-type: none"> <li>• Blue fill – original project area (field assessment unless otherwise stated)</li> <li>• Orange outline – additional project area (desktop assessment)</li> <li>• Green fill – mapped native vegetation</li> <li>• Green dot – mapped scattered tree</li> <li>• Black outline/dot – value mapped through desktop not field assessment</li> </ul>
1042	Yes	Yes	Yes	Desktop mapped native vegetation was included in the existing conditions and impact assessment. Further field assessment is proposed for the property on the south side of Avenel-Longwood Road as access was not available at time of the field assessment.

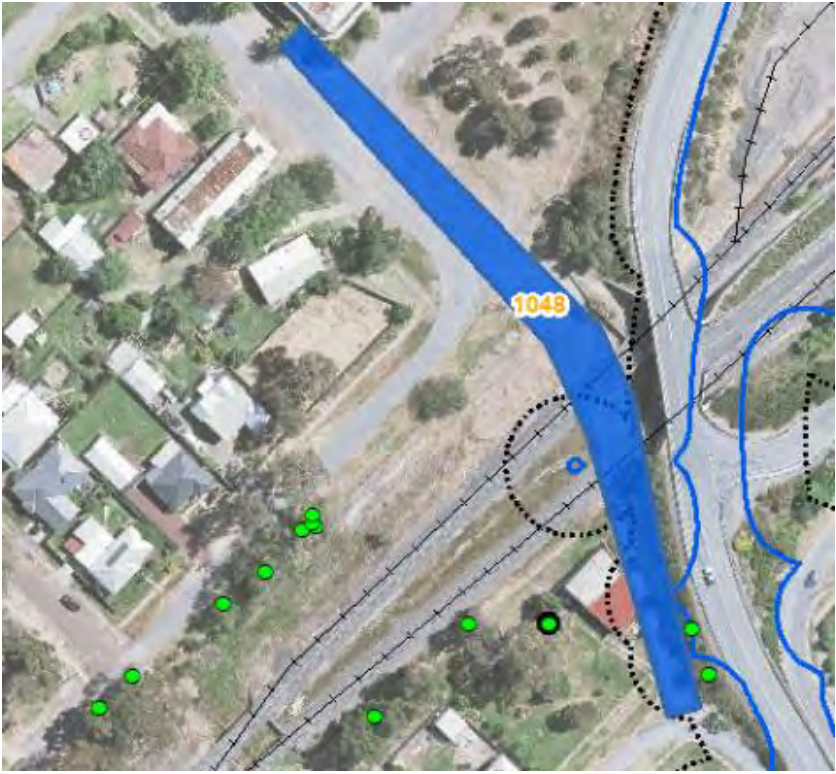
Investigation Area ID	Field assessment conducted?	Change to project area?	Field assessment proposed?	Desktop assessment notes	Image snip for illustration Key: <ul style="list-style-type: none"> <li>• Blue fill – original project area (field assessment unless otherwise stated)</li> <li>• Orange outline – additional project area (desktop assessment)</li> <li>• Green fill – mapped native vegetation</li> <li>• Green dot – mapped scattered tree</li> <li>• Black outline/dot – value mapped through desktop not field assessment</li> </ul>
1048	Yes	No	No	No access to private property where the desktop scattered tree is located. The scattered tree is associated with the Euroa enhancement site investigation area. No further field assessment proposed.

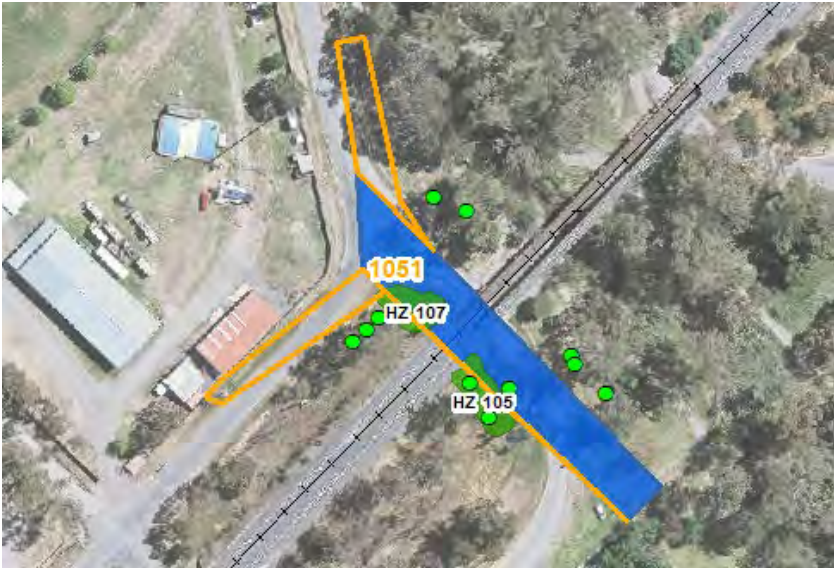
Investigation Area ID	Field assessment conducted?	Change to project area?	Field assessment proposed?	Desktop assessment notes	Image snip for illustration Key: <ul style="list-style-type: none"> <li>• Blue fill – original project area (field assessment unless otherwise stated)</li> <li>• Orange outline – additional project area (desktop assessment)</li> <li>• Green fill – mapped native vegetation</li> <li>• Green dot – mapped scattered tree</li> <li>• Black outline/dot – value mapped through desktop not field assessment</li> </ul>
1051	Yes	Yes	Yes	Additional area appears to be road reserve (exotic grass) from aerial photos but further field assessment is proposed to confirm.

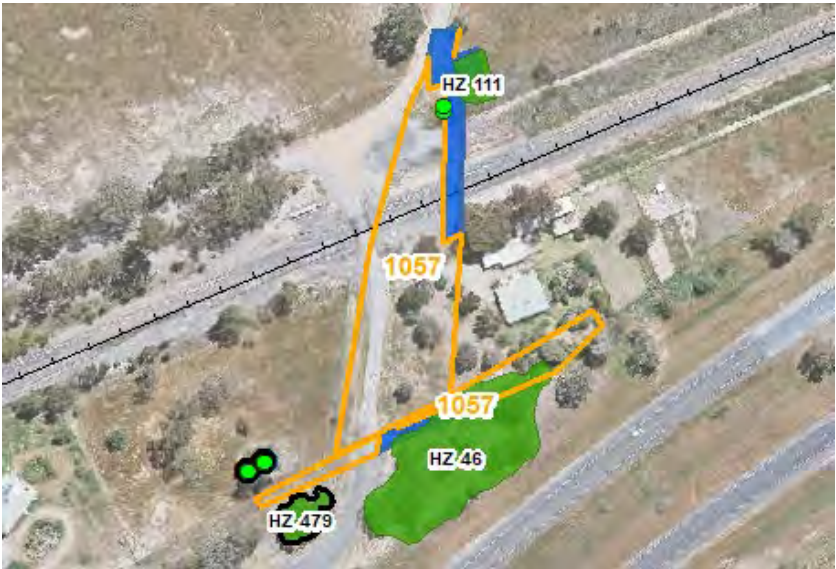
1057	Yes	Yes	Yes	Desktop mapped native vegetation was included in the existing conditions and impact assessment. Further field assessment is proposed.

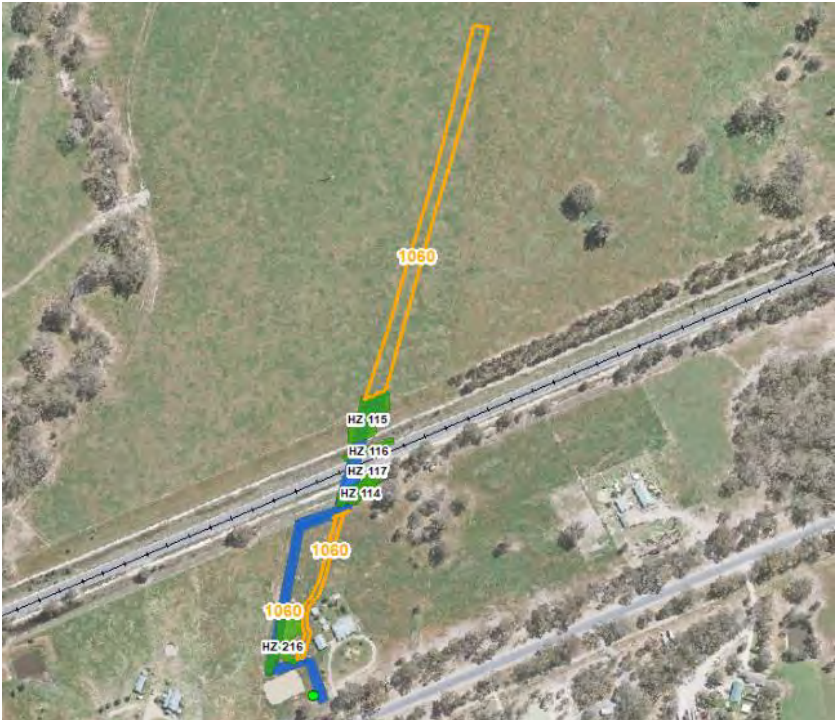
Investigation Area ID	Field assessment conducted?	Change to project area?	Field assessment proposed?	Desktop assessment notes	Image snip for illustration Key: <ul style="list-style-type: none"> <li>• Blue fill – original project area (field assessment unless otherwise stated)</li> <li>• Orange outline – additional project area (desktop assessment)</li> <li>• Green fill – mapped native vegetation</li> <li>• Green dot – mapped scattered tree</li> <li>• Black outline/dot – value mapped through desktop not field assessment</li> </ul>
1060	Yes	Yes	Yes	Additional area contains potential treeless vegetation. Further field assessment is proposed.

<p>The image snip shows an aerial view of a landscape with a railway line running diagonally from the bottom left to the top right. A blue-shaded area, labeled '1060', follows the railway line. An orange-outlined area, also labeled '1060', extends further north and east from the blue area. Several green-shaded areas are labeled 'HZ 114', 'HZ 115', 'HZ 116', and 'HZ 117'. A green dot is labeled 'HZ 216'. The surrounding area is a mix of green grass and brownish vegetation.</p>

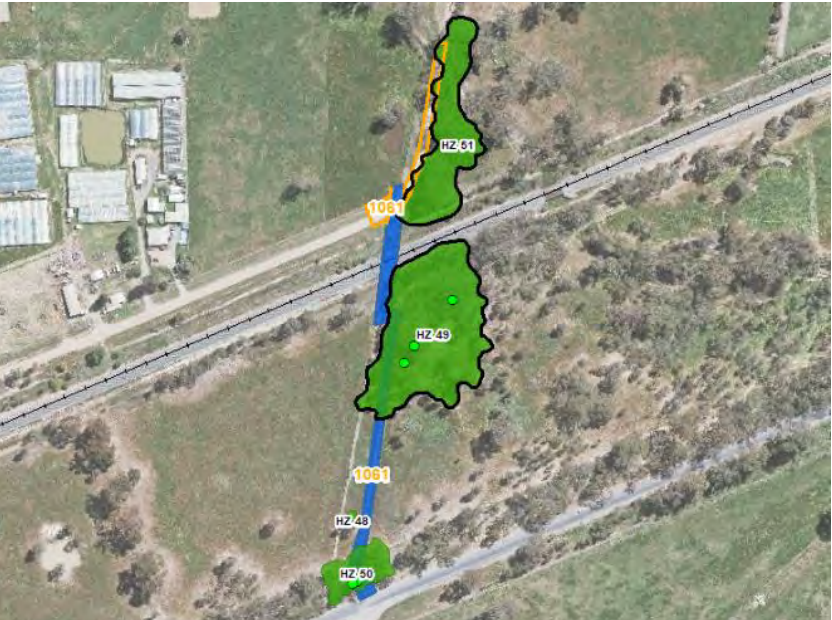
Investigation Area ID	Field assessment conducted?	Change to project area?	Field assessment proposed?	Desktop assessment notes	Image snip for illustration Key: <ul style="list-style-type: none"> <li>• Blue fill – original project area (field assessment unless otherwise stated)</li> <li>• Orange outline – additional project area (desktop assessment)</li> <li>• Green fill – mapped native vegetation</li> <li>• Green dot – mapped scattered tree</li> <li>• Black outline/dot – value mapped through desktop not field assessment</li> </ul>
1061	Yes	Yes	Yes	Desktop mapped native vegetation was included in the existing conditions and impact assessment. No access to private property immediately adjacent to the powerline easement, therefore HZ 49 was mapped using values observed within the easement and seen over a fence. The patch extent was extended from the investigation area to provide context. Large Trees in Patches were mapped based on observation over fence. Further field assessment is proposed.

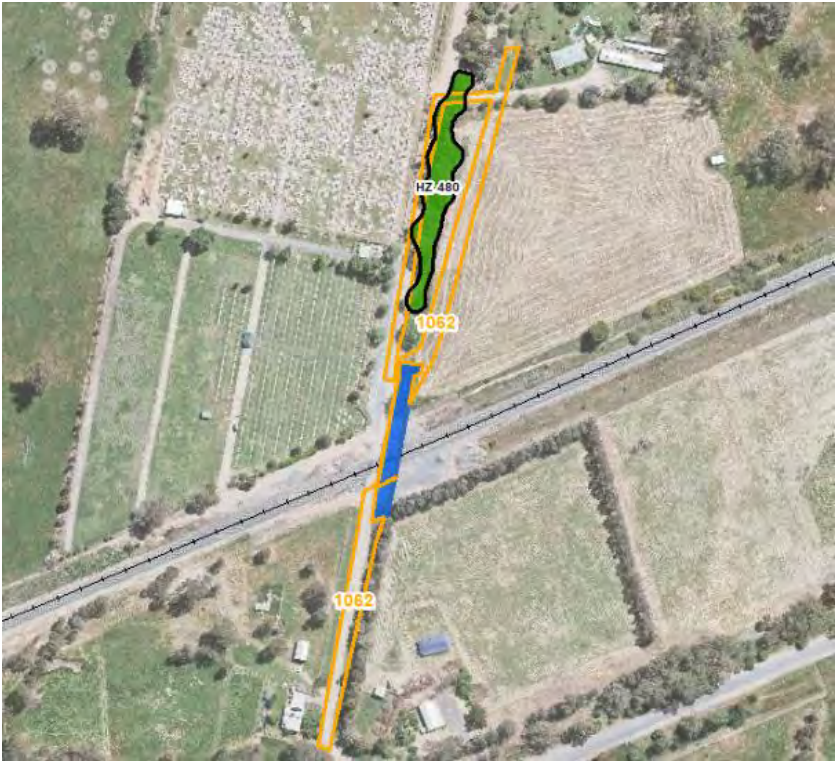
Investigation Area ID	Field assessment conducted?	Change to project area?	Field assessment proposed?	Desktop assessment notes	Image snip for illustration Key: <ul style="list-style-type: none"> <li>• Blue fill – original project area (field assessment unless otherwise stated)</li> <li>• Orange outline – additional project area (desktop assessment)</li> <li>• Green fill – mapped native vegetation</li> <li>• Green dot – mapped scattered tree</li> <li>• Black outline/dot – value mapped through desktop not field assessment</li> </ul>
1062	Yes	Yes	Yes	Desktop mapped native vegetation was included in the existing conditions and impact assessment. Further field assessment is proposed.

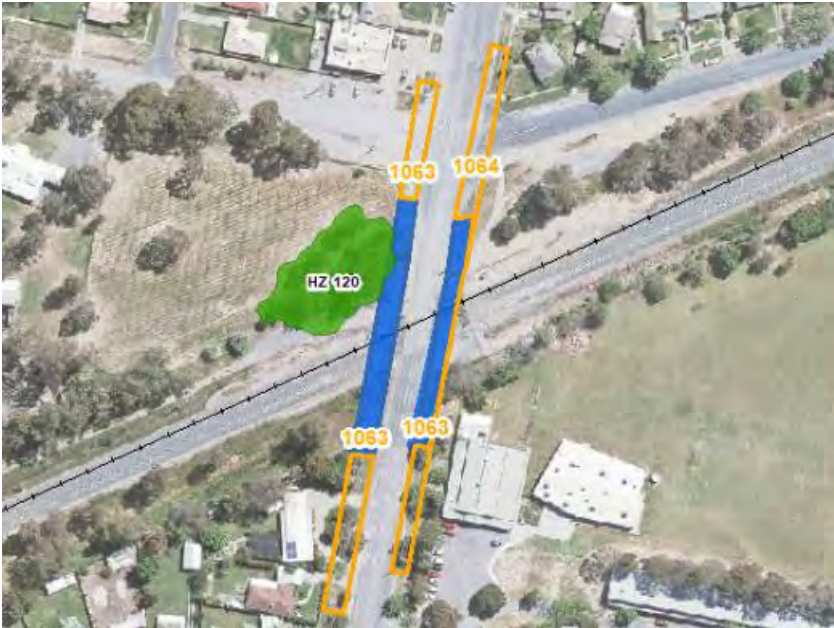
Investigation Area ID	Field assessment conducted?	Change to project area?	Field assessment proposed?	Desktop assessment notes	Image snip for illustration Key: <ul style="list-style-type: none"> <li>• Blue fill – original project area (field assessment unless otherwise stated)</li> <li>• Orange outline – additional project area (desktop assessment)</li> <li>• Green fill – mapped native vegetation</li> <li>• Green dot – mapped scattered tree</li> <li>• Black outline/dot – value mapped through desktop not field assessment</li> </ul>
1063	Yes	Yes	No	Additional area is existing rail infrastructure, roads and footpaths, and exotic vegetation. No further field assessment is proposed.

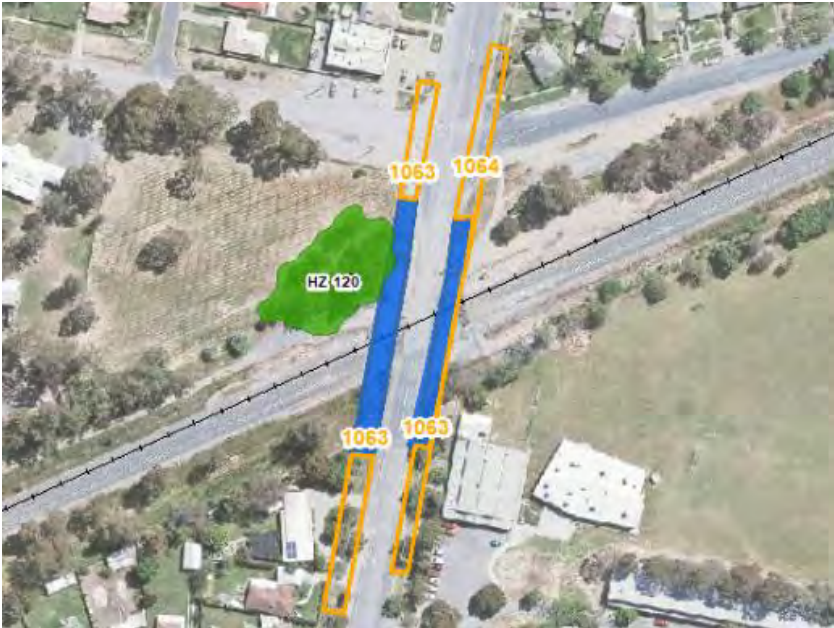
Investigation Area ID	Field assessment conducted?	Change to project area?	Field assessment proposed?	Desktop assessment notes	Image snip for illustration Key: <ul style="list-style-type: none"> <li>• Blue fill – original project area (field assessment unless otherwise stated)</li> <li>• Orange outline – additional project area (desktop assessment)</li> <li>• Green fill – mapped native vegetation</li> <li>• Green dot – mapped scattered tree</li> <li>• Black outline/dot – value mapped through desktop not field assessment</li> </ul>
1064	Yes	Yes	No	Additional area is existing rail infrastructure, roads and footpaths, and exotic vegetation. No further field assessment proposed.

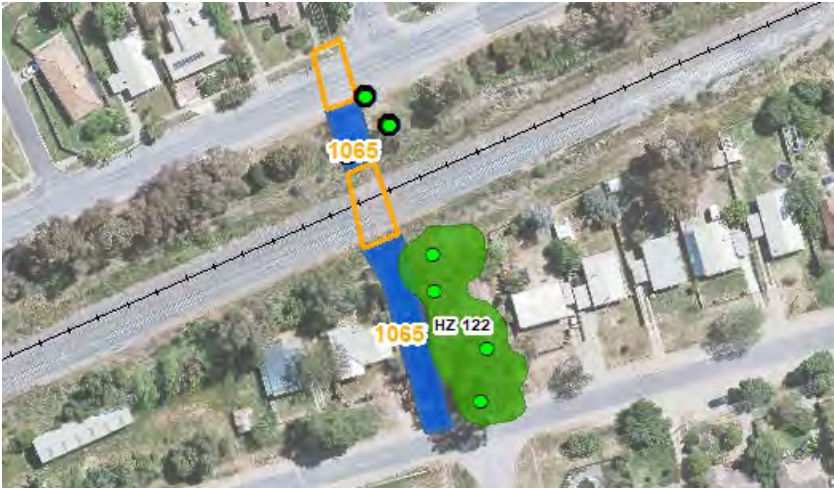
Investigation Area ID	Field assessment conducted?	Change to project area?	Field assessment proposed?	Desktop assessment notes	Image snip for illustration Key: <ul style="list-style-type: none"> <li>• Blue fill – original project area (field assessment unless otherwise stated)</li> <li>• Orange outline – additional project area (desktop assessment)</li> <li>• Green fill – mapped native vegetation</li> <li>• Green dot – mapped scattered tree</li> <li>• Black outline/dot – value mapped through desktop not field assessment</li> </ul>
1065	Yes	Yes	Yes	Desktop mapped native vegetation was included in the existing conditions and impact assessment. Further field assessment is proposed.

An aerial photograph showing a project area labeled '1065'. The area is outlined in orange. A portion of the area is filled with blue, and another portion is filled with green. There are several green dots scattered within the green-filled area. The area is situated near a road and some buildings.

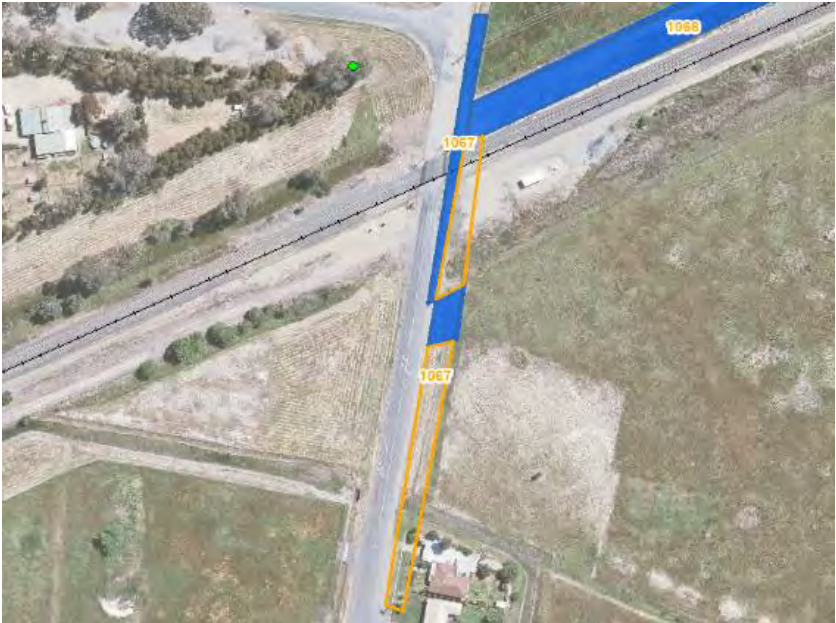
Investigation Area ID	Field assessment conducted?	Change to project area?	Field assessment proposed?	Desktop assessment notes	Image snip for illustration Key: <ul style="list-style-type: none"> <li>• Blue fill – original project area (field assessment unless otherwise stated)</li> <li>• Orange outline – additional project area (desktop assessment)</li> <li>• Green fill – mapped native vegetation</li> <li>• Green dot – mapped scattered tree</li> <li>• Black outline/dot – value mapped through desktop not field assessment</li> </ul>
1067	Yes	Yes	No	Additional area is existing rail infrastructure, roads, and exotic vegetation. No further field assessment proposed.

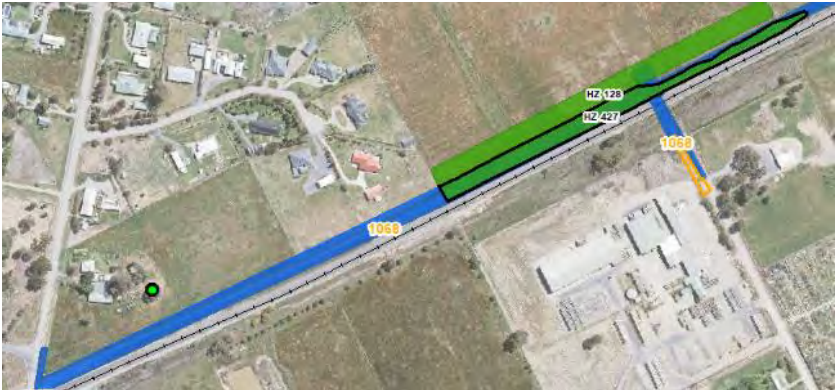
Investigation Area ID	Field assessment conducted?	Change to project area?	Field assessment proposed?	Desktop assessment notes	Image snip for illustration Key: <ul style="list-style-type: none"> <li>• Blue fill – original project area (field assessment unless otherwise stated)</li> <li>• Orange outline – additional project area (desktop assessment)</li> <li>• Green fill – mapped native vegetation</li> <li>• Green dot – mapped scattered tree</li> <li>• Black outline/dot – value mapped through desktop not field assessment</li> </ul>
1068	Yes	Yes	Yes	Desktop mapped native vegetation was included in the existing conditions and impact assessment. Further field assessment is proposed.

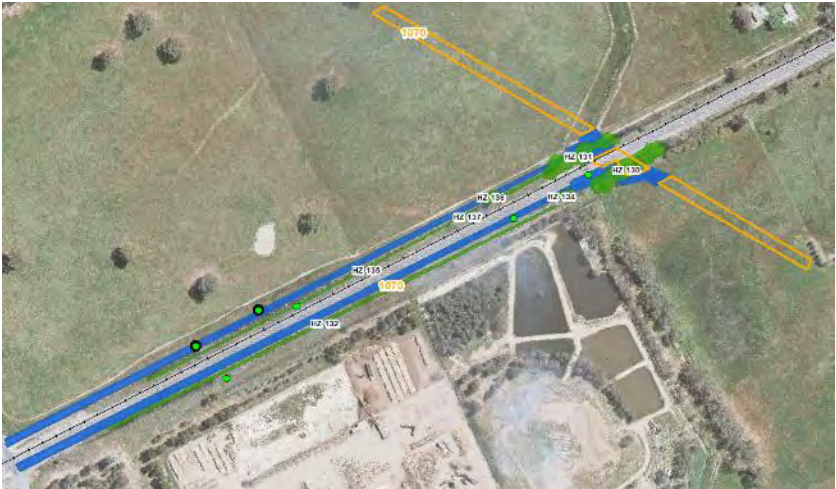
An aerial photograph showing a proposed rail corridor. A blue-shaded area follows the corridor, with an orange-shaded area extending further. Green dots and outlines indicate mapped native vegetation and scattered trees. Labels include '1070' and various HZ codes (e.g., HZ 130, HZ 131, HZ 132, HZ 133, HZ 134, HZ 137, HZ 138, HZ 139, HZ 140).

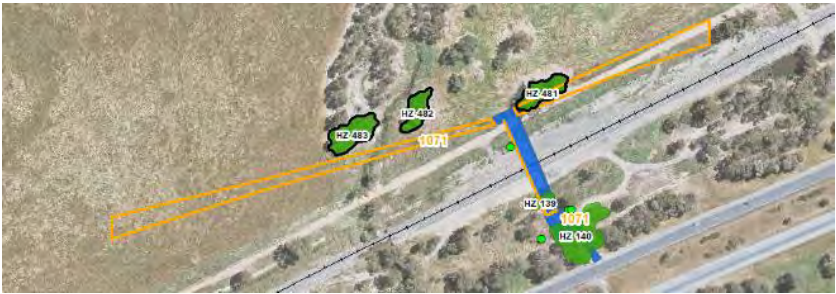
1071	Yes	Yes	Yes	Desktop mapped native vegetation was included in the existing conditions and impact assessment. Additional area also contains potential treeless vegetation. Further field assessment is proposed.

An aerial photograph showing a proposed rail corridor. A blue-shaded area follows the corridor, with an orange-shaded area extending further. Green dots and outlines indicate mapped native vegetation and scattered trees. Labels include '1071' and various HZ codes (e.g., HZ 481, HZ 482, HZ 483, HZ 139, HZ 140).

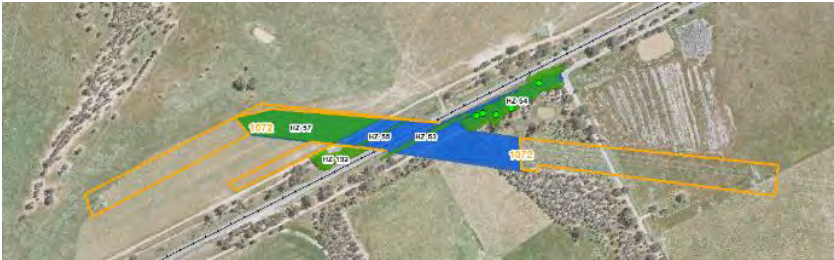
Investigation Area ID	Field assessment conducted?	Change to project area?	Field assessment proposed?	Desktop assessment notes	Image snip for illustration Key: <ul style="list-style-type: none"> <li>• Blue fill – original project area (field assessment unless otherwise stated)</li> <li>• Orange outline – additional project area (desktop assessment)</li> <li>• Green fill – mapped native vegetation</li> <li>• Green dot – mapped scattered tree</li> <li>• Black outline/dot – value mapped through desktop not field assessment</li> </ul>
1072	Yes	Yes	Yes	Additional area contains potential treeless vegetation. Further field assessment is proposed

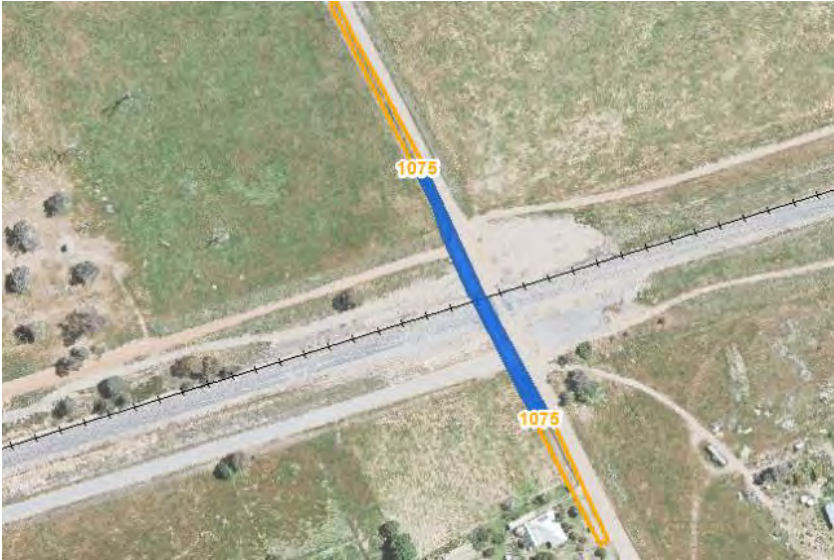
1075	Yes	Yes	No	Roadside contained exotic vegetation only. No further field assessment proposed.

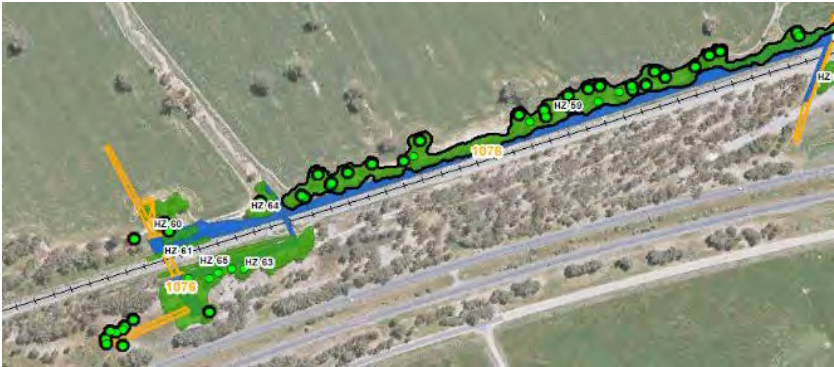
Investigation Area ID	Field assessment conducted?	Change to project area?	Field assessment proposed?	Desktop assessment notes	Image snip for illustration Key: <ul style="list-style-type: none"> <li>• Blue fill – original project area (field assessment unless otherwise stated)</li> <li>• Orange outline – additional project area (desktop assessment)</li> <li>• Green fill – mapped native vegetation</li> <li>• Green dot – mapped scattered tree</li> <li>• Black outline/dot – value mapped through desktop not field assessment</li> </ul>
1076	Yes	Yes	Yes	Desktop mapped native vegetation was included in the existing conditions and impact assessment. Limited access to private property. Further field assessment is proposed.

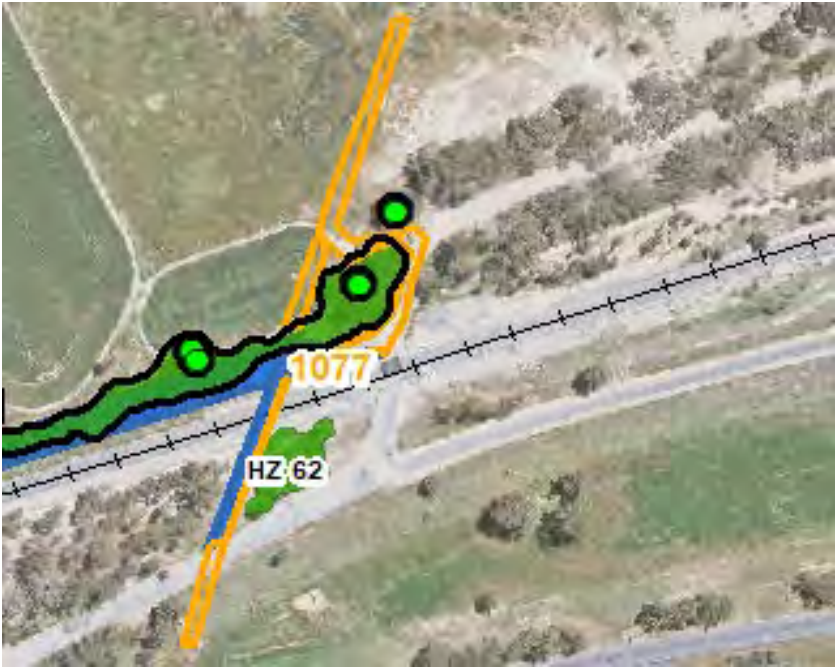
Investigation Area ID	Field assessment conducted?	Change to project area?	Field assessment proposed?	Desktop assessment notes	Image snip for illustration Key: <ul style="list-style-type: none"> <li>• Blue fill – original project area (field assessment unless otherwise stated)</li> <li>• Orange outline – additional project area (desktop assessment)</li> <li>• Green fill – mapped native vegetation</li> <li>• Green dot – mapped scattered tree</li> <li>• Black outline/dot – value mapped through desktop not field assessment</li> </ul>
1077	Yes	Yes	Yes	Desktop mapped native vegetation was included in the existing conditions and impact assessment. Limited access to private property. Further field assessment is proposed.

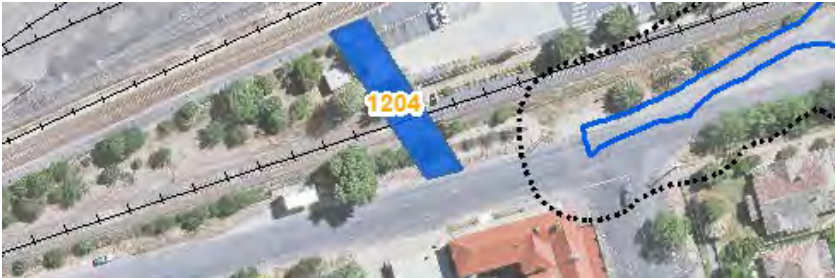
1204	Yes	No	No	No additional project area, therefore, no further field assessment is proposed.

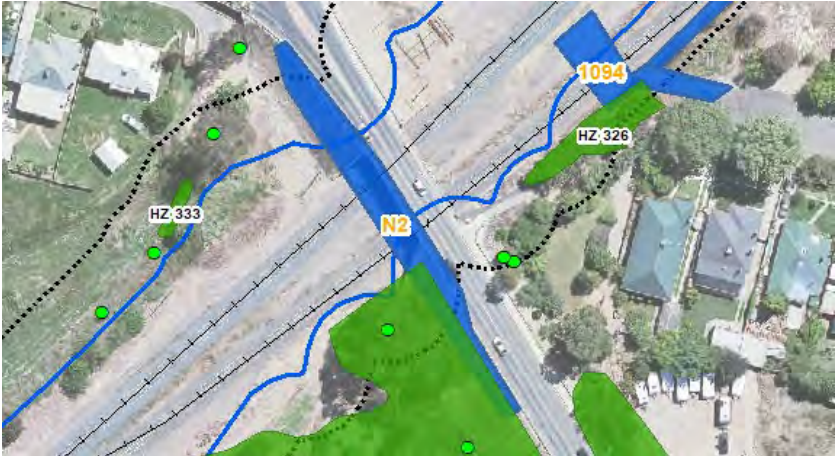
<p>This aerial image shows the project area for investigation N2. A solid blue area represents the original project area, which follows a road corridor. An orange outline indicates an additional project area. Green fill areas represent mapped native vegetation, with several green dots indicating scattered trees. Labels include 'N2' in the center, 'HZ 333' on the left, and '1094' and 'HZ 326' on the right. A black dashed line outlines a larger area, likely mapped through desktop assessment.</p>

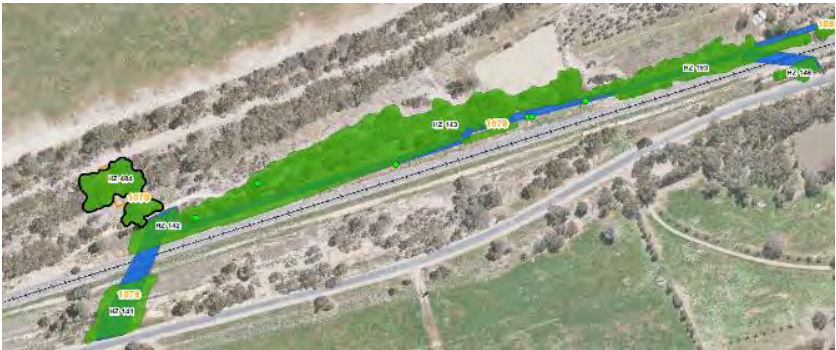
1078	Yes	Yes	Yes	Desktop mapped native vegetation was included in the existing conditions and impact assessment. Further field assessment is proposed.

<p>This aerial image shows the project area for investigation 1078. A solid blue area represents the original project area, which follows a road corridor. An orange outline indicates an additional project area. Green fill areas represent mapped native vegetation, with several green dots indicating scattered trees. Labels include '1078' in the center, '1079' on the left, and '1080', '1081', '1082', and '1083' on the right. A black dashed line outlines a larger area, likely mapped through desktop assessment.</p>

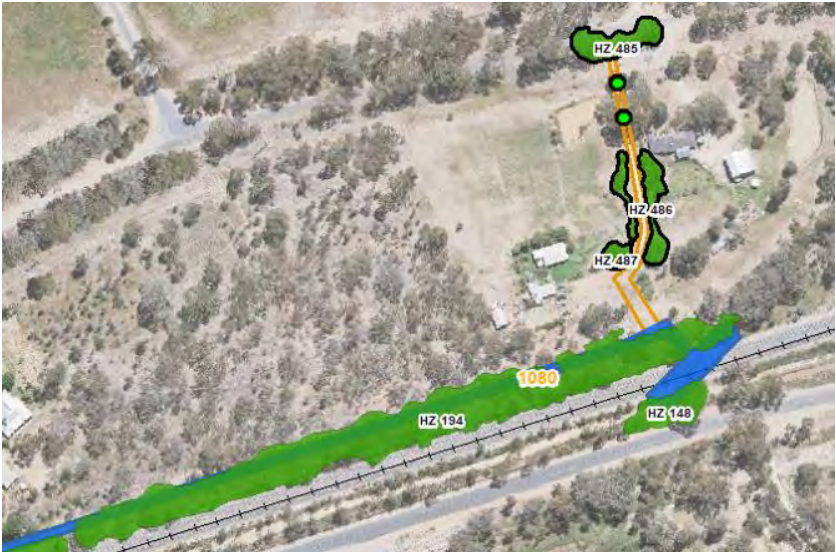
Investigation Area ID	Field assessment conducted?	Change to project area?	Field assessment proposed?	Desktop assessment notes	Image snip for illustration Key: <ul style="list-style-type: none"> <li>• Blue fill – original project area (field assessment unless otherwise stated)</li> <li>• Orange outline – additional project area (desktop assessment)</li> <li>• Green fill – mapped native vegetation</li> <li>• Green dot – mapped scattered tree</li> <li>• Black outline/dot – value mapped through desktop not field assessment</li> </ul>
1080	Yes	Yes	Yes	Desktop mapped native vegetation was included in the existing conditions and impact assessment. Further field assessment is proposed.

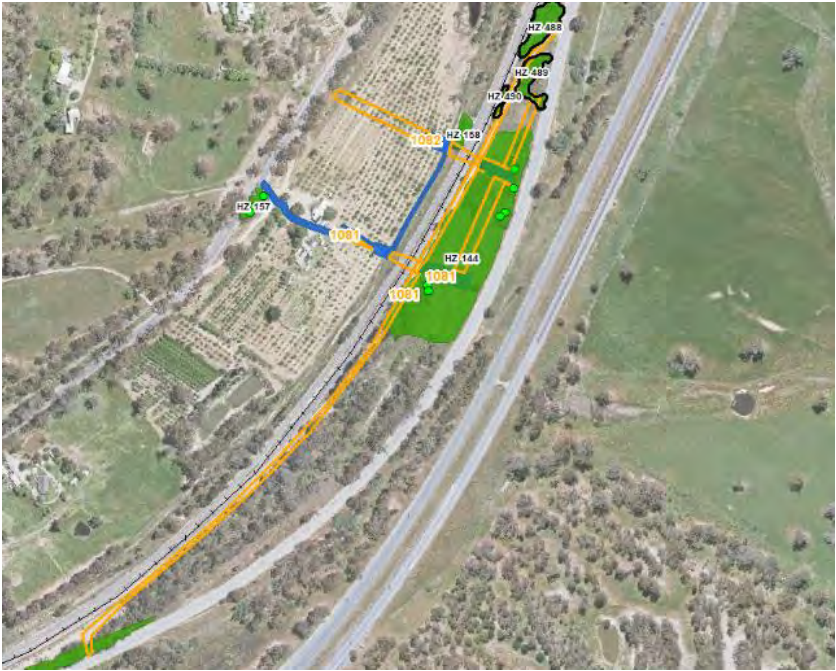
Investigation Area ID	Field assessment conducted?	Change to project area?	Field assessment proposed?	Desktop assessment notes	Image snip for illustration Key: <ul style="list-style-type: none"> <li>• Blue fill – original project area (field assessment unless otherwise stated)</li> <li>• Orange outline – additional project area (desktop assessment)</li> <li>• Green fill – mapped native vegetation</li> <li>• Green dot – mapped scattered tree</li> <li>• Black outline/dot – value mapped through desktop not field assessment</li> </ul>
1081	Yes	Yes	Yes	Desktop mapped native vegetation was included in the existing conditions and impact assessment. Additional area appears to follow access tracks but need to confirm during field assessment, particularly impacts to tree TPZs.
