## Appendix A – Figures

Figure 7 Environmental overlays

**Environmental Overlays**

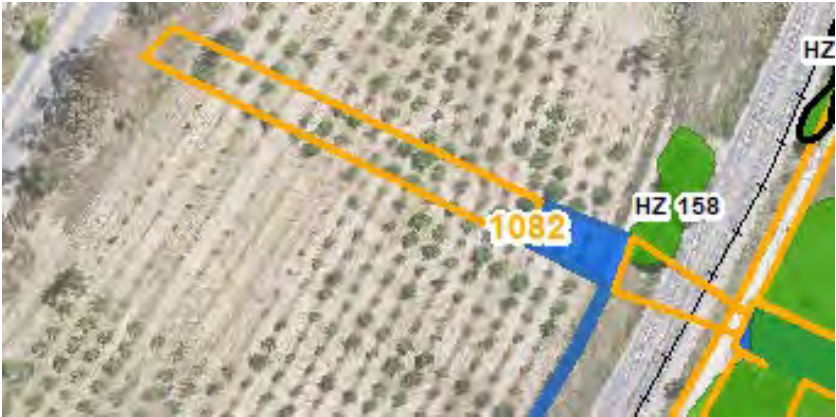
Investigation Area ID	Field assessment conducted?	Change to project area?	Field assessment proposed?	Desktop assessment notes	Image snip for illustration Key: <ul style="list-style-type: none"> <li>• Blue fill – original project area (field assessment unless otherwise stated)</li> <li>• Orange outline – additional project area (desktop assessment)</li> <li>• Green fill – mapped native vegetation</li> <li>• Green dot – mapped scattered tree</li> <li>• Black outline/dot – value mapped through desktop not field assessment</li> </ul>
1082	Yes	Yes	No	Additional area is planted orchard. No further field assessment proposed.

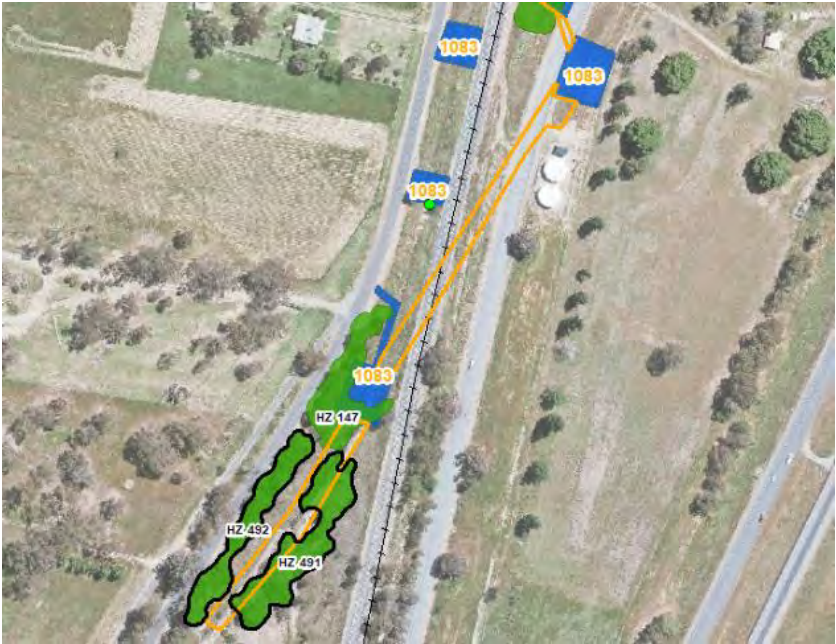
<p>The image snip shows an aerial view of a rural area with a road and a railway line. Several areas are highlighted: a blue-filled area labeled '1083' along the railway line, an orange-outlined area also labeled '1083' extending from it, and green-filled areas representing native vegetation. Three hazard zones are labeled: 'HZ 147' (a green dot), 'HZ 492' (a black dot), and 'HZ 491' (a black dot). The surrounding landscape includes fields, trees, and a residential area.</p>

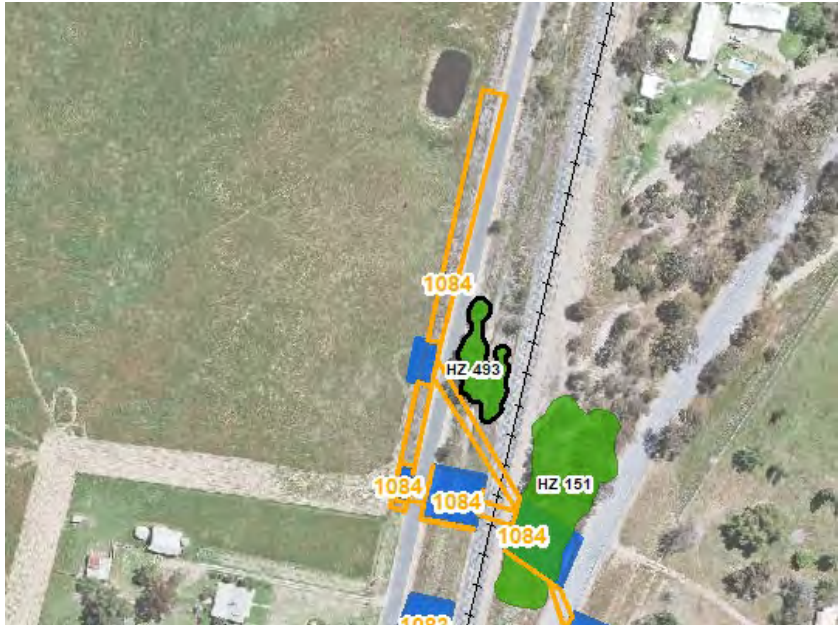
Investigation Area ID	Field assessment conducted?	Change to project area?	Field assessment proposed?	Desktop assessment notes	Image snip for illustration Key: <ul style="list-style-type: none"> <li>• Blue fill – original project area (field assessment unless otherwise stated)</li> <li>• Orange outline – additional project area (desktop assessment)</li> <li>• Green fill – mapped native vegetation</li> <li>• Green dot – mapped scattered tree</li> <li>• Black outline/dot – value mapped through desktop not field assessment</li> </ul>
1084	Yes	Yes	Yes	Desktop mapped native vegetation was included in the existing conditions and impact assessment. Further field assessment is proposed.

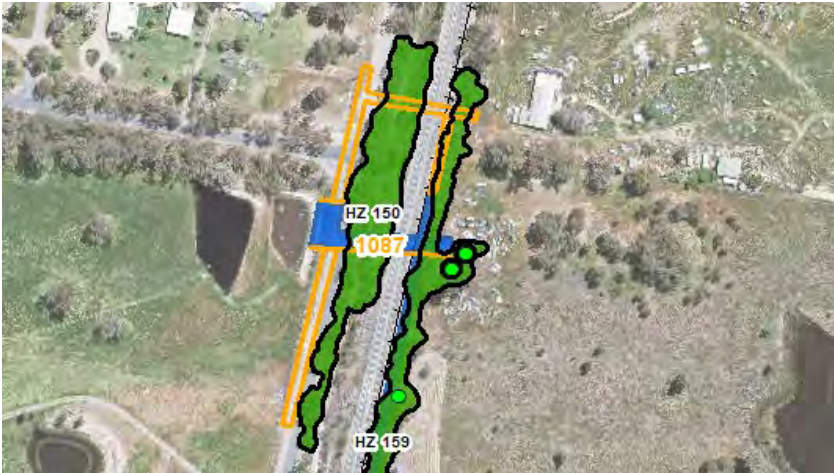
Investigation Area ID	Field assessment conducted?	Change to project area?	Field assessment proposed?	Desktop assessment notes	Image snip for illustration Key: <ul style="list-style-type: none"> <li>• Blue fill – original project area (field assessment unless otherwise stated)</li> <li>• Orange outline – additional project area (desktop assessment)</li> <li>• Green fill – mapped native vegetation</li> <li>• Green dot – mapped scattered tree</li> <li>• Black outline/dot – value mapped through desktop not field assessment</li> </ul>
1087	Yes	Yes	Yes	Existing patch mapped in the original project area extended to cover additional project area. Large Trees in Patches mapped on the eastern side of the rail corridor were observed over the fence as there was no access to private property. Further field assessment proposed.

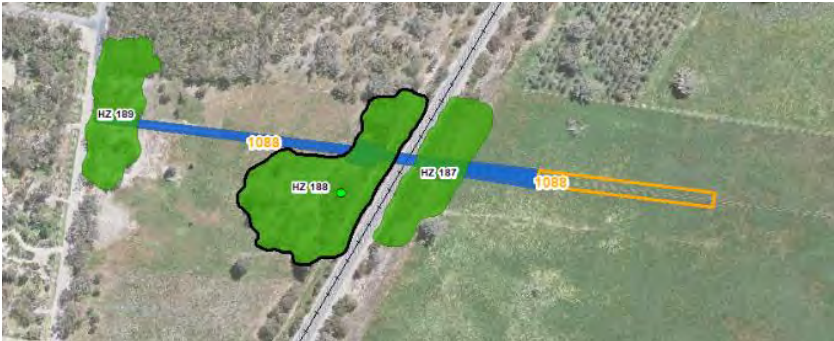
1088	Yes	Yes	Yes	No access to private property on either side of the rail corridor. Values were identified from the rail corridor and Warby Range Road. Further field assessment is proposed.

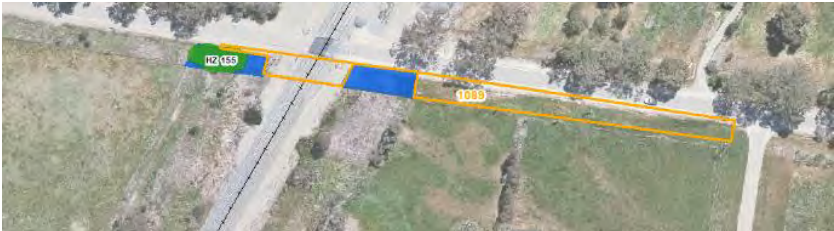
Investigation Area ID	Field assessment conducted?	Change to project area?	Field assessment proposed?	Desktop assessment notes	Image snip for illustration Key: <ul style="list-style-type: none"> <li>• Blue fill – original project area (field assessment unless otherwise stated)</li> <li>• Orange outline – additional project area (desktop assessment)</li> <li>• Green fill – mapped native vegetation</li> <li>• Green dot – mapped scattered tree</li> <li>• Black outline/dot – value mapped through desktop not field assessment</li> </ul>
1089	Yes	Yes	Yes	Additional area contains potential treeless vegetation. Further field assessment is proposed.

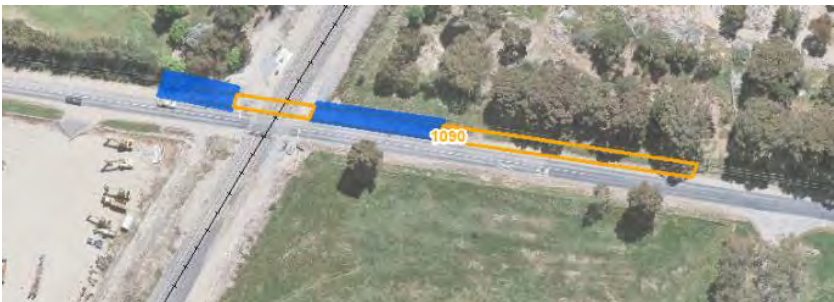
1090	Yes	Yes	No	Additional areas contain disturbed roadside and exotic vegetation. No further field assessment is proposed.

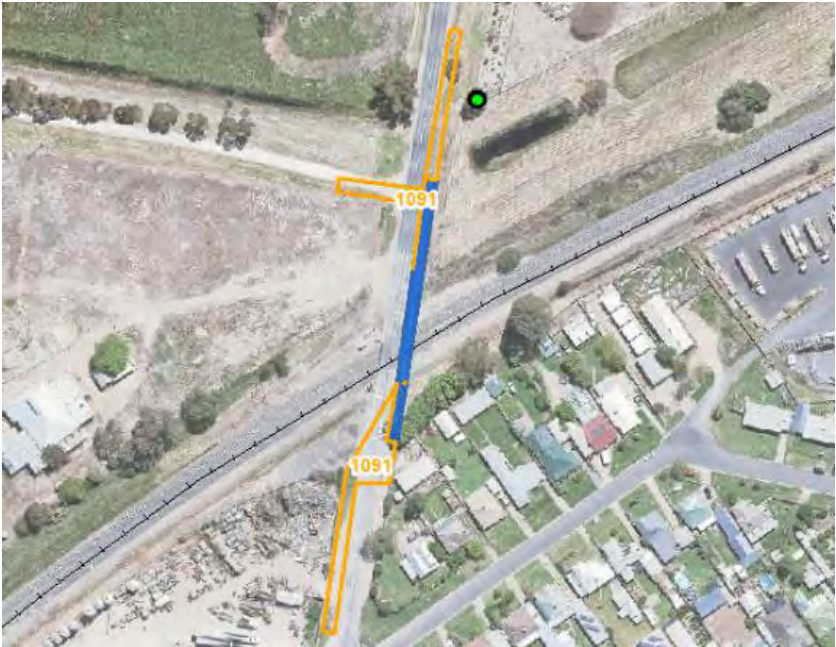
Investigation Area ID	Field assessment conducted?	Change to project area?	Field assessment proposed?	Desktop assessment notes	Image snip for illustration Key: <ul style="list-style-type: none"> <li>• Blue fill – original project area (field assessment unless otherwise stated)</li> <li>• Orange outline – additional project area (desktop assessment)</li> <li>• Green fill – mapped native vegetation</li> <li>• Green dot – mapped scattered tree</li> <li>• Black outline/dot – value mapped through desktop not field assessment</li> </ul>
1091	Yes	Yes	Yes	Desktop mapped native vegetation was included in the existing conditions and impact assessment. Further field assessment is proposed.

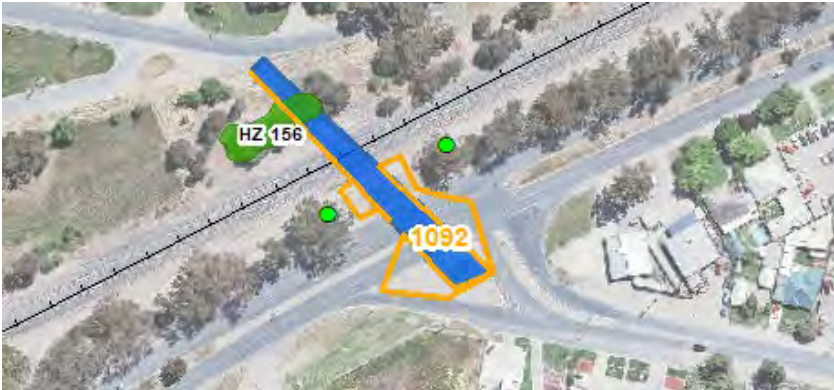
Investigation Area ID	Field assessment conducted?	Change to project area?	Field assessment proposed?	Desktop assessment notes	Image snip for illustration Key: <ul style="list-style-type: none"> <li>• Blue fill – original project area (field assessment unless otherwise stated)</li> <li>• Orange outline – additional project area (desktop assessment)</li> <li>• Green fill – mapped native vegetation</li> <li>• Green dot – mapped scattered tree</li> <li>• Black outline/dot – value mapped through desktop not field assessment</li> </ul>
1092	Yes	Yes	No	Additional areas contain disturbed road area and exotic vegetation. No further field assessment is proposed.

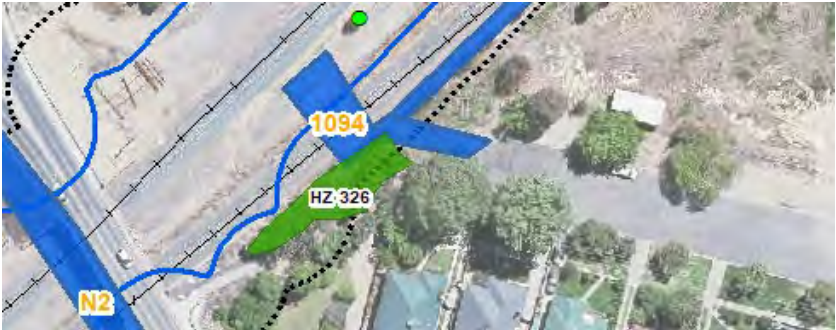
Investigation Area ID	Field assessment conducted?	Change to project area?	Field assessment proposed?	Desktop assessment notes	Image snip for illustration Key: <ul style="list-style-type: none"> <li>• Blue fill – original project area (field assessment unless otherwise stated)</li> <li>• Orange outline – additional project area (desktop assessment)</li> <li>• Green fill – mapped native vegetation</li> <li>• Green dot – mapped scattered tree</li> <li>• Black outline/dot – value mapped through desktop not field assessment</li> </ul>
1094	Yes	No	No	No additional project area, therefore, no further field assessment is proposed.

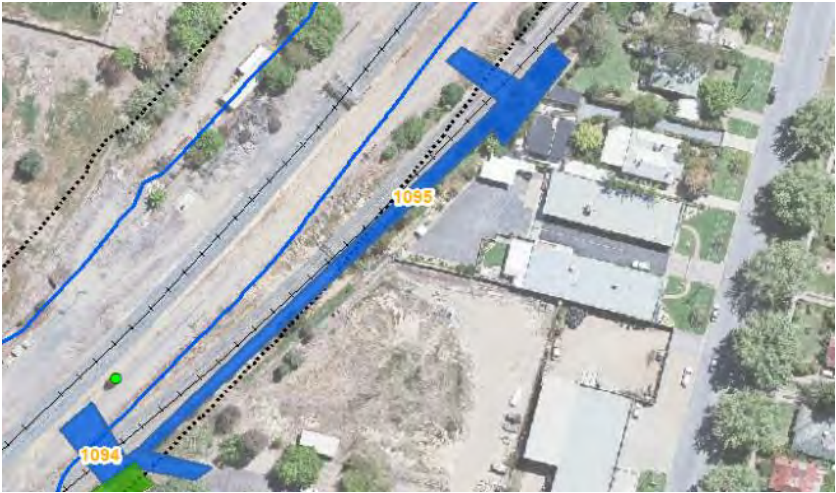
1095	Yes	No	No	No additional project area, therefore, no further field assessment is proposed.

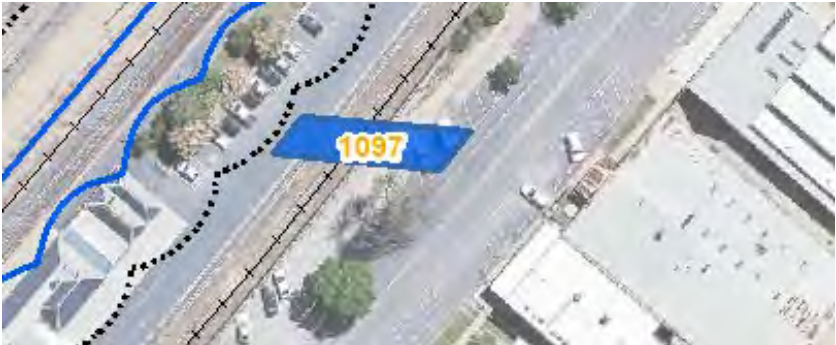
Investigation Area ID	Field assessment conducted?	Change to project area?	Field assessment proposed?	Desktop assessment notes	Image snip for illustration Key: <ul style="list-style-type: none"> <li>• Blue fill – original project area (field assessment unless otherwise stated)</li> <li>• Orange outline – additional project area (desktop assessment)</li> <li>• Green fill – mapped native vegetation</li> <li>• Green dot – mapped scattered tree</li> <li>• Black outline/dot – value mapped through desktop not field assessment</li> </ul>
1097	Yes	No	No	No additional project area, therefore, no further field assessment is proposed.

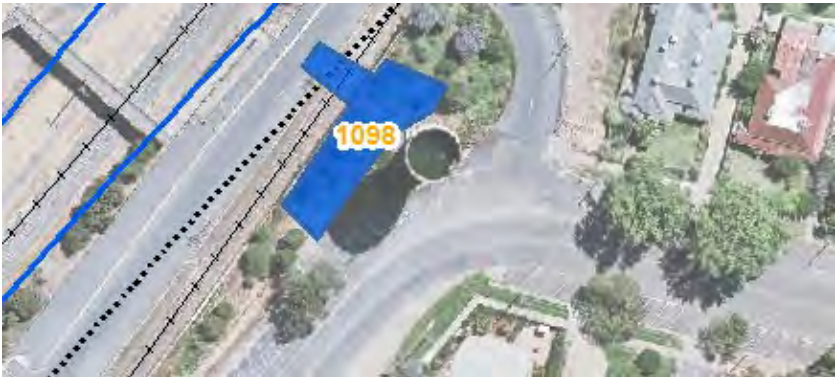
1098	Yes	No	No	No additional project area, therefore, no further field assessment is proposed.

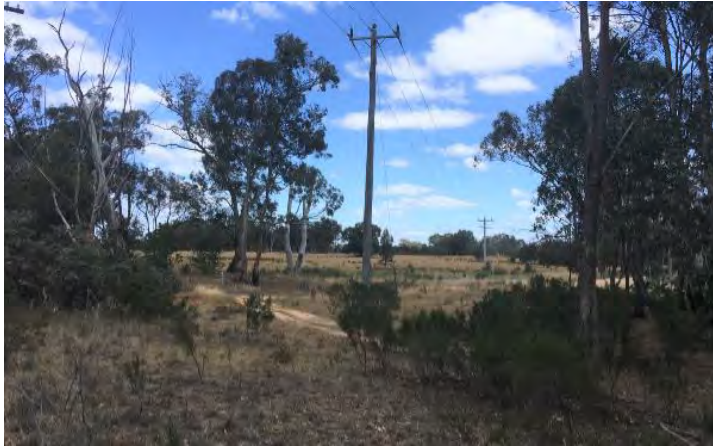
Figure 2. Typical vegetation and habitat present beneath overhead powerlines

The majority of powerline project areas were in a similar condition, where trees and tall shrubs have been removed directly beneath the powerlines, with cleared areas extending in widths from 5 m to 10 m out from the powerlines. In most instances, the vegetation usually consisted of derived grassland areas, with occasional low shrubs and regenerating eucalypts. In some cases the vegetation comprised sufficient cover and diversity to be considered a TEC, notably GBGW and WBYBBRGW. In other locations, these significant communities were present surrounding the project area, but previous disturbance under the powerlines has resulted in disturbed vegetation that does not qualify as any TEC. An example of the typical vegetation structure beneath a powerline is shown in Figure 2 below.

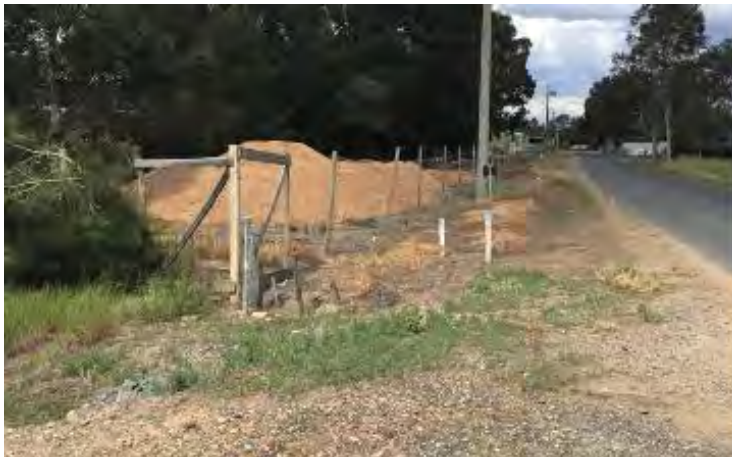
Figure 3. Typical vegetation present beneath overhead powerlines adjacent to roads (photo taken in Wangaratta)

Native vegetation patches, including those that were considered potential habitat for threatened flora and fauna species and threatened ecological communities, were more frequently recorded within road and rail reserves. Powerline project areas close to high activity areas, including road level crossings, regional towns and around railway stations, were more likely to be degraded, often containing no native vegetation or only scattered native grasses that did not meet patch definition (DELWP 2017a). Private land was generally cleared of native vegetation and habitat and was predominately grazed paddocks with exotic pasture. An example of the vegetation typically present at project areas in high activity areas is shown in Figure 3 below.

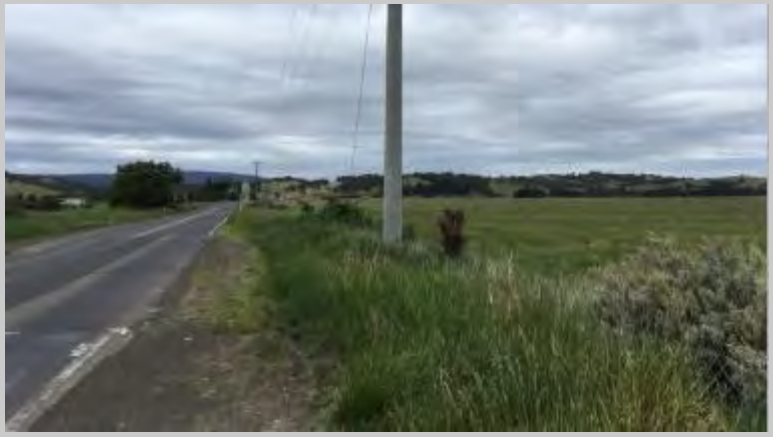
Project area	Chainage	Asset Type	Summary of proposed works	Desktop Assessment Results		Field Confirmation				
				Modelled EVC	TEC/Threatened Species	Project area	Project area Characteristics	EVC Field Assessment	TEC/Threatened Species Field Confirmation	Image
127	47.26	Electrical LV	Relocate underground	126: Swampy Riparian Complex	Swamp Everlasting	East	No native vegetation or habitat for threatened species	No EVC	No TEC or potential habitat for threatened species observed

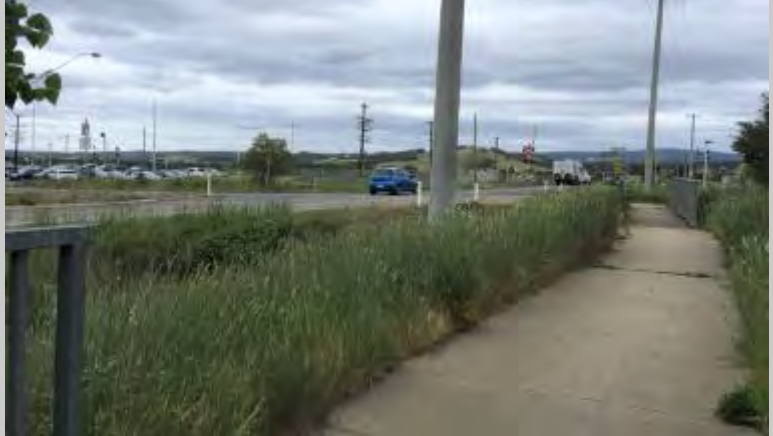
Central	No native vegetation or habitat for threatened species	No EVC	No TEC or potential habitat for threatened species observed	 
						West	Low quality patch containing silver wattle	126: Swampy Riparian Complex	Potential growing grass frog habitat. Location to be a 'no-go zone'

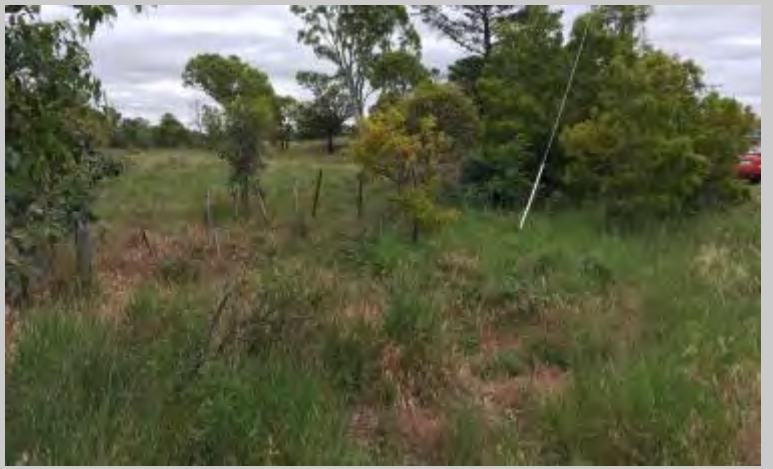
Project area	Chainage	Asset Type	Summary of proposed works	Desktop Assessment Results		Field Confirmation				
				Modelled EVC	TEC/Threatened Species	Project area	Project area Characteristics	EVC Field Assessment	TEC/Threatened Species Field Confirmation	Image
29	48.4	Electrical 22kV	Replace pole	18: Riparian Woodland	Matted Flax-lily	East	Scattered native vegetation including blackwood and immature eucalypts Avoid southern mahogany LOT in south east corner	18: Riparian Woodland	Potential Growling Grass Frog habitat (project area is located 5m from Merri Creek)

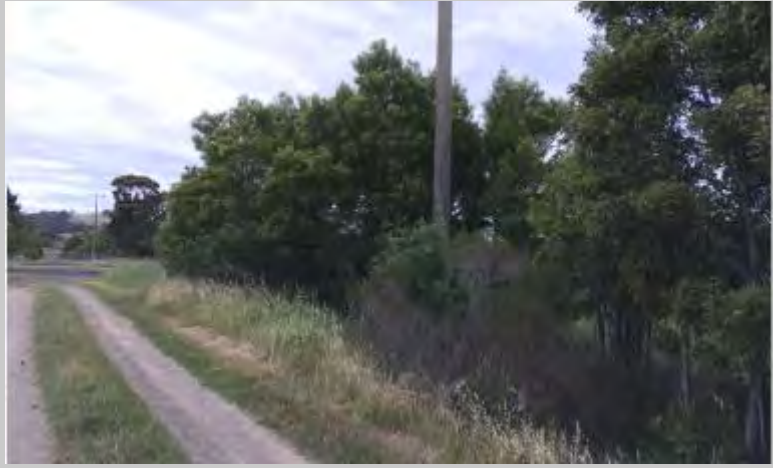
West	Low quality patch containing blackwood and Chinese scrub	18: Riparian Woodland	No TEC or potential habitat for threatened species observed

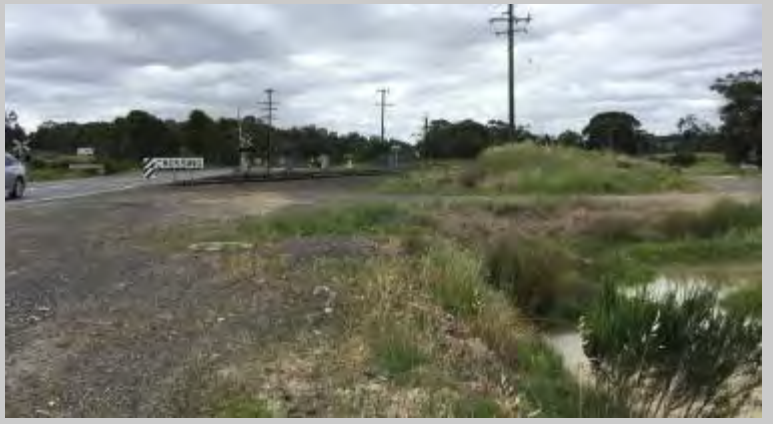
30	50.65	Electrical LV	Relocate Underground	18: Riparian Woodland	N/A	East	No native vegetation or habitat for threatened species	18: Riparian Woodland	Potential Growling Grass Frog habitat adjacent to survey area (pond and Merri Creek nearby)

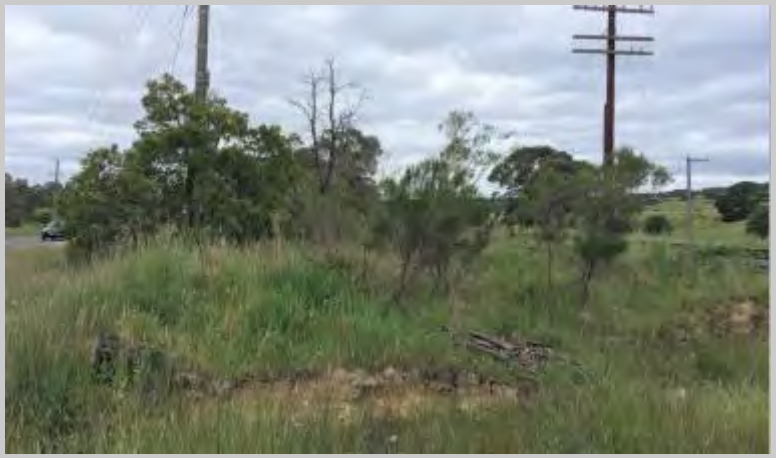
Project area	Chainage	Asset Type	Summary of proposed works	Desktop Assessment Results		Field Confirmation				
				Modelled EVC	TEC/Threatened Species	Project area	Project area Characteristics	EVC Field Assessment	TEC/Threatened Species Field Confirmation	Image
						West	Scattered native vegetation, including 2-3 blackwoods and sifton bush	No EVC	No TEC or potential habitat for threatened species observed

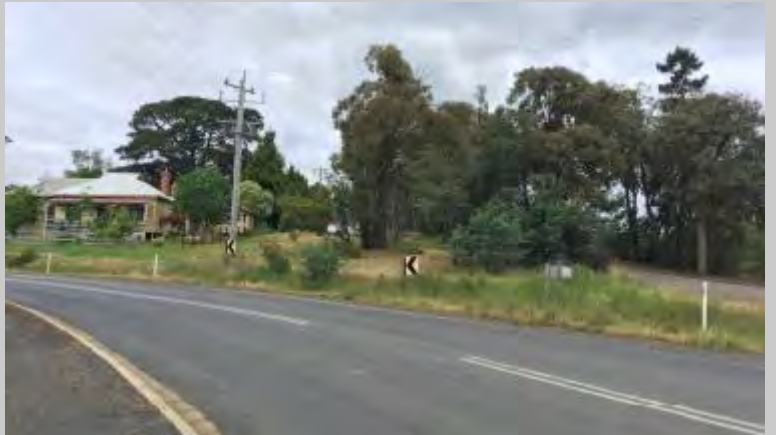
128	53.39	Electrical 22kV Electrical LV	Replace pole Relocate Underground	127: Valley Heathy Forest	N/A	East	Patch of silver wattle Scattered native grasses (project area was mown at time of assessment) Scattered regrowth trees Montpellier Broom	127: Valley Heathy Forest	No TEC or potential habitat for threatened species observed

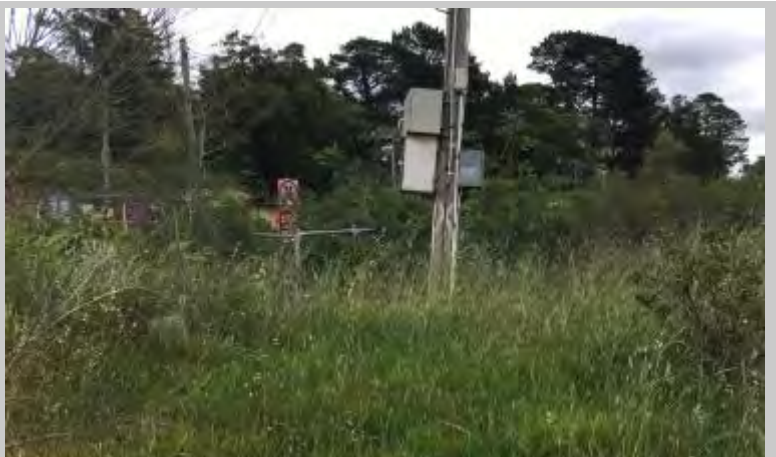
East 2	Planted buloke Rosemary grevillea Scattered native vegetation	No EVC	VROT Rosemary Grevillea (not listed)

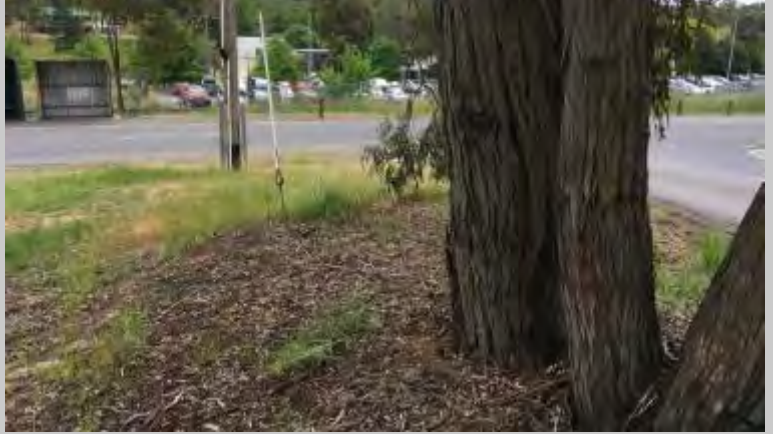
Project area	Chainage	Asset Type	Summary of proposed works	Desktop Assessment Results		Field Confirmation				
				Modelled EVC	TEC/Threatened Species	Project area	Project area Characteristics	EVC Field Assessment	TEC/Threatened Species Field Confirmation	Image
32	55.11	Communications	Decommission or abandon – access only	47: Valley Grassy Forest	N/A	East	1 planted large red Ironbark.	No EVC	No TEC or potential habitat for threatened species observed

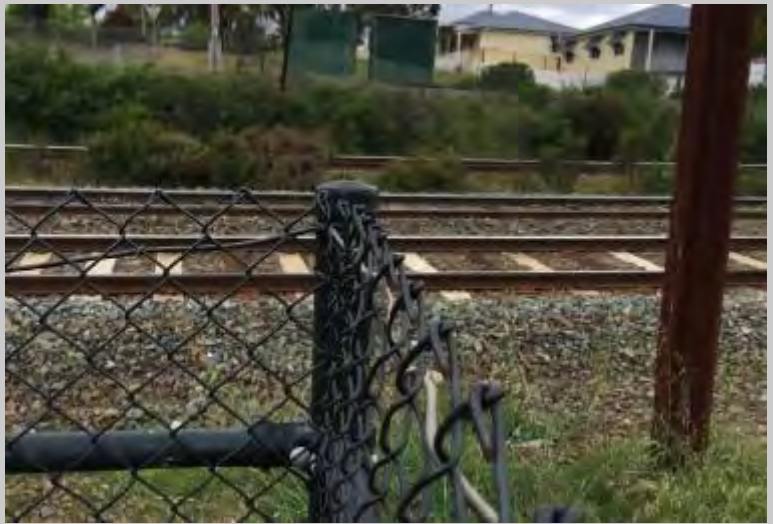
Central	No native vegetation or habitat for threatened species	No EVC	No TEC or potential habitat for threatened species observed

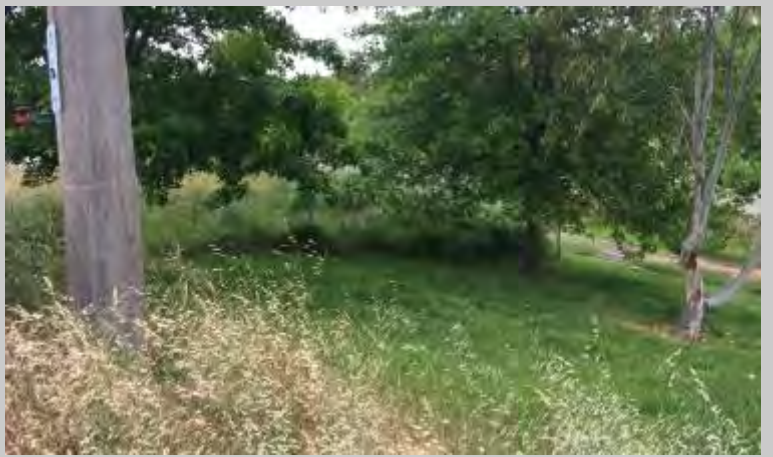
West	No native vegetation or habitat for threatened species (planted eucalypt in centre)	No EVC	No TEC or potential habitat for threatened species observed

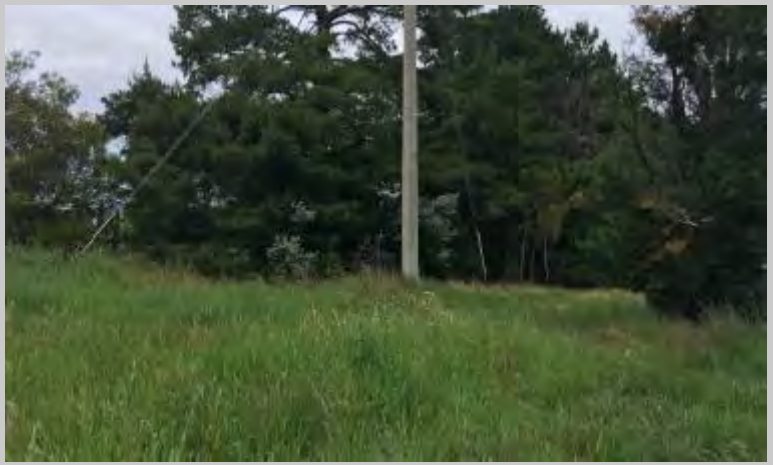
Project area	Chainage	Asset Type	Summary of proposed works	Desktop Assessment Results		Field Confirmation				
				Modelled EVC	TEC/Threatened Species	Project area	Project area Characteristics	EVC Field Assessment	TEC/Threatened Species Field Confirmation	Image
33	64.22	Electrical 66kV Electrical 22kV	Replace pole Replace pole	23: Herb-rich Foothill Forest	WBYBBRG	East	Poor quality patch of lightwood	No EVC	No TEC or potential habitat for threatened species observed

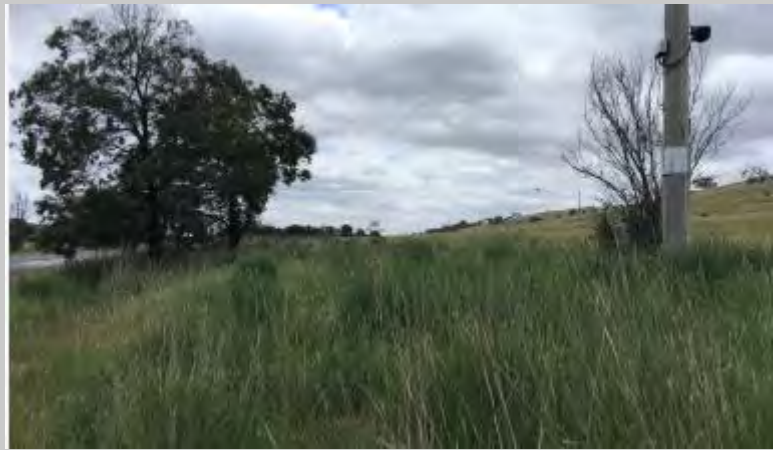
West	Private land – inaccessible without V/Line access. Looks like scattered Chinese scrub only from accessible areas.	Unknown	No TEC or potential habitat for threatened species observed	No photo
34	65.31	Electrical 22kV	Replace pole	22: Grassy Dry Forest	WBYBBRG	East	1 silver wattle at edge (avoid)	No EVC	No TEC or potential habitat for threatened species observed

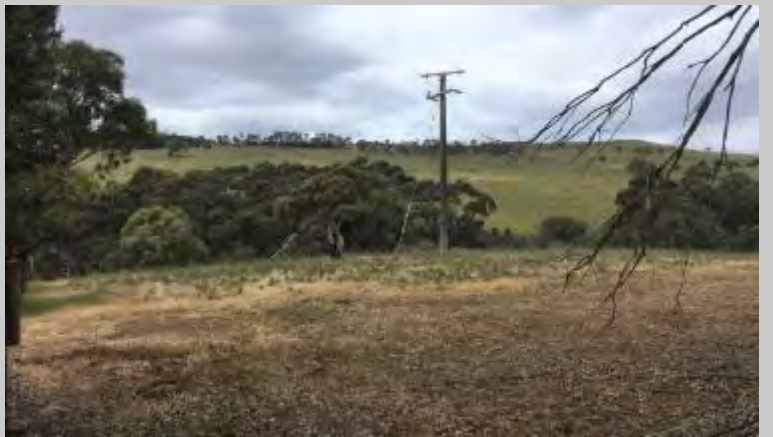
West	Patch of native grasses at south east side Planted indigenous vegetation, including red box at roadside	22: Grassy Dry Forest	Potential habitat for VTWBC observed.

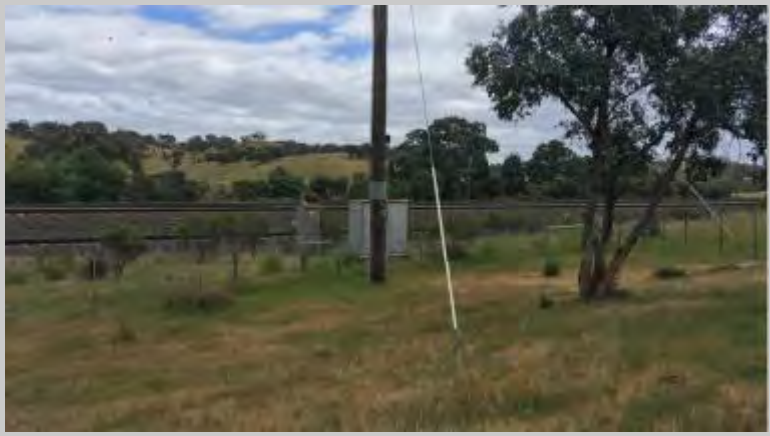
Project area	Chainage	Asset Type	Summary of proposed works	Desktop Assessment Results		Field Confirmation				
				Modelled EVC	TEC/Threatened Species	Project area	Project area Characteristics	EVC Field Assessment	TEC/Threatened Species Field Confirmation	Image
35	67.04	Electrical 22kV	Replace pole	293: Riparian Forest/Creekline Grassy Woodland Mosaic 47: Valley Grassy Forest	N/A	East	Poor quality patch of native vegetation, including Chinese scrub, exotic or native spear grasses, river red gum and grey box impacted by weeds and grazing Scattered native grasses further into paddock	47: Valley Grassy Forest	No TEC or potential habitat for threatened species observed

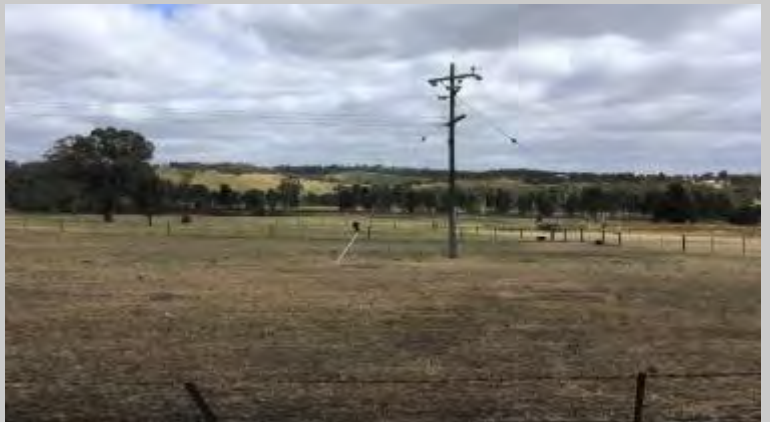
West	Private land – inaccessible (access denied). Location could not be viewed during the assessment.	Unknown	Unknown	No photo
36	70.2	Electrical LV	Replace pole	47: Valley Grassy Forest	VTWBC	East	Scattered native grasses, heavily grazed	No EVC	No TEC or potential habitat for threatened species observed

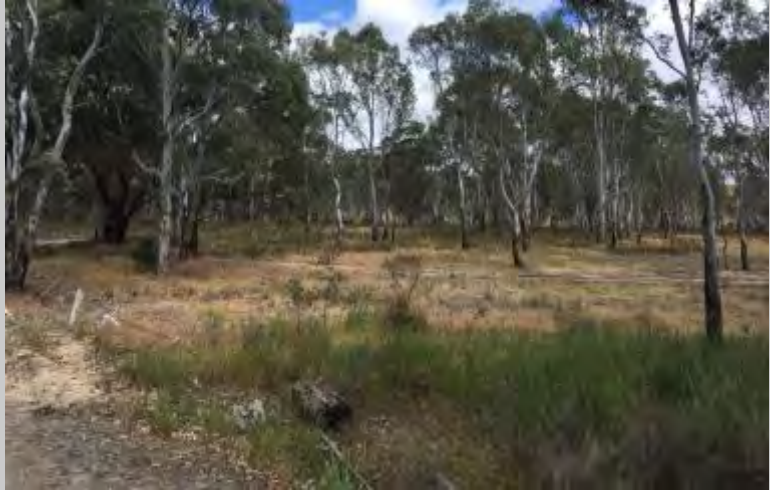
West	Private land – inaccessible Northern most point of project area contains a patch of good quality native vegetation, which appears to extend into private land, as viewed from adjacent rail and road reserves.	47: Valley Grassy Forest	Unknown – potential WBYBBRGGW

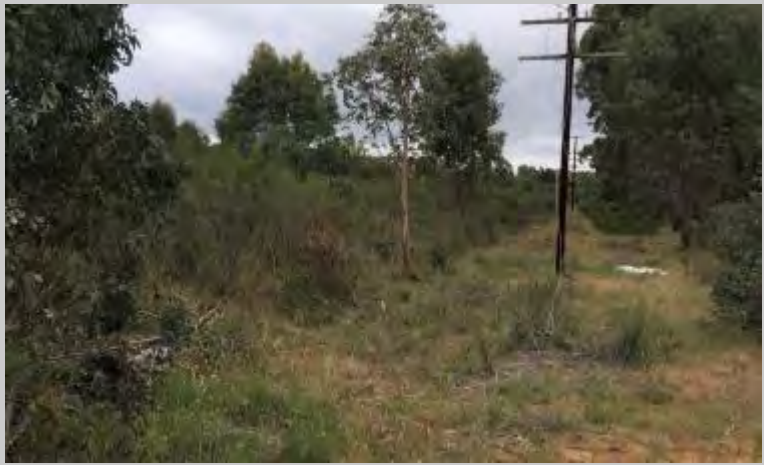
Project area	Chainage	Asset Type	Summary of proposed works	Desktop Assessment Results		Field Confirmation				
				Modelled EVC	TEC/Threatened Species	Project area	Project area Characteristics	EVC Field Assessment	TEC/Threatened Species Field Confirmation	Image
37	71.63	Electrical 22kV	Replace pole	175: Grassy Woodland	N/A	East	Private land – inaccessible. Potential for golden sun moth, considering apparent grassland and previous records. However, grass species present and habitat quality needs to be confirmed during a detailed site assessment.	Unknown	Unknown – potential habitat for golden sun moth	No photo
						West	Good quality patch of native vegetation in rail reserve, with no mature trees  Western side of project area is private land and inaccessible without access agreement and could not be easily viewed from adjacent areas.	175: Grassy Woodland	VTWBC

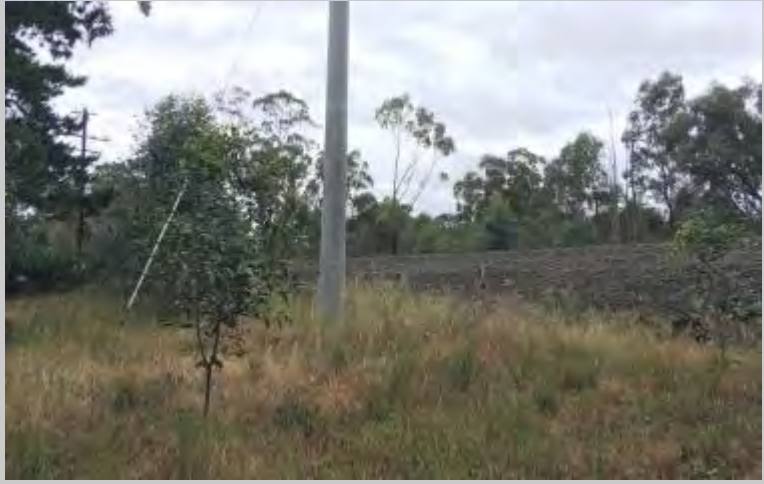
West	Patch of native vegetation to north, including tussock-grasses, needle grasses and chocolate lilies.  Scattered immature eucalypts and native grasses to south.	175: Grassy Woodland	Potential golden sun moth habitat VTWBC

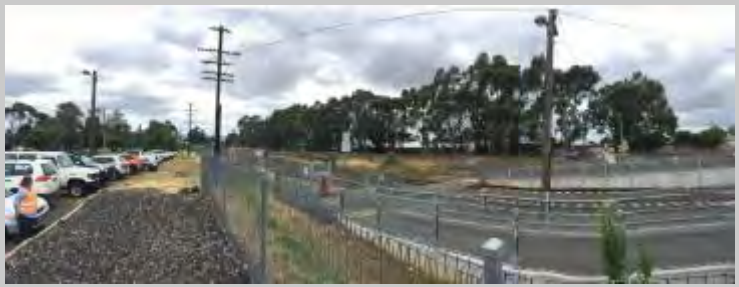
Project area	Chainage	Asset Type	Summary of proposed works	Desktop Assessment Results		Field Confirmation				
				Modelled EVC	TEC/Threatened Species	Project area	Project area Characteristics	EVC Field Assessment	TEC/Threatened Species Field Confirmation	Image
129	75.31	Electrical LV	Relocate underground	N/A	N/A		No native vegetation or habitat for threatened species	No EVC	No TEC or potential habitat for threatened species observed

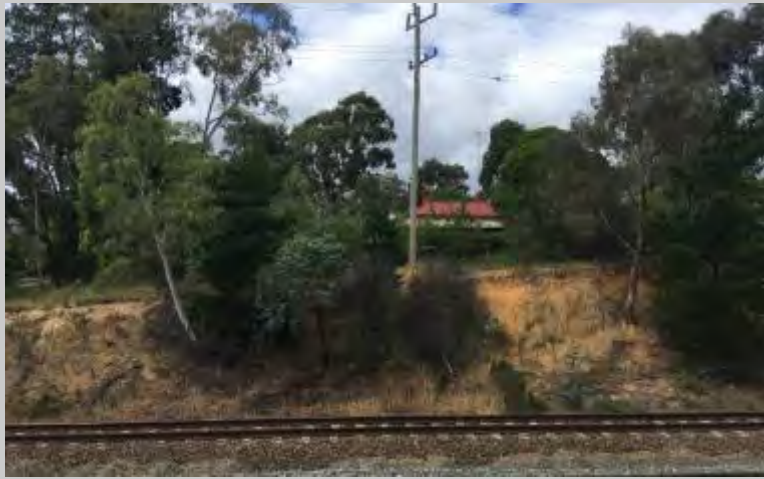
39	75.67	Electrical 66kV Electrical LV	Replace pole Relocate underground	N/A	N/A	East	Scattered trees	No EVC	No TEC or potential habitat for threatened species observed

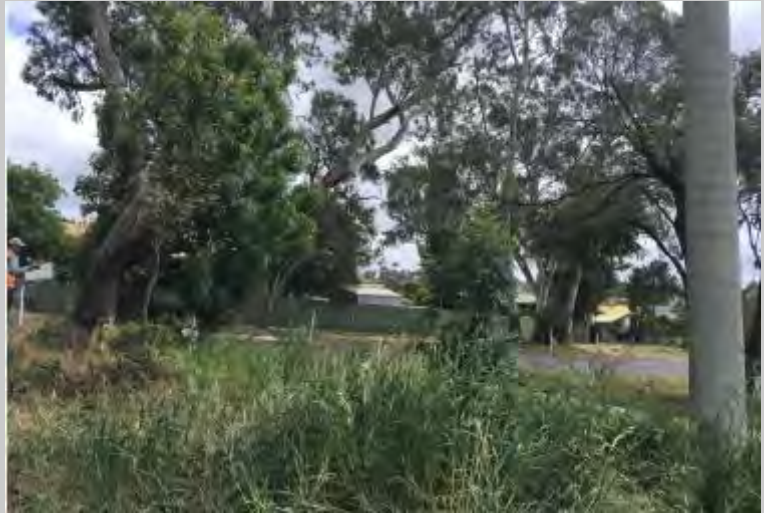
West	Scattered native vegetation 2x scattered river red gum should be avoided.	No EVC	No TEC or potential habitat for threatened species observed

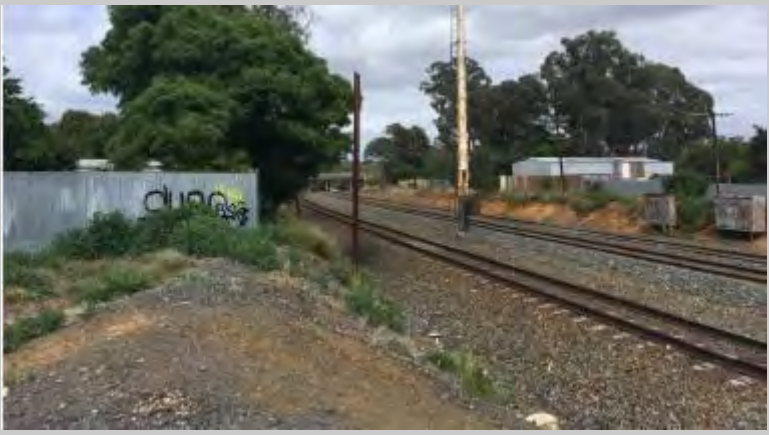
Project area	Chainage	Asset Type	Summary of proposed works	Desktop Assessment Results		Field Confirmation				
				Modelled EVC	TEC/Threatened Species	Project area	Project area Characteristics	EVC Field Assessment	TEC/Threatened Species Field Confirmation	Image
130	76.87	Infrastructure Infrastructure	Replace pole Replace pole	N/A	N/A		No native vegetation or habitat for threatened species	No EVC	No TEC or potential habitat for threatened species observed

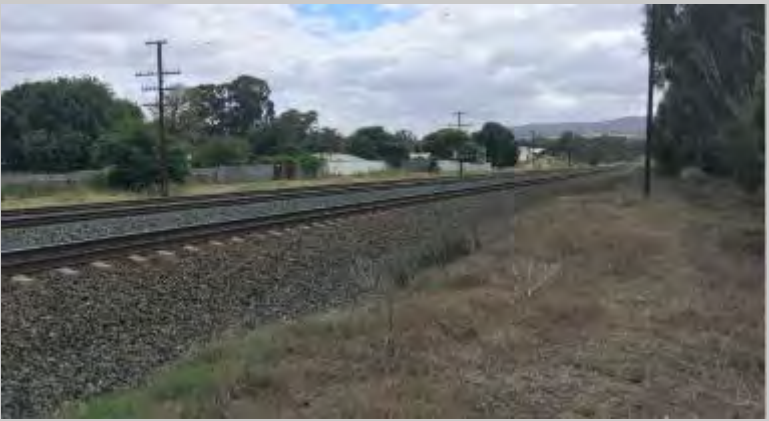
131	76.9	Infrastructure	Replace pole	N/A	N/A		No native vegetation or habitat for threatened species	No EVC	No TEC or potential habitat for threatened species observed

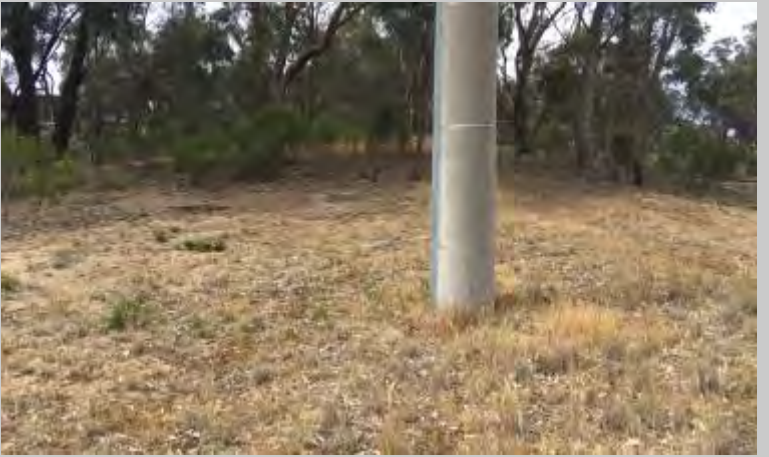
41	77.88	Electrical 22kV	Replace pole	175: Grassy Woodland	N/A		Private land - inaccessible	Unknown	Unknown	No photo
42	78.62	Electrical 22kV	Replace pole	175: Grassy Woodland 55: Plains Grassy Woodland	N/A	East	Scattered river red gum regrowth to north Patch of native grasses to south	175: Grassy Woodland	GBGW

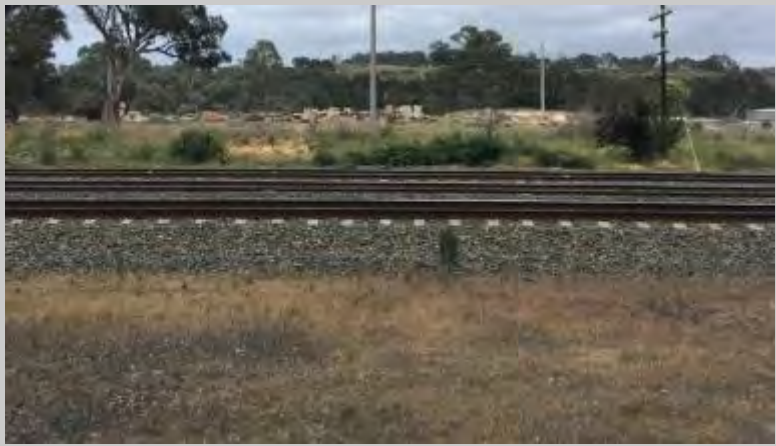
Project area	Chainage	Asset Type	Summary of proposed works	Desktop Assessment Results		Field Confirmation				
				Modelled EVC	TEC/Threatened Species	Project area	Project area Characteristics	EVC Field Assessment	TEC/Threatened Species Field Confirmation	Image
						West	Private land – inaccessible, possibly native grasses present that was visible from adjacent rail reserve.	Unknown	Unknown

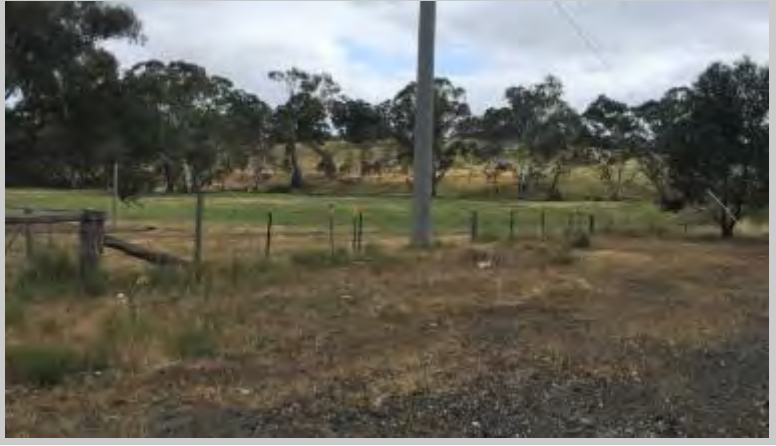
43	80.01	Electrical 22kV	Replace pole	55: Plains Grassy Woodland	N/A	East	Scattered native grasses	No EVC	No TEC or potential habitat for threatened species observed

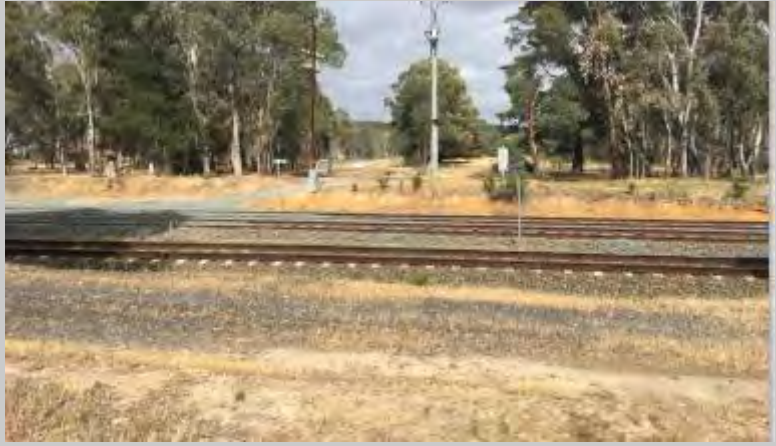
West	Scattered regrowth Scattered native grasses	175: Grassy Woodland	No TEC or potential habitat for threatened species observed

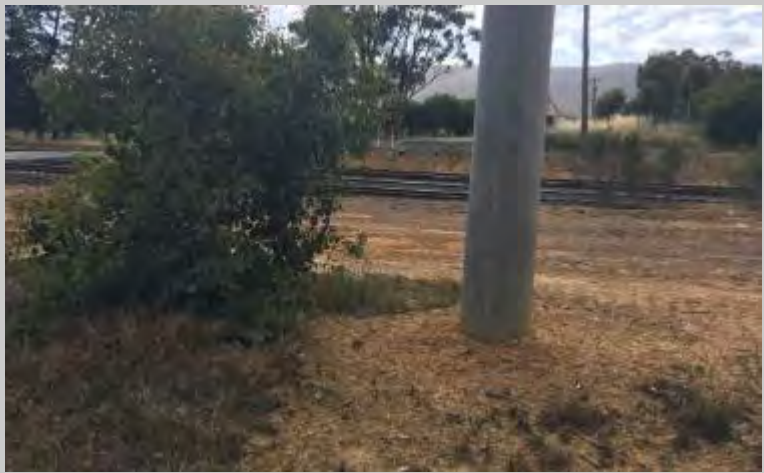
Project area	Chainage	Asset Type	Summary of proposed works	Desktop Assessment Results		Field Confirmation				
				Modelled EVC	TEC/Threatened Species	Project area	Project area Characteristics	EVC Field Assessment	TEC/Threatened Species Field Confirmation	Image
				55: Plains Grassy Woodland		South West	Native regrowth including red box and Chinese scrub	175: Grassy Woodland	VTWBC

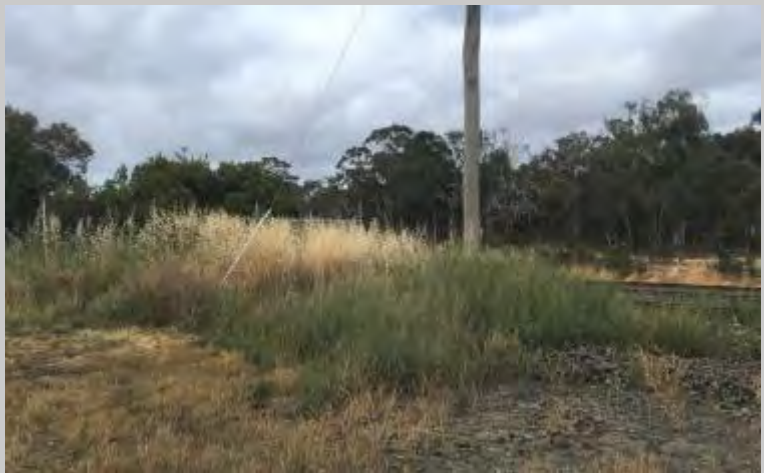
South East			Avoid planted native shrubs inside fenced area. Nothing outside fenced area.	No EVC	No TEC or potential habitat for threatened species observed

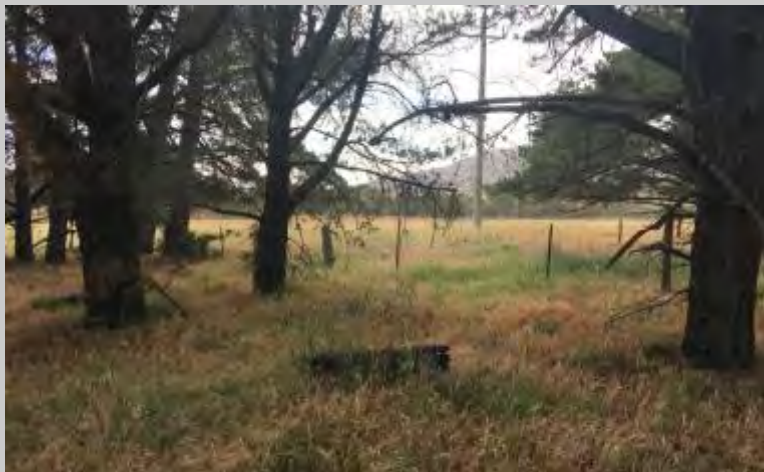
North East			Avoid scattered regrowth trees between project area and rail track. Nothing within project area.	No EVC	No TEC or potential habitat for threatened species observed

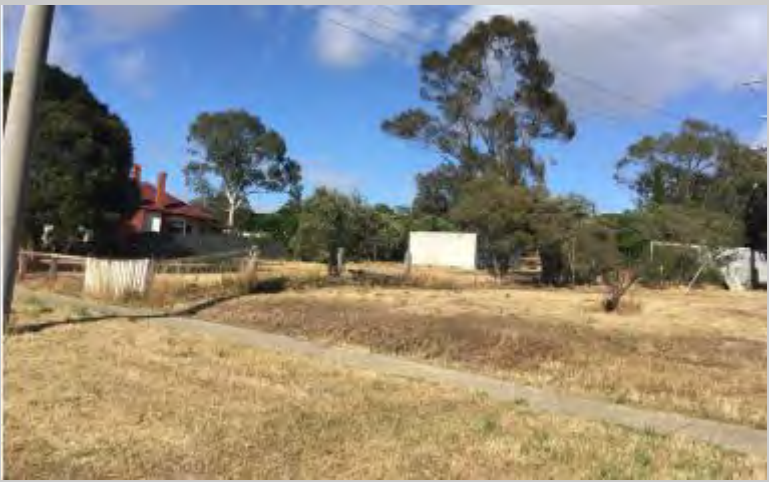
Project area	Chainage	Asset Type	Summary of proposed works	Desktop Assessment Results		Field Confirmation				
				Modelled EVC	TEC/Threatened Species	Project area	Project area Characteristics	EVC Field Assessment	TEC/Threatened Species Field Confirmation	Image
45	89.79	Electrical 22kV Electrical LV	Relocate underground Relocate underground	175: Grassy Woodland	N/A	East	Avoid planted eucalypts to north, including indigenous species river red gum and grey box. Scattered wallaby grasses	No EVC	No TEC or potential habitat for threatened species observed

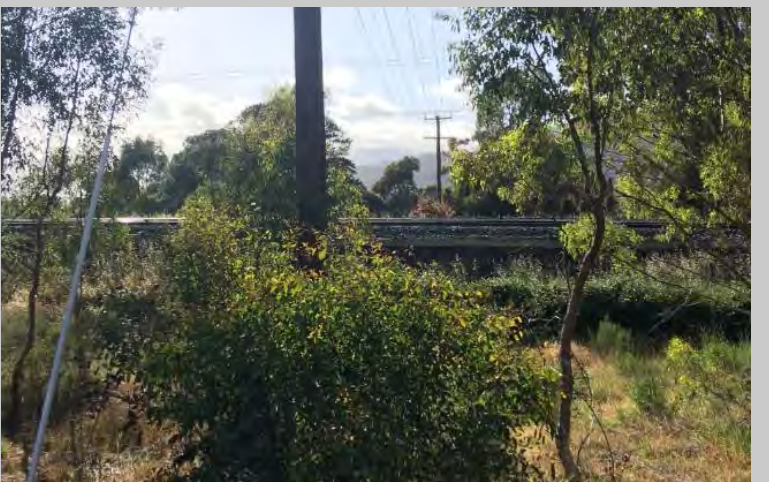
West	Scattered trees including regrowth yellow box Scattered wetland species including rushes	No EVC	No TEC or potential habitat for threatened species observed

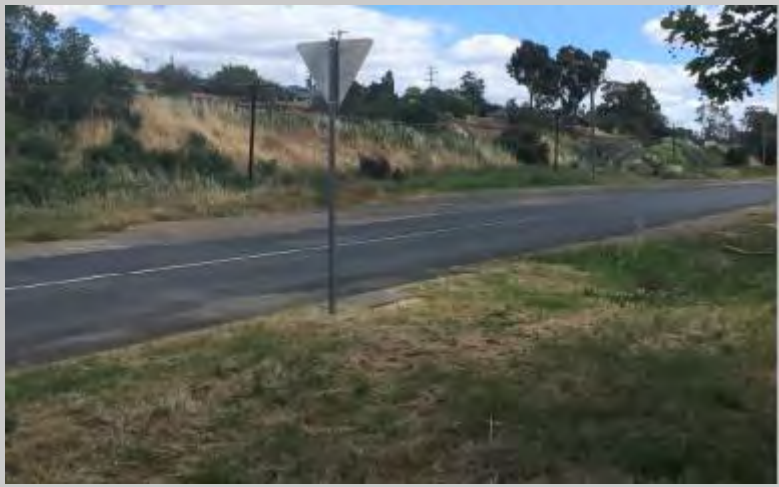
Project area	Chainage	Asset Type	Summary of proposed works	Desktop Assessment Results		Field Confirmation				
				Modelled EVC	TEC/Threatened Species	Project area	Project area Characteristics	EVC Field Assessment	TEC/Threatened Species Field Confirmation	Image
						West	No native vegetation or habitat for threatened species	No EVC	No TEC or potential habitat for threatened species observed
