## Appendix A – Figures

Figure 7 Environmental overlays

**Environmental Overlays**

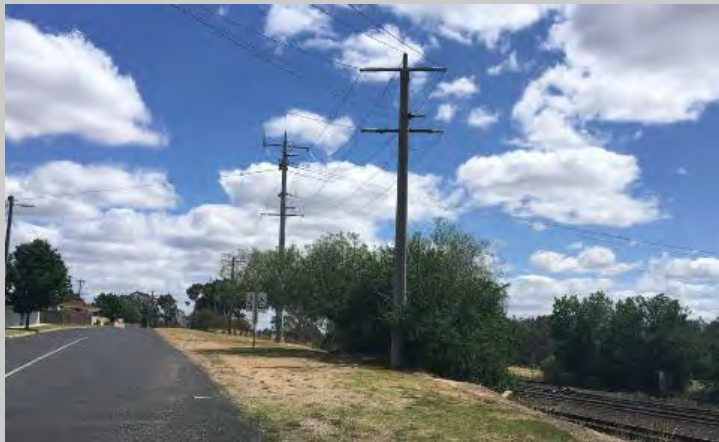
48	98.31	Electrical 66kV Electrical 22kV	Replace pole Replace pole	N/A	N/A	East	Patch of silver wattle	55: Plains Grassy Woodland	No TEC or potential habitat for threatened species observed

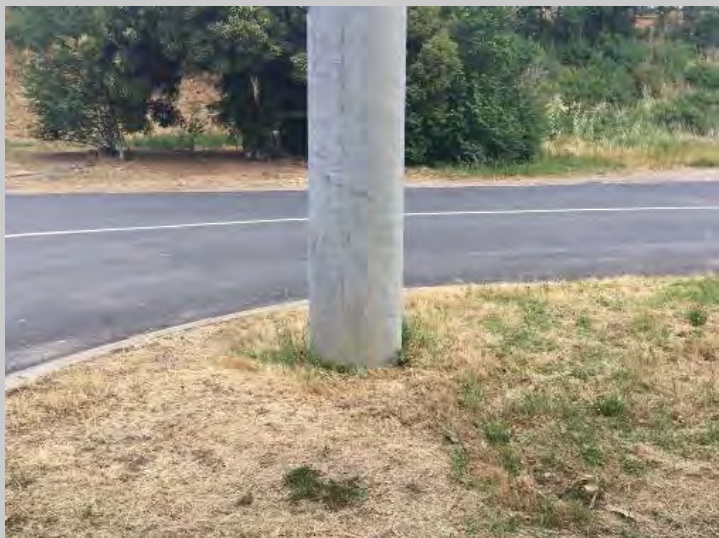
West	No native vegetation or habitat for threatened species	No EVC	No TEC or potential habitat for threatened species observed

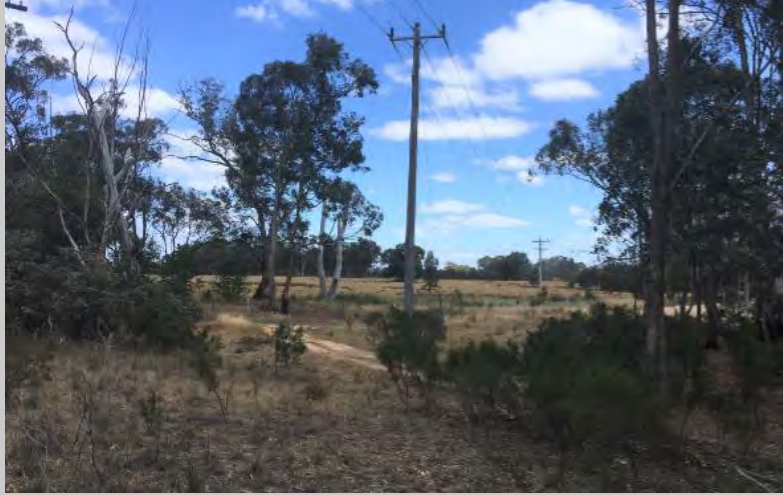
Project area	Chainage	Asset Type	Summary of proposed works	Desktop Assessment Results		Field Confirmation				
				Modelled EVC	TEC/Threatened Species	Project area	Project area Characteristics	EVC Field Assessment	TEC/Threatened Species Field Confirmation	Image
51	108.65	Electrical 22kV	Replace pole	55 Plains Grassy Woodland	VTWBC	East	Patch of native vegetation including native grasses, shrubs and one large grey box.	55 Plains Grassy Woodland	VTWBC GBGW

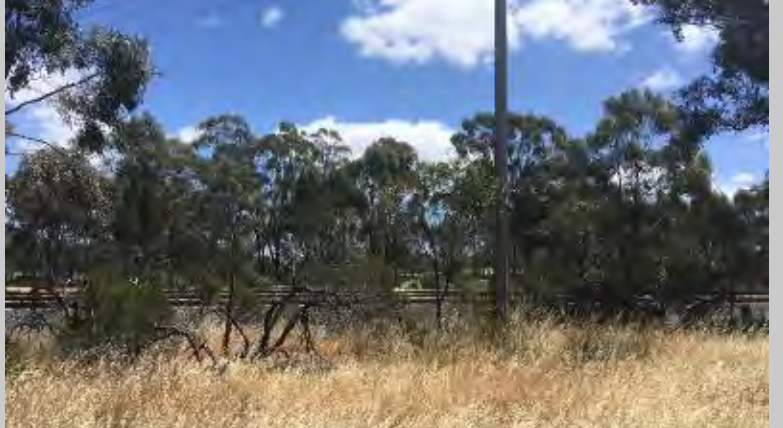
West	Scattered grasses Scattered trees (regrowth)	55 Plains Grassy Woodland	No TEC or potential habitat for threatened species observed

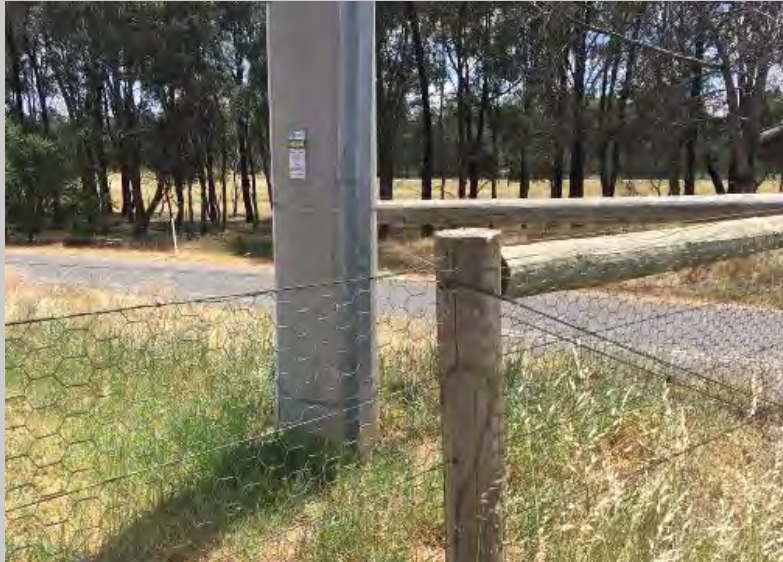
52	114.95	Electrical 22kV	Replace pole	N/A	N/A		No native vegetation or habitat for threatened species	No EVC	No TEC or potential habitat for threatened species observed

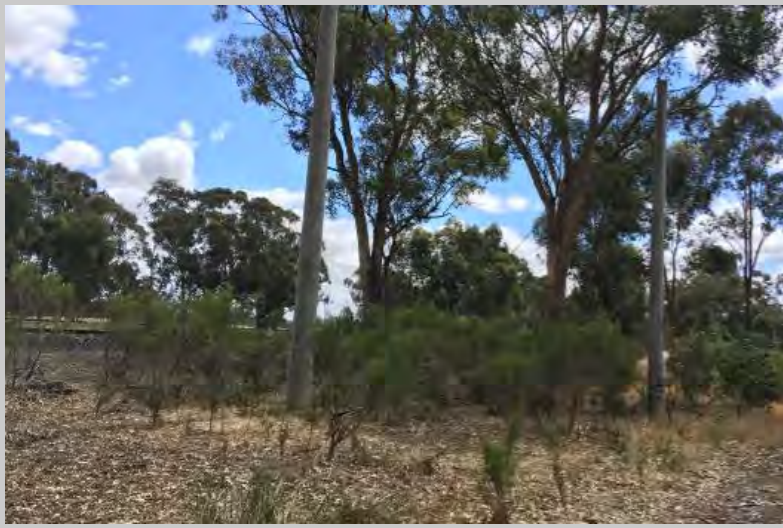
Project area	Chainage	Asset Type	Summary of proposed works	Desktop Assessment Results		Field Confirmation				
				Modelled EVC	TEC/Threatened Species	Project area	Project area Characteristics	EVC Field Assessment	TEC/Threatened Species Field Confirmation	Image
55	127.46	Electrical 22kV	Replace pole	287: Plains Grassy Woodland/ Box Ironbark Forest Complex	VTWBC	East	Patch of native vegetation including grey box and Chinese scrub	55: Plains Grassy Woodland	No TEC or potential habitat for threatened species observed

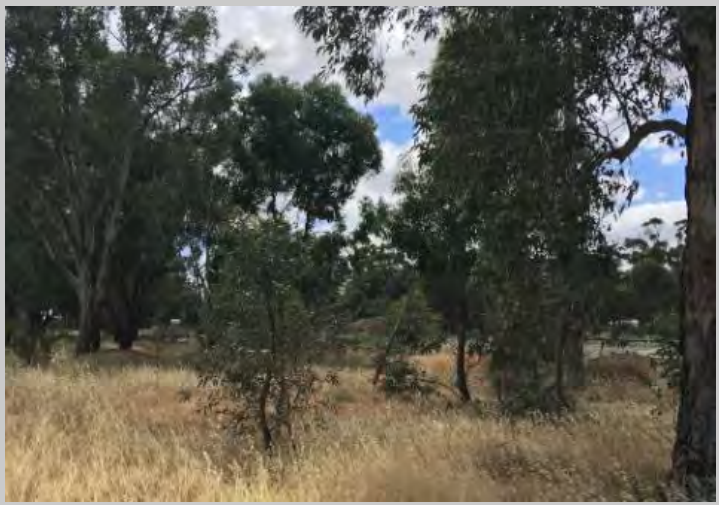
West	Patch of native vegetation including grey box, understory species but affected by weeds	55: Plains Grassy Woodland	No TEC or potential habitat for threatened species observed

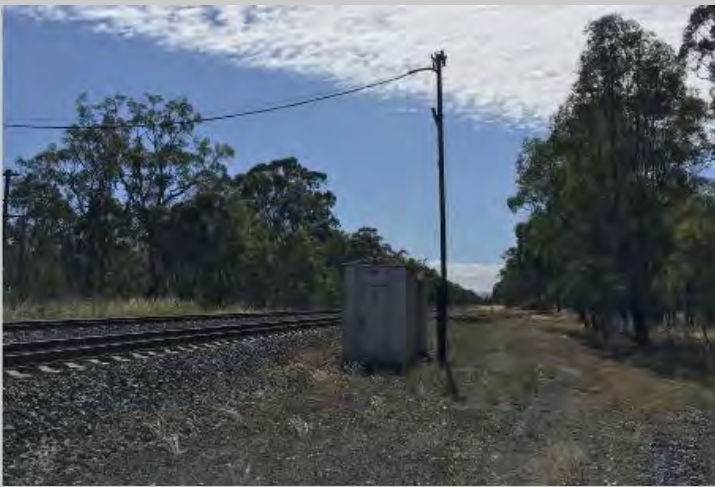
Project area	Chainage	Asset Type	Summary of proposed works	Desktop Assessment Results		Field Confirmation				
				Modelled EVC	TEC/Threatened Species	Project area	Project area Characteristics	EVC Field Assessment	TEC/Threatened Species Field Confirmation	Image
		Electrical 22kV Electrical LV	Replace pole Relocate overhead	Plains Grassy Woodland Complex 55 Plains Grassy Woodland		North East	No native vegetation or habitat for threatened species	No EVC	No TEC or potential habitat for threatened species observed

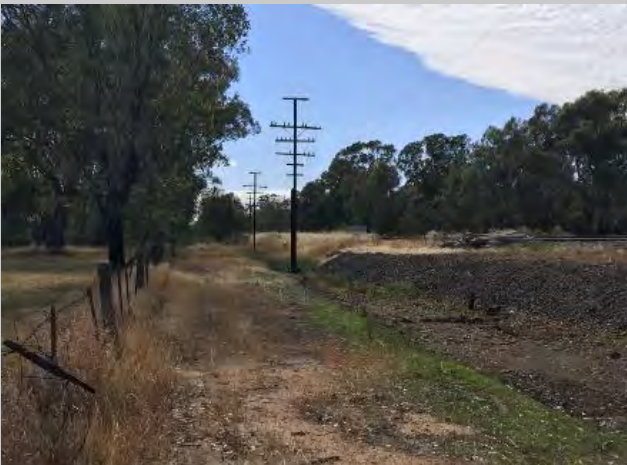
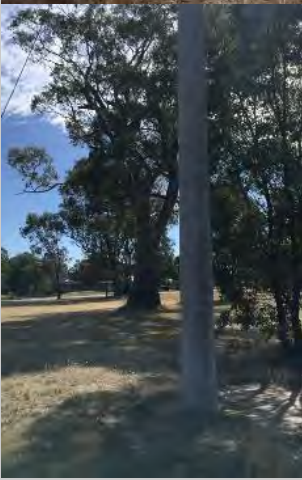
West	Good quality patch of native vegetation including grey box, and diverse understory species. Scattered trees Scattered native grasses Avoid adjacent large tree which contains hollows	55: Plains Grassy Woodland	No TEC or potential habitat for threatened species observed

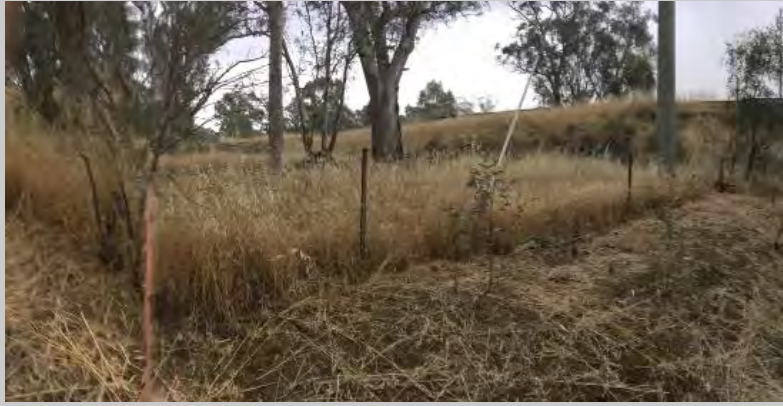
Project area	Chainage	Asset Type	Summary of proposed works	Desktop Assessment Results		Field Confirmation				
				Modelled EVC	TEC/Threatened Species	Project area	Project area Characteristics	EVC Field Assessment	TEC/Threatened Species Field Confirmation	Image
62	151.12	2x Electrical LV	Relocate underground	N/A	N/A		No native vegetation or habitat for threatened species	No EVC	No TEC or potential habitat for threatened species observed	No photo
63	151.76	Electrical 22kV	Relocate underground	55: Plains Grassy Woodland 56:Floodplain Riparian Woodland	N/A		Scattered Trees	No EVC	No TEC or potential habitat for threatened species observed

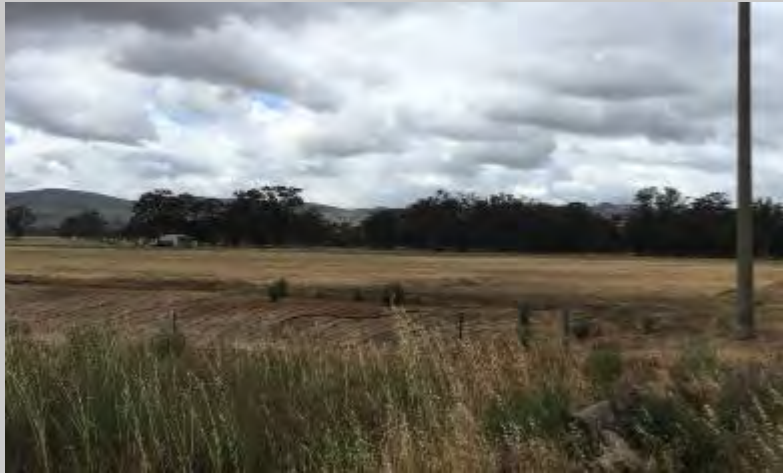
64	158.96	Electrical 22kV	Replace pole	N/A	N/A	East	Scattered native grasses, extending into private land, as seen from fence line in the rail reserve.	No EVC	No TEC or potential habitat for threatened species observed

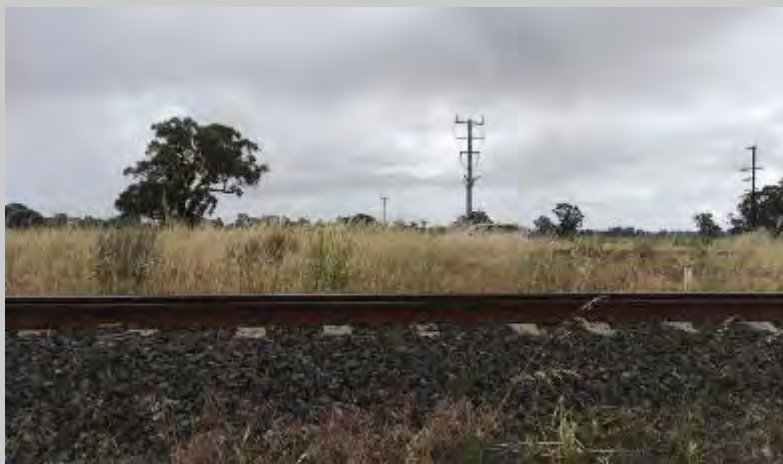
West	No native vegetation or habitat for threatened species	No EVC	No TEC or potential habitat for threatened species observed

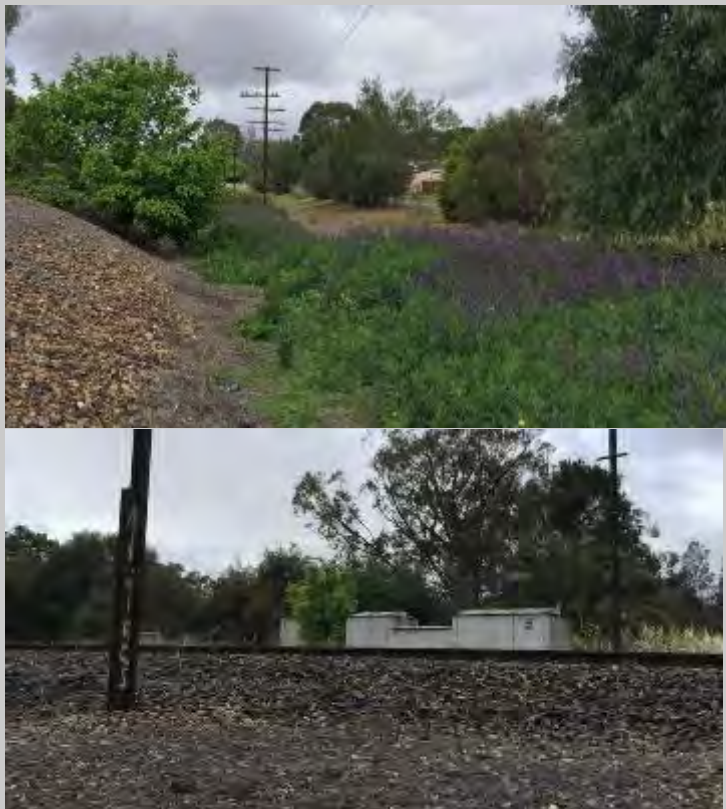
Project area	Chainage	Asset Type	Summary of proposed works	Desktop Assessment Results		Field Confirmation				
				Modelled EVC	TEC/Threatened Species	Project area	Project area Characteristics	EVC Field Assessment	TEC/Threatened Species Field Confirmation	Image
65	169.45	2x Electrical LV Electrical 22kV Communications	Relocate underground Relocate underground Relocate underground	N/A	N/A		No native vegetation or habitat for threatened species	No EVC	No TEC or potential habitat for threatened species observed

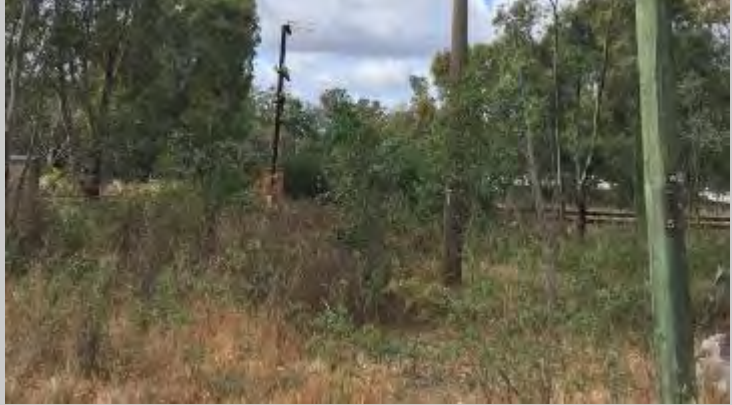
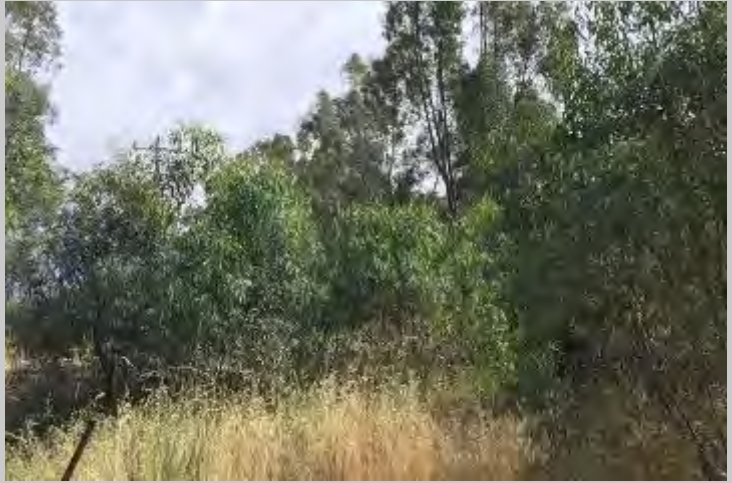
Project area	Chainage	Asset Type	Summary of proposed works	Desktop Assessment Results		Field Confirmation				
				Modelled EVC	TEC/Threatened Species	Project area	Project area Characteristics	EVC Field Assessment	TEC/Threatened Species Field Confirmation	Image
66	170.19	Electrical 22kV	Replace pole	N/A	N/A		Patch of native vegetation Scattered trees Montpellier broom	68: Creepline Grassy Woodland	No TEC or potential habitat for threatened species observed within project area. Adjacent to VTWBC habitat

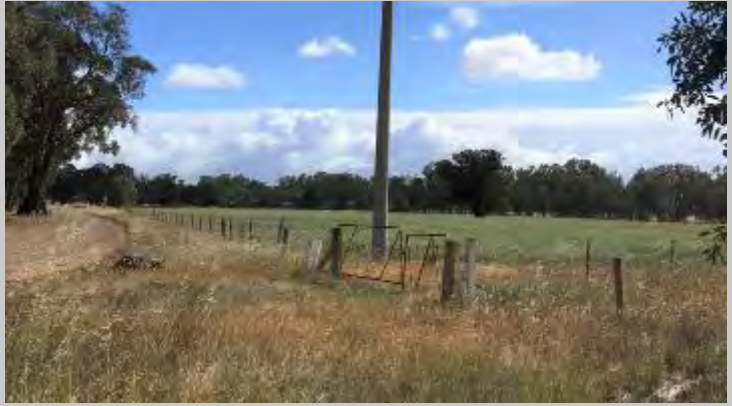
67	171.5	Electrical 22kV	Replace pole	N/A	N/A	East	Patch of native vegetation including white box and yellow box.	55: Plains Grassy Woodland	Too poor quality to qualify as WBYBBRGGW

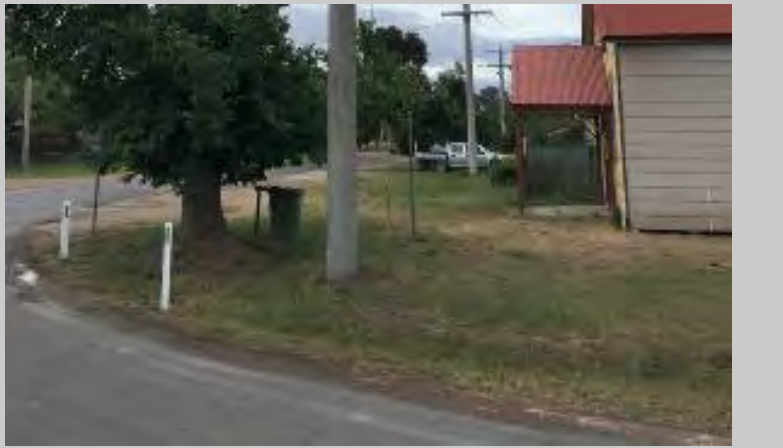
Project area	Chainage	Asset Type	Summary of proposed works	Desktop Assessment Results		Field Confirmation				
				Modelled EVC	TEC/Threatened Species	Project area	Project area Characteristics	EVC Field Assessment	TEC/Threatened Species Field Confirmation	Image
68	177.25	Electrical 22kV	Replace pole	55: Plains Grassy Woodland	VTWBC WBYBBRG	East	Patch of native vegetation at the edge of patch Scattered native vegetation within project area Avoid trees at edge of project area	No EVC	No TEC or potential habitat for threatened species observed	 
						West	Scattered native grasses	No EVC	No TEC or potential habitat for threatened species observed	 
69	183.13	Electrical 22kV Electrical LV	Replace pole Replace pole	55: Plains Grassy Woodland	N/A	East	No native vegetation or habitat for threatened species	No EVC	No TEC or potential habitat for threatened species observed

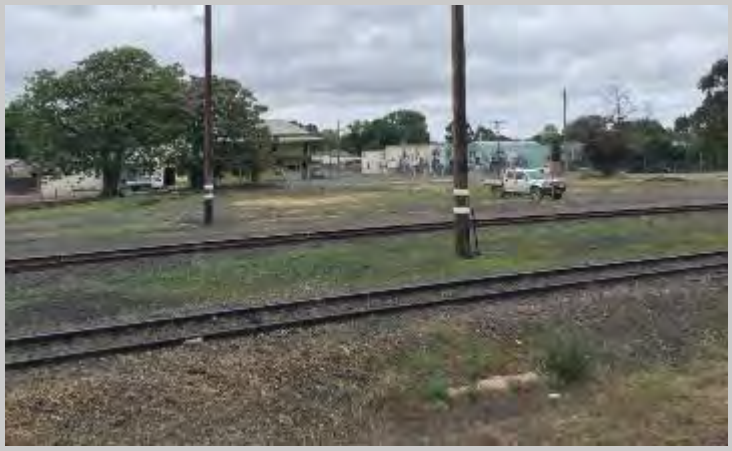
Project area	Chainage	Asset Type	Summary of proposed works	Desktop Assessment Results		Field Confirmation				
				Modelled EVC	TEC/Threatened Species	Project area	Project area Characteristics	EVC Field Assessment	TEC/Threatened Species Field Confirmation	Image
75	195	Electrical LV	Decommission or abandon – no works	N/A	N/A		No native vegetation or habitat for threatened species	No EVC	No TEC or potential habitat for threatened species observed

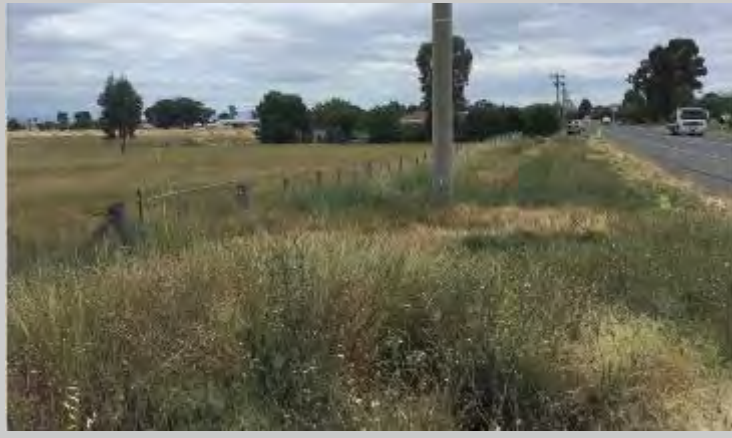
76	196.84	Electrical 22kV	Replace pole	N/A	N/A	East	Scattered regrowth native grasses	No EVC	No TEC or potential habitat for threatened species observed

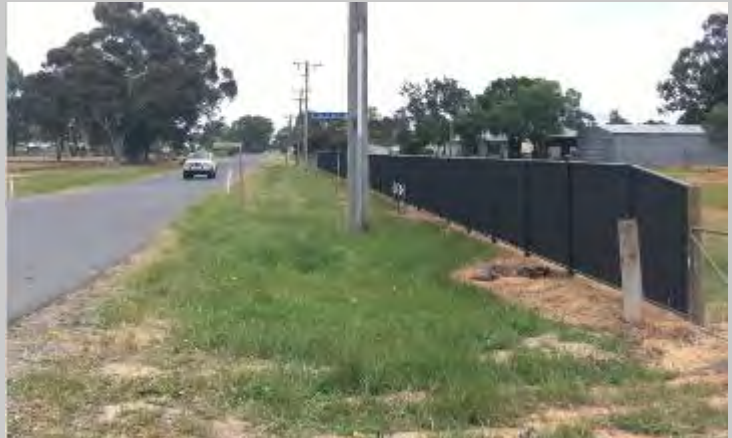
West	No native vegetation or habitat for threatened species	No EVC	No TEC or potential habitat for threatened species observed

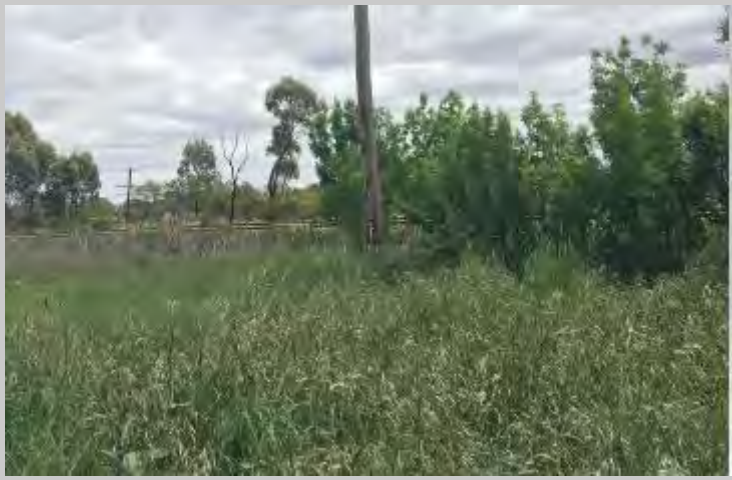
Project area	Chainage	Asset Type	Summary of proposed works	Desktop Assessment Results		Field Confirmation				
				Modelled EVC	TEC/Threatened Species	Project area	Project area Characteristics	EVC Field Assessment	TEC/Threatened Species Field Confirmation	Image
77	197.58	Electrical 22kV	Replace pole	N/A	N/A		Cumbungi located in drain	No EVC	No TEC or potential habitat for threatened species observed

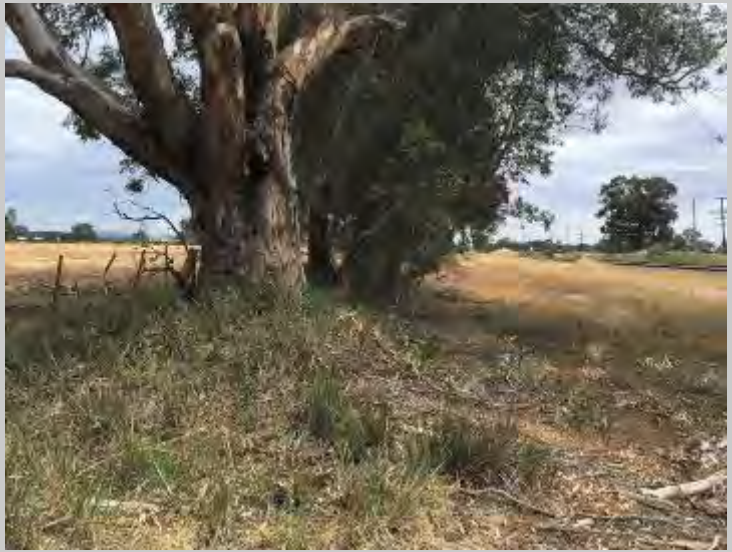
78	198.07	Electrical 22kV Electrical 66kV	Replace pole Replace pole	N/A	N/A	North East	Very old large river red gum in rail reserve (outside project area)	No EVC	No TEC or potential habitat for threatened species observed

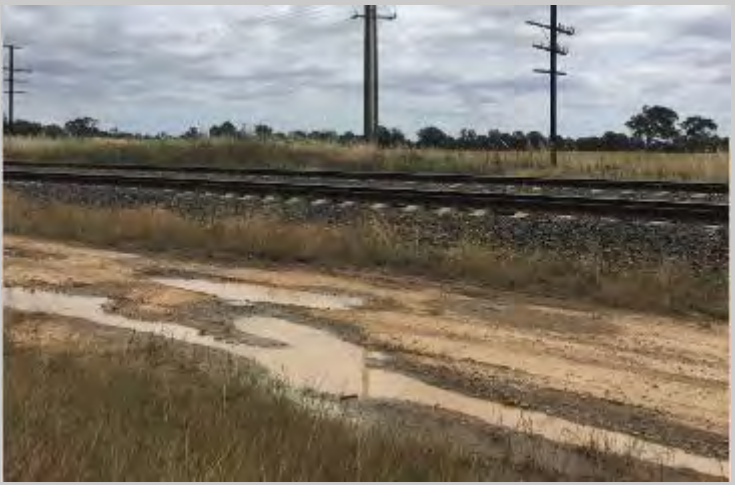
Project area	Chainage	Asset Type	Summary of proposed works	Desktop Assessment Results		Field Confirmation				
				Modelled EVC	TEC/Threatened Species	Project area	Project area Characteristics	EVC Field Assessment	TEC/Threatened Species Field Confirmation	Image
						West	No native vegetation or habitat for threatened species	No EVC	No TEC or potential habitat for threatened species observed

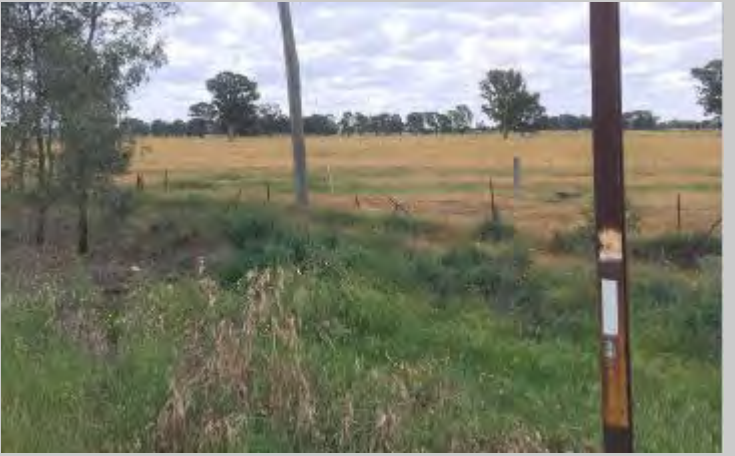
79	201.28	Electrical 22kV	Replace pole	N/A	N/A	East	Big pond in borrow pit within project area Drain alongside track contains cumbungi and river red gum scattered trees Access along track clear	No EVC	No TEC or potential habitat for threatened species observed	 
						West	Native vegetation in drain including wallaby Grass Access not possible along track	No EVC	Potential listed wallaby grass

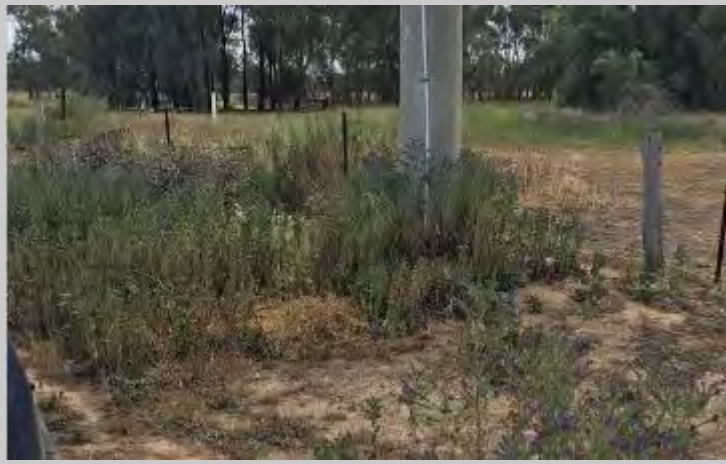
Project area	Chainage	Asset Type	Summary of proposed works	Desktop Assessment Results		Field Confirmation				
				Modelled EVC	TEC/Threatened Species	Project area	Project area Characteristics	EVC Field Assessment	TEC/Threatened Species Field Confirmation	Image
80	204.76	Electrical 22kV	Replace pole	55: Plains Grassy Woodland	N/A	North	No native vegetation or habitat for threatened species	No EVC	No TEC or potential habitat for threatened species observed

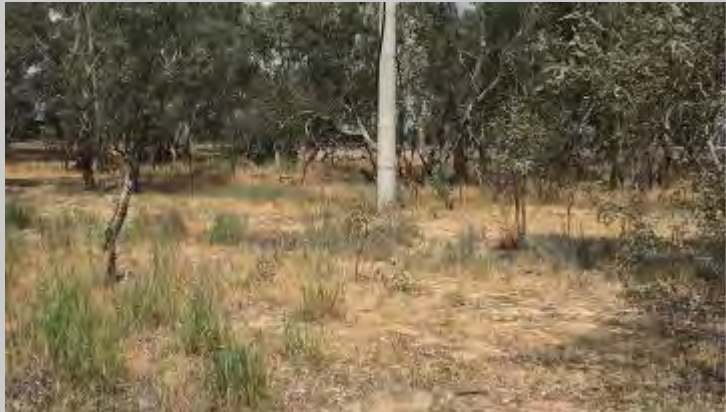
South	Scattered trees with disturbed understory Patch of fenced native vegetation between the project area and the Hume Freeway.	No EVC	No TEC or potential habitat for threatened species observed

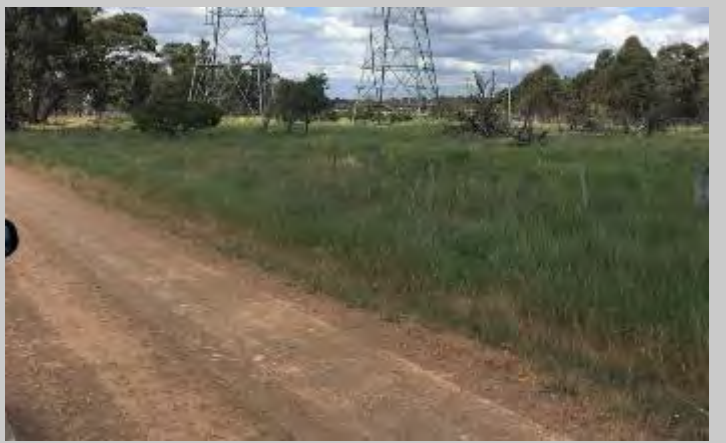
81	208.4	2x Electrical 220kV Electrical 66kV	Replace pole Replace pole	N/A	N/A	East	Scattered native vegetation	No EVC	No TEC or potential habitat for threatened species observed

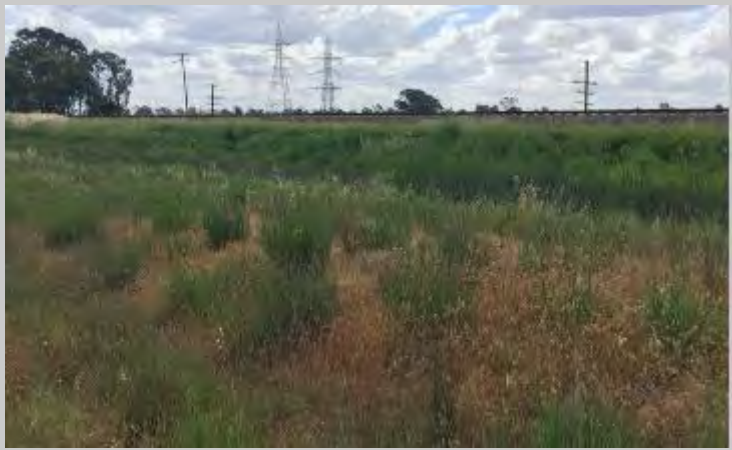
Project area	Chainage	Asset Type	Summary of proposed works	Desktop Assessment Results		Field Confirmation				
				Modelled EVC	TEC/Threatened Species	Project area	Project area Characteristics	EVC Field Assessment	TEC/Threatened Species Field Confirmation	Image
						West	Patch of native vegetation (also considered to be a TEC) that extends into the rail corridor. Private land contained a patch of native vegetation. This was viewed from over the fence from the adjacent rail reserve.	55: Plains Grassy Woodland	GBGW TEC

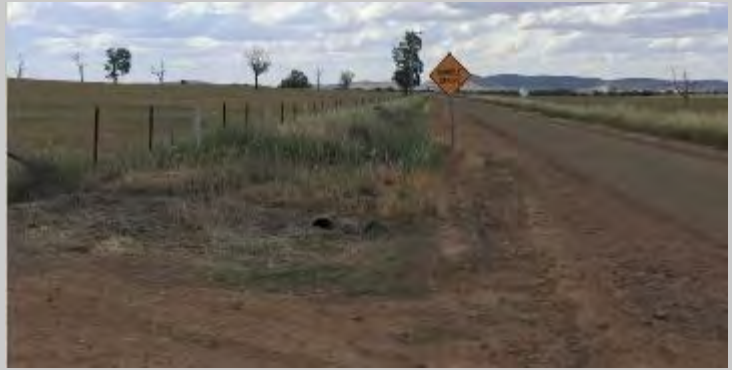
82	210.97	Electrical 22kV	Replace pole	N/A	N/A	East	Scattered native vegetation	No EVC	No TEC or potential habitat for threatened species observed	No photo
						West	No native vegetation or habitat for threatened species	No EVC	No TEC or potential habitat for threatened species observed

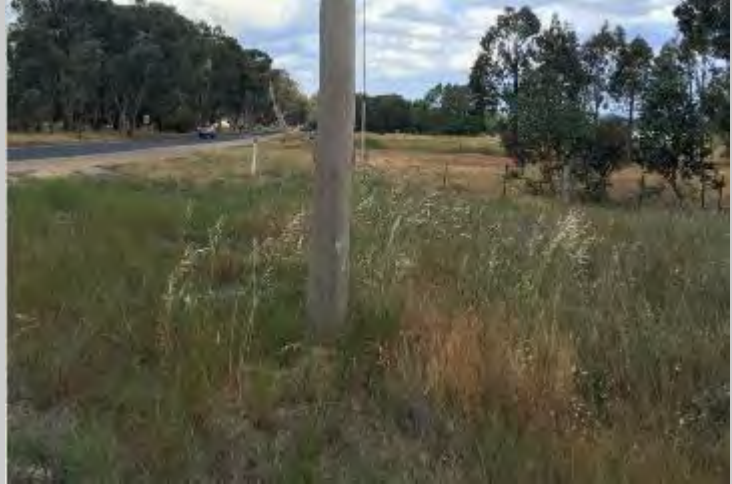
92	225.64	Electrical 22kV	Replace pole	175: Grassy Woodland	VTWBC Purple Diuris Warby Range Swamp Gum	East	Patch of native grasses from powerline south	175: Grassy Woodland	No TEC or potential habitat for threatened species observed

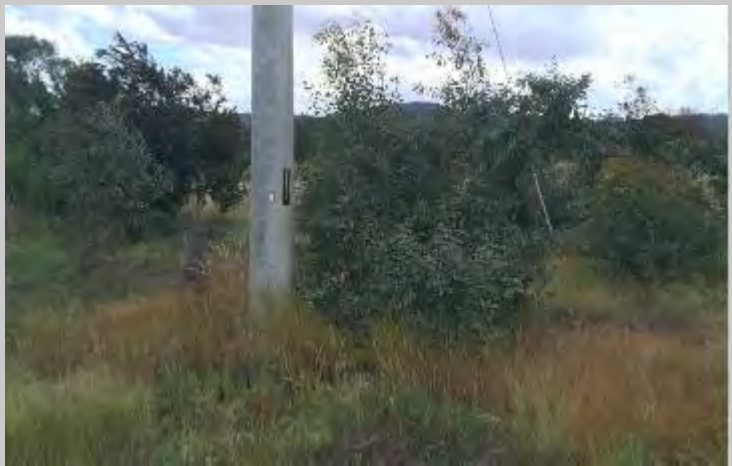
Project area	Chainage	Asset Type	Summary of proposed works	Desktop Assessment Results		Field Confirmation				
				Modelled EVC	TEC/Threatened Species	Project area	Project area Characteristics	EVC Field Assessment	TEC/Threatened Species Field Confirmation	Image
						West	Patch of grey box regrowth	No EVC	No TEC or potential habitat for threatened species observed

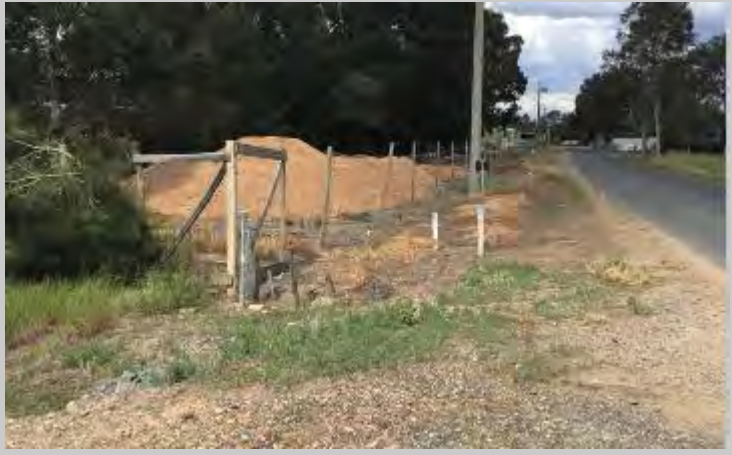
93	230.4	Electrical 22kV	Replace pole	240: Plains Grassy Woodland/ Creekline Grassy Woodland/ Wetland Formation Mosaic	N/A	East	No native vegetation or habitat for threatened species	No EVC	No TEC or potential habitat for threatened species observed

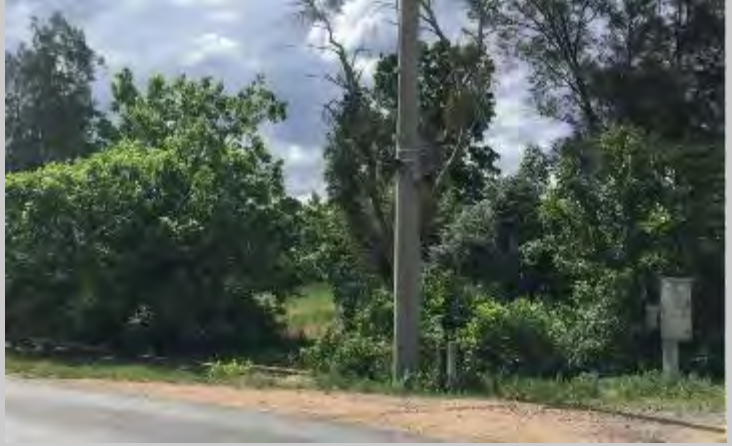
West	No native vegetation or habitat for threatened species	No EVC	No TEC or potential habitat for threatened species observed

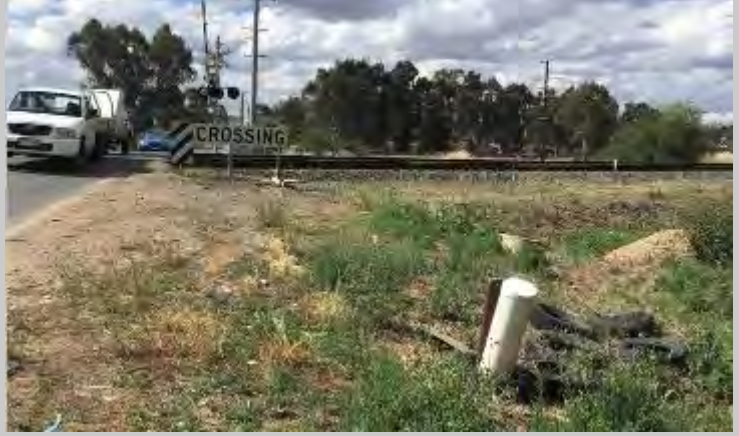
Project area	Chainage	Asset Type	Summary of proposed works	Desktop Assessment Results		Field Confirmation				
				Modelled EVC	TEC/Threatened Species	Project area	Project area Characteristics	EVC Field Assessment	TEC/Threatened Species Field Confirmation	Image
94	231.17	Electrical 22kV Electrical LV	Replace pole Replace pole	N/A	N/A	East	No native vegetation or habitat for threatened species	No EVC	No TEC or potential habitat for threatened species observed

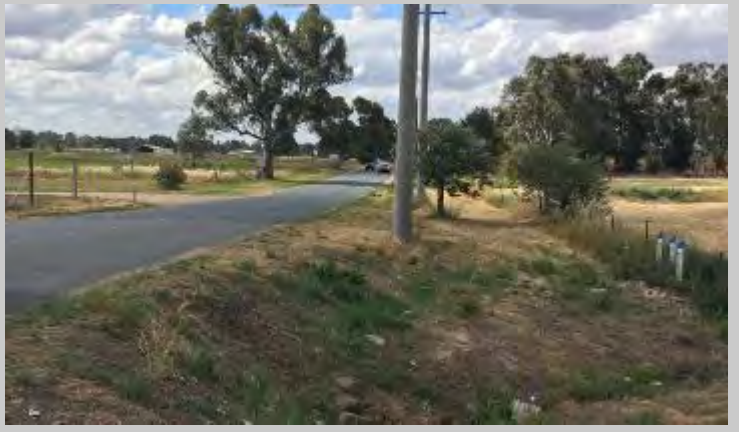
West	No native vegetation or habitat for threatened species	No EVC	No TEC or potential habitat for threatened species observed

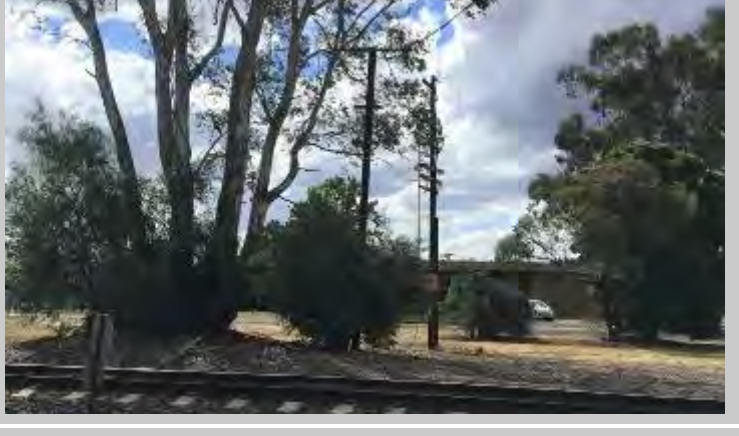
134	232.95	Electrical LV	Relocate underground	N/A	N/A		1 scattered tree (river red gum) on west side should be avoided	No EVC	No TEC or potential habitat for threatened species observed

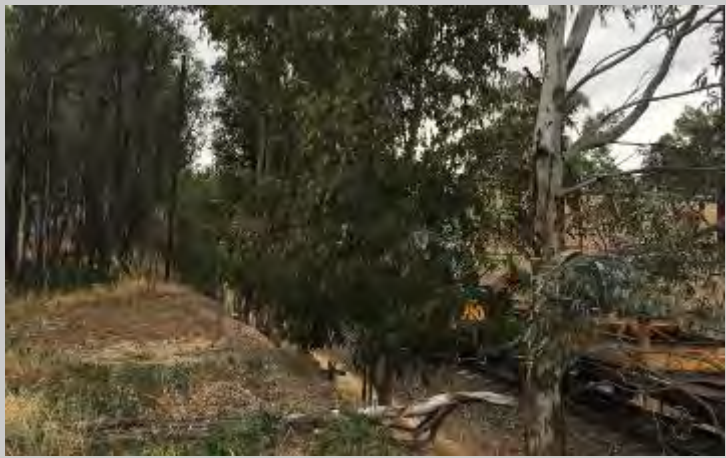
Project area	Chainage	Asset Type	Summary of proposed works	Desktop Assessment Results		Field Confirmation				
				Modelled EVC	TEC/Threatened Species	Project area	Project area Characteristics	EVC Field Assessment	TEC/Threatened Species Field Confirmation	Image
						South	Scattered lightwood	No EVC	No TEC or potential habitat for threatened species observed

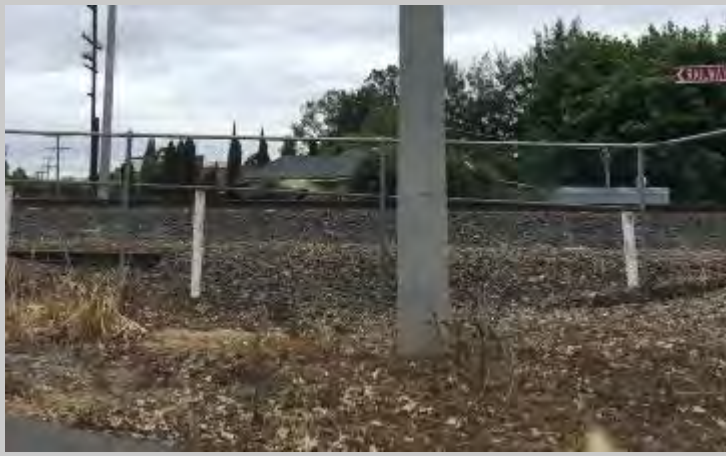
98	234.1	Electrical LV	Relocate overhead	N/A	N/A		No native vegetation or habitat for threatened species	No EVC	No TEC or potential habitat for threatened species observed	No photo
136	234.15	Infrastructure	Replace pole	N/A	N/A		No native vegetation or habitat for threatened species	No EVC	No TEC or potential habitat for threatened species observed	No photo
137	234.6	Electrical 22kV	Replace pole	N/A	N/A		No native vegetation or habitat for threatened species Avoid scattered tree to east	No EVC	No TEC or potential habitat for threatened species observed

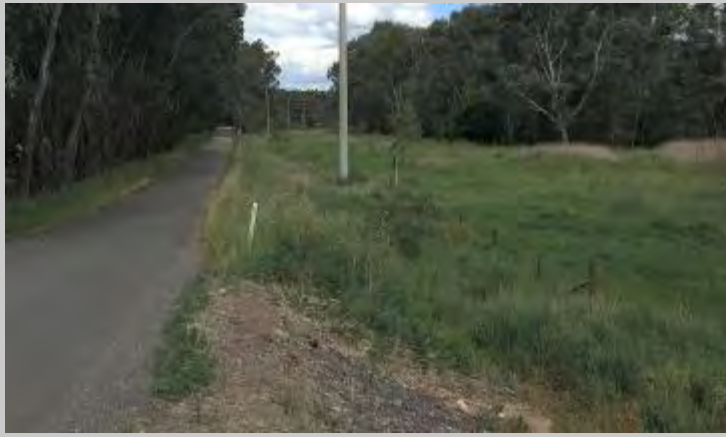
99	236.29	Electrical 22kV Electrical 22kV	Replace pole Replace pole	240: Riverine Grassy Woodland/ Riverine Swampy Woodland Mosaic	VTWBC WBYBBRG	East	Scattered regrowth river red gum	No EVC	No TEC or potential habitat for threatened species observed

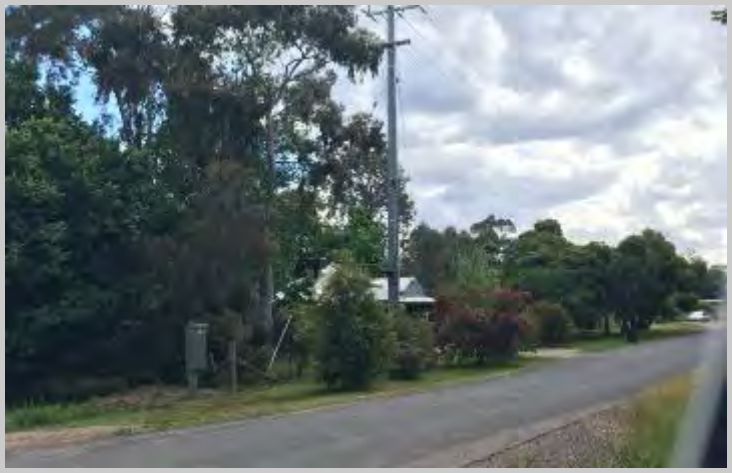
Project area	Chainage	Asset Type	Summary of proposed works	Desktop Assessment Results		Field Confirmation				
				Modelled EVC	TEC/Threatened Species	Project area	Project area Characteristics	EVC Field Assessment	TEC/Threatened Species Field Confirmation	Image
						West	No native vegetation or habitat for threatened species	No EVC	No TEC or potential habitat for threatened species observed

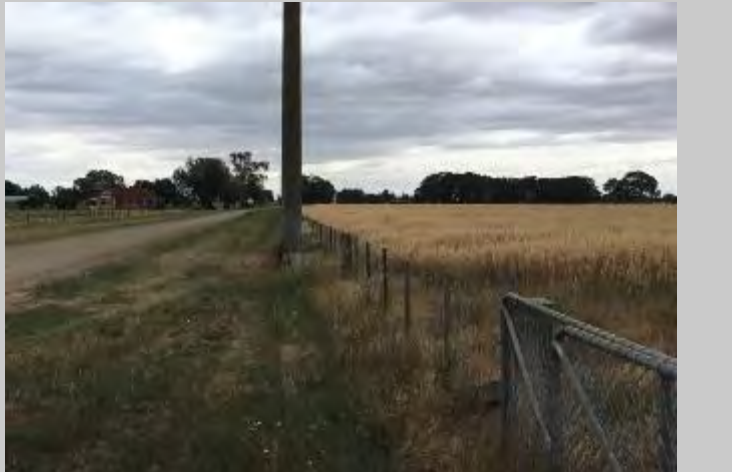
102	239.3	Electrical LV	Relocate overhead	N/A	N/A		Scattered native grasses Planted native trees under pole river red gum and apple box	No EVC	No TEC or potential habitat for threatened species observed

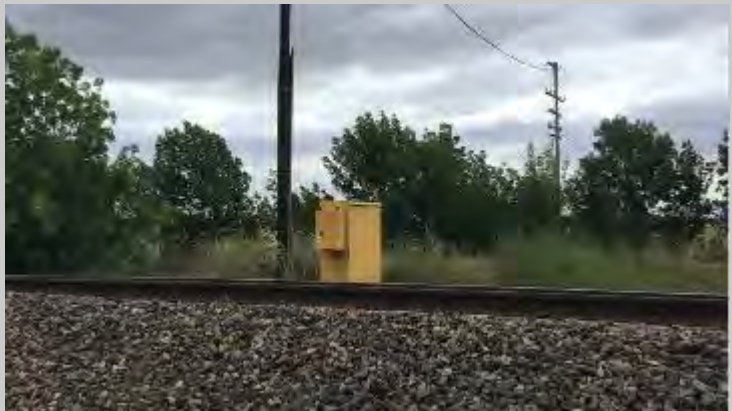
138	239.89	Infrastructure	Replace pole	803: Plains Woodland	N/A		Scattered native grasses	No EVC	No TEC or potential habitat for threatened species observed

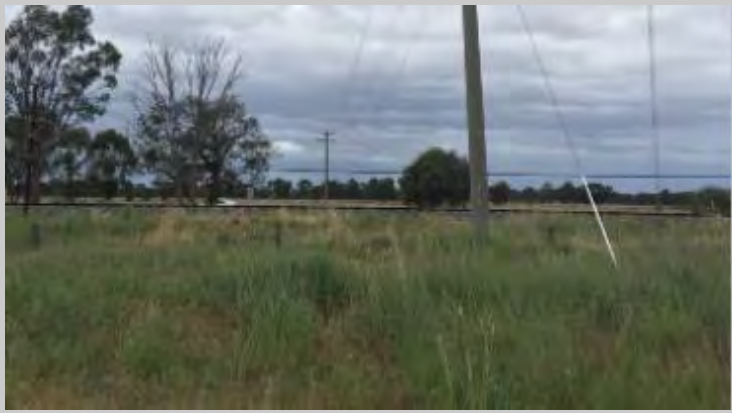
Project area	Chainage	Asset Type	Summary of proposed works	Desktop Assessment Results		Field Confirmation				
				Modelled EVC	TEC/Threatened Species	Project area	Project area Characteristics	EVC Field Assessment	TEC/Threatened Species Field Confirmation	Image
103	240.78	Electrical 22kV	Replace pole	N/A	N/A		Scattered native vegetation 1x scattered tree	175: Grassy Woodland 55: Plains Grassy Woodland	No TEC or potential habitat for threatened species observed

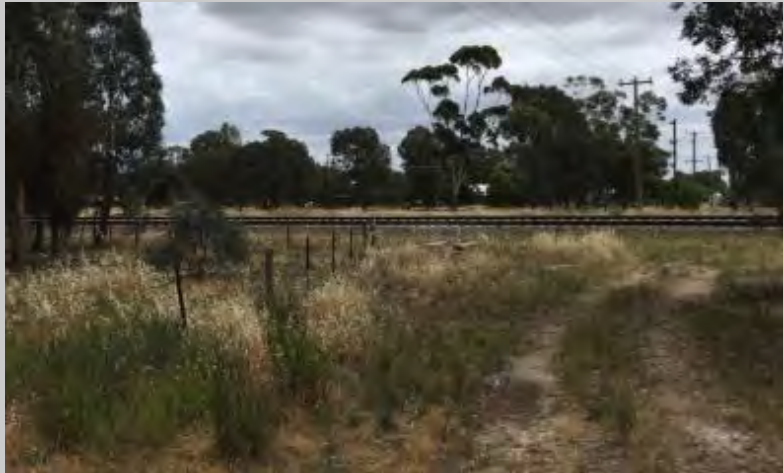
105	256.97	Electrical 22kV	Replace pole	803: Plains Woodland	N/A	East	1x scattered tree Scattered native vegetation	No EVC	No TEC or potential habitat for threatened species observed

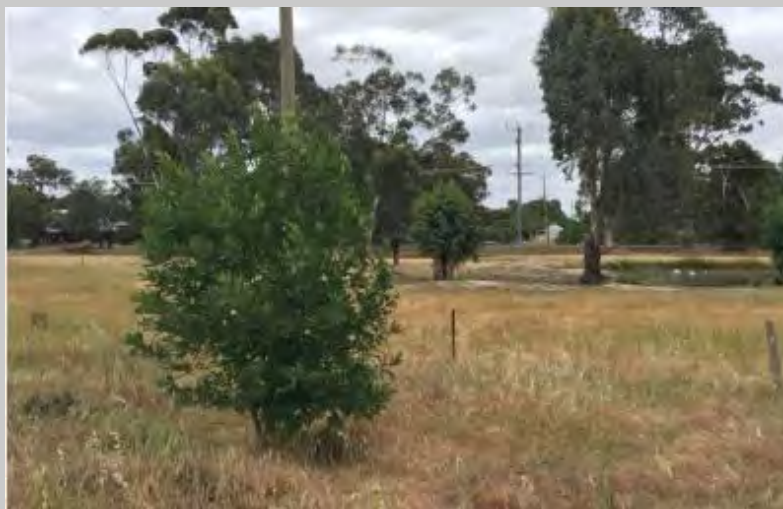
West	1x scattered tree	No EVC	No TEC or potential habitat for threatened species observed

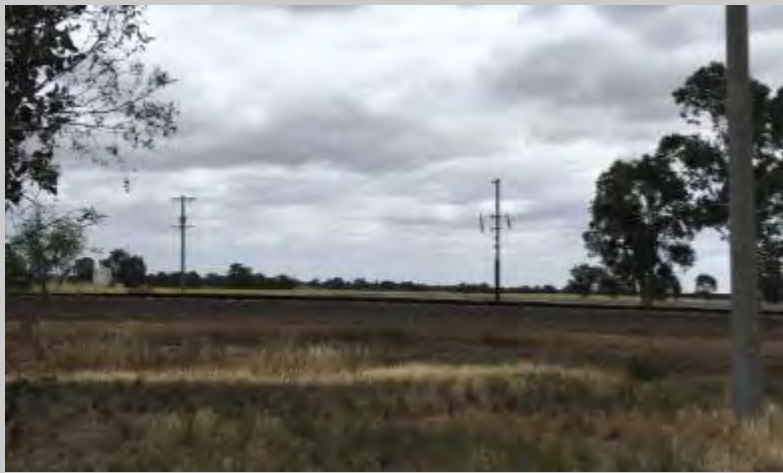
Project area	Chainage	Asset Type	Summary of proposed works	Desktop Assessment Results		Field Confirmation				
				Modelled EVC	TEC/Threatened Species	Project area	Project area Characteristics	EVC Field Assessment	TEC/Threatened Species Field Confirmation	Image
						West	No native vegetation or habitat for threatened species	No EVC	No TEC or potential habitat for threatened species observed

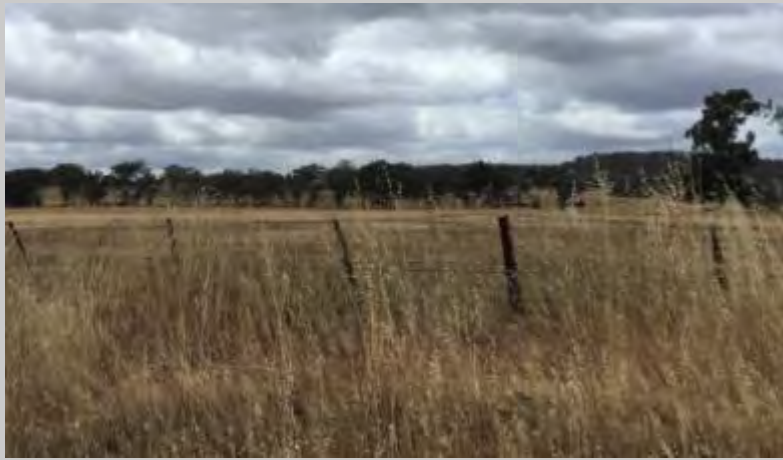
107	259.21	Electrical 22kV	Replace pole	803: Plains Woodland	N/A	East	Patch of native vegetation including regenerating grasses, especially in private land. Planted scattered trees	803: Plains Woodland / 55: Plains Grassy Woodland / 175: Grassy Woodland	No TEC or potential habitat for threatened species observed

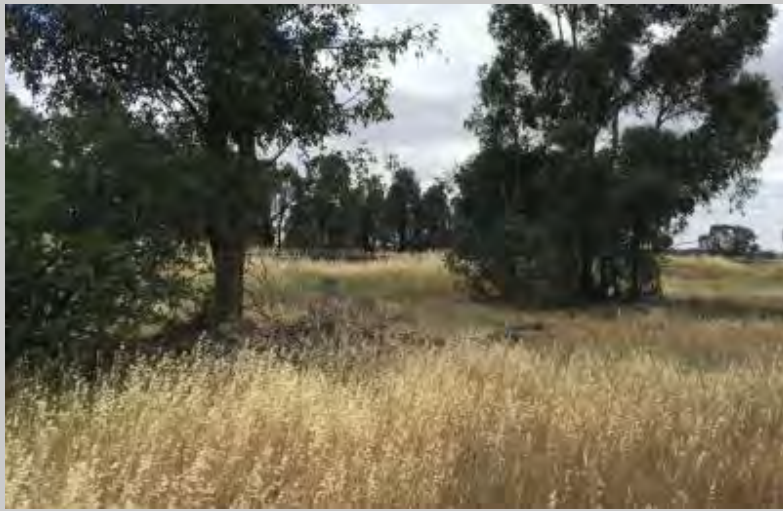
West	Scattered native grasses, planted trees	No EVC	No TEC or potential habitat for threatened species observed

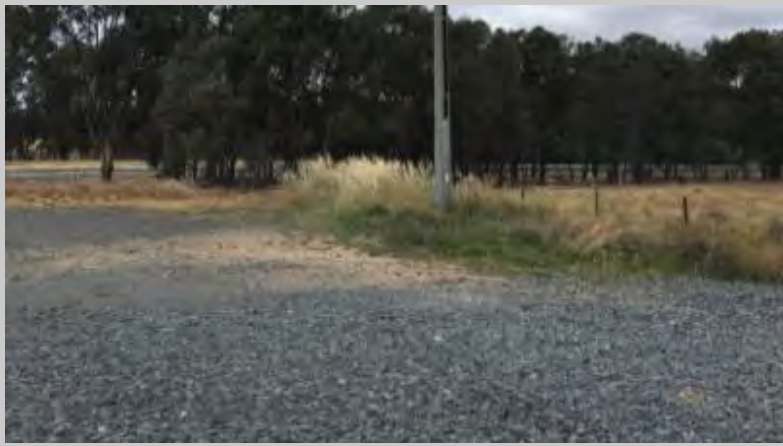
Project area	Chainage	Asset Type	Summary of proposed works	Desktop Assessment Results		Field Confirmation				
				Modelled EVC	TEC/Threatened Species	Project area	Project area Characteristics	EVC Field Assessment	TEC/Threatened Species Field Confirmation	Image
108	262.03	Electrical 22kV	Replace pole	47: Valley Grassy Forest	GBGW VTWBC WBYBBRG		Scattered native grasses adjacent to fence, otherwise clear. Scattered trees along access track – avoid use of track	55: Plains Grassy Woodland	No TEC or potential habitat for threatened species observed

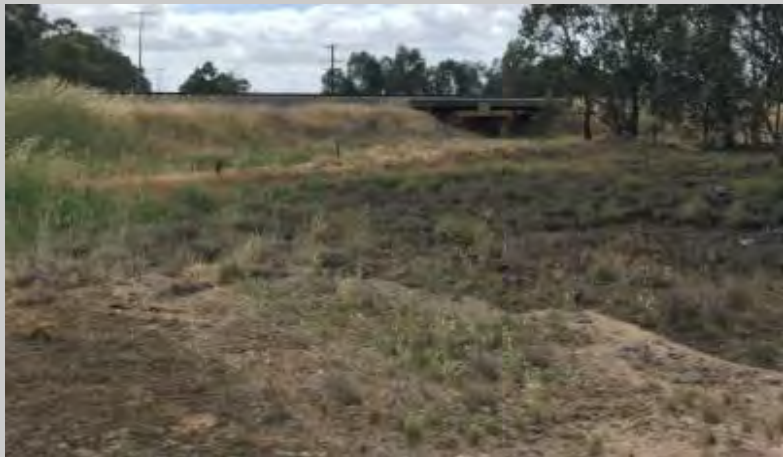
109	267.19	Electrical 22kV	Replace pole	55: Plains Grassy Woodland 68: Creepline Grassy Woodland	GBGW VTWBC WBYBBRG Late-flower flax-lily Mugga		Patch of native vegetation including yellow box, white box and wetland habitat Scattered trees	68: Creepline Grassy Woodland	WBYBBRG Brown toadlet heard calling Potential habitat for threatened species Sloane's froglet

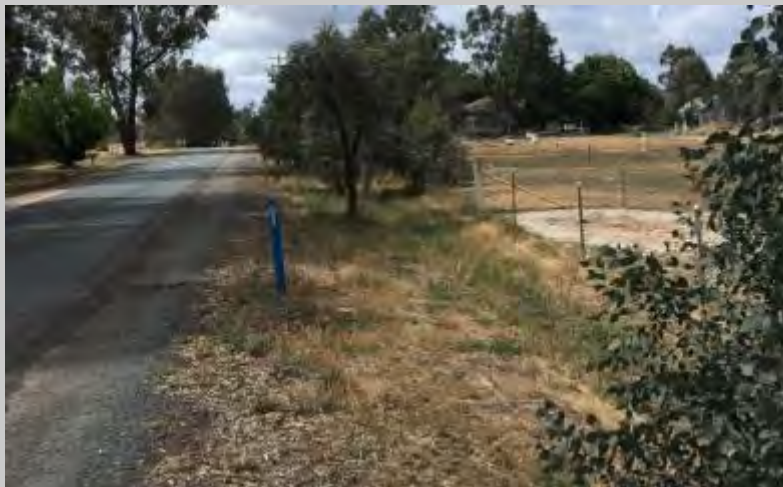
110	269.25	Electrical 22kV	Replace pole	47: Valley Grassy Forest	N/A	East	Scattered native vegetation	No EVC	No TEC or potential habitat for threatened species observed

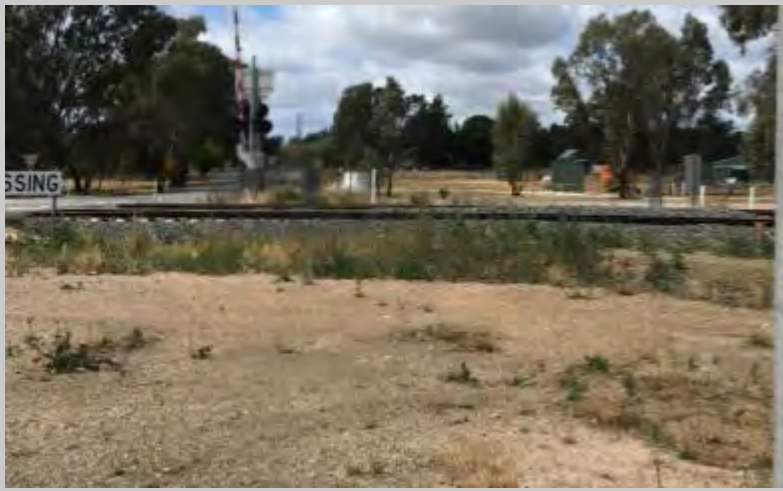
Project area	Chainage	Asset Type	Summary of proposed works	Desktop Assessment Results		Field Confirmation				
				Modelled EVC	TEC/Threatened Species	Project area	Project area Characteristics	EVC Field Assessment	TEC/Threatened Species Field Confirmation	Image
						West	No native vegetation or habitat for threatened species	No EVC	No TEC or potential habitat for threatened species observed
