## Appendix A – Figures

Figure 7 Environmental overlays

**Environmental Overlays**

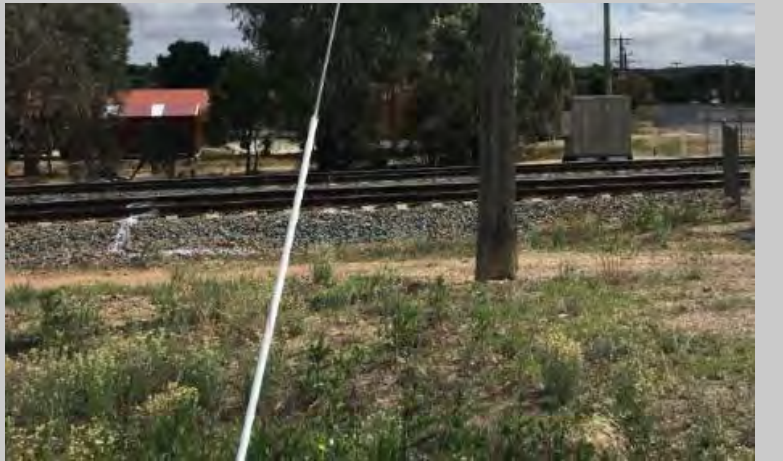
111	270.91	Electrical 22kV Electrical LV	Replace pole Replace pole	153: Alluvial Terraces Herb-rich Woodland/ Valley Grassy Forest Complex	N/A		Scattered native vegetation including jersey cudweed Scattered trees on western edge of project area - avoidable	No EVC	No TEC or potential habitat for threatened species observed

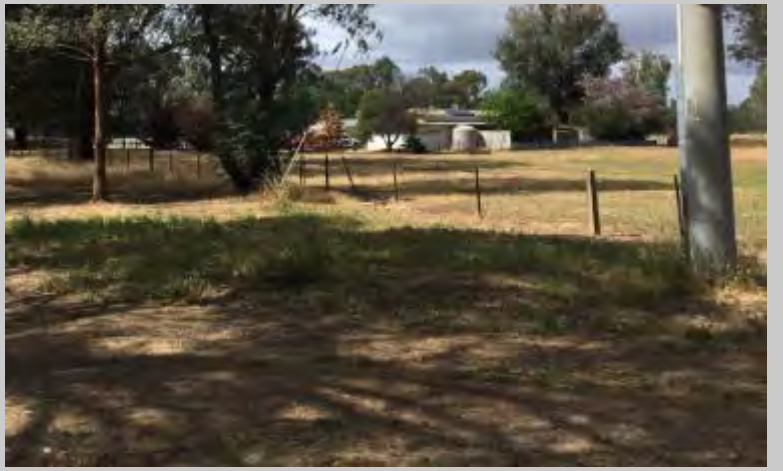
114	279.2	Electrical LV	Replace pole	152: Alluvial Terraces Herb-rich Woodland/ Plains Grassy Woodlands Complex	N/A	East	No native vegetation or habitat for threatened species	No EVC	No TEC or potential habitat for threatened species observed

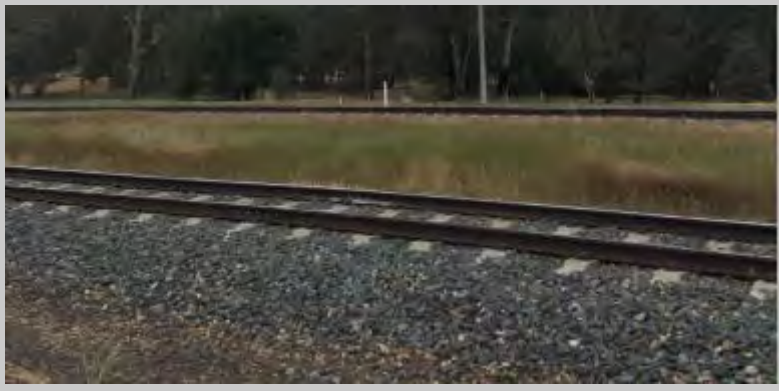
Project area	Chainage	Asset Type	Summary of proposed works	Desktop Assessment Results		Field Confirmation				
				Modelled EVC	TEC/Threatened Species	Project area	Project area Characteristics	EVC Field Assessment	TEC/Threatened Species Field Confirmation	Image
						Central	Scattered native vegetation of jersey cudweed	No EVC	No TEC or potential habitat for threatened species observed

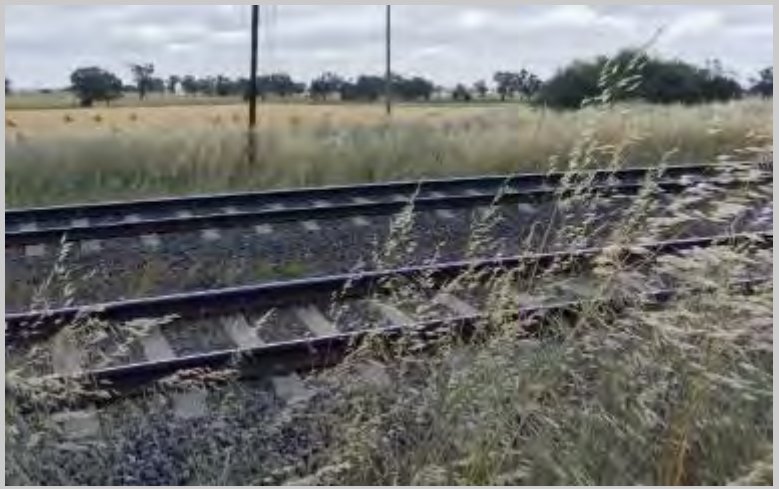
West	No native vegetation or habitat for threatened species	No EVC	No TEC or potential habitat for threatened species observed	No photo
118	283.33	Electrical LV	Replace pole	N/A	N/A		Scattered indigenous grasses	No EVC	No TEC or potential habitat for threatened species observed

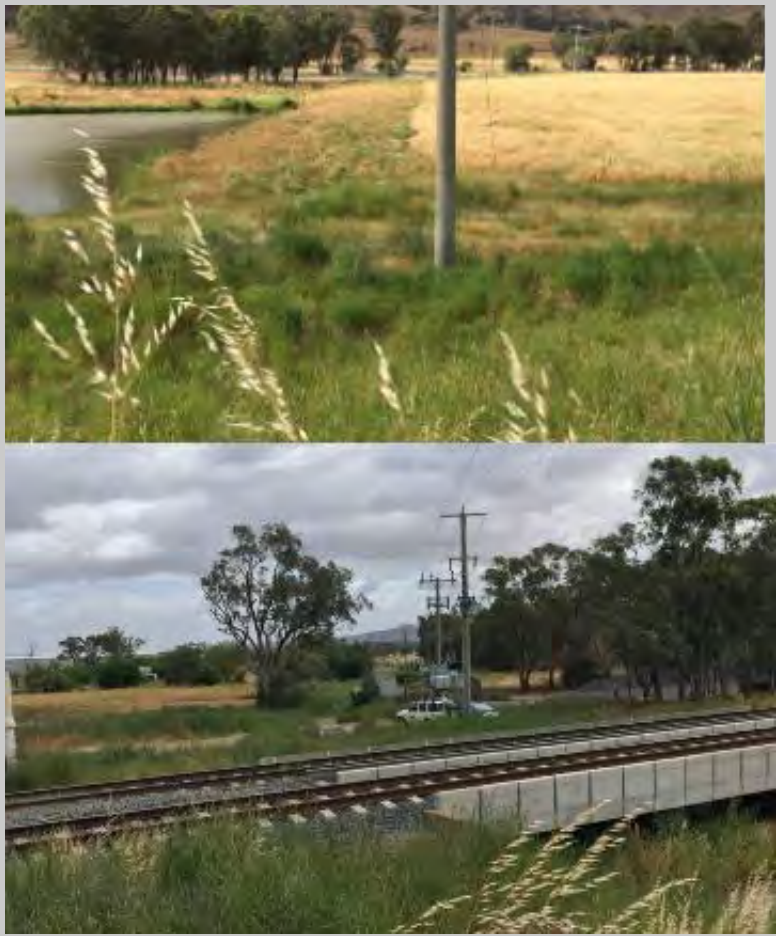
Project area	Chainage	Asset Type	Summary of proposed works	Desktop Assessment Results		Field Confirmation				
				Modelled EVC	TEC/Threatened Species	Project area	Project area Characteristics	EVC Field Assessment	TEC/Threatened Species Field Confirmation	Image
119	284.93	Electrical 22kV	Replace pole	N/A	N/A		No native vegetation or habitat for threatened species.	No EVC	No TEC or potential habitat for threatened species observed

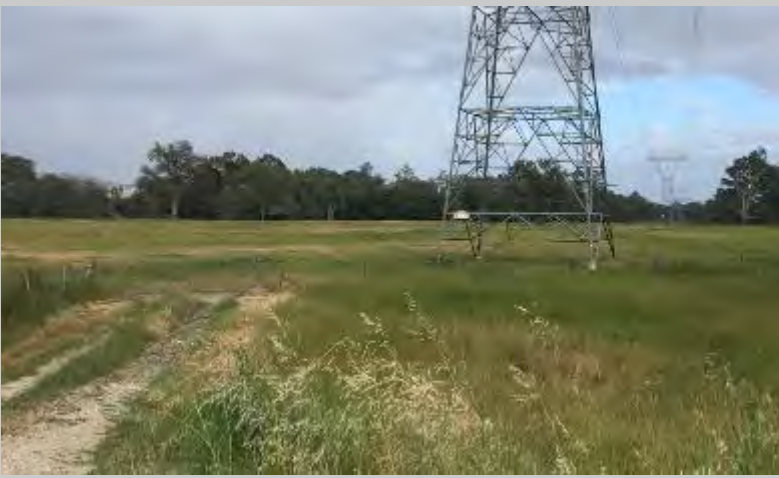
Project area	Chainage	Asset Type	Summary of proposed works	Desktop Assessment Results		Field Confirmation				
				Modelled EVC	TEC/Threatened Species	Project area	Project area Characteristics	EVC Field Assessment	TEC/Threatened Species Field Confirmation	Image
121	290.91	Electrical 66kV	Replace pole	N/A	N/A		Scattered native grasses	No EVC	No TEC or potential habitat for threatened species observed	 
122	301	Electrical 330kV	Replace pole	815: Riverine Swamy Woodland	VTWBC	East	No native vegetation in project area, avoid 2 scattered trees either side of access track	815: Riverine Swamy Woodland	No TEC or potential habitat for threatened species observed	No photo
						West	Patch of river red gum – easily avoided	No EVC	No TEC or potential habitat for threatened species observed

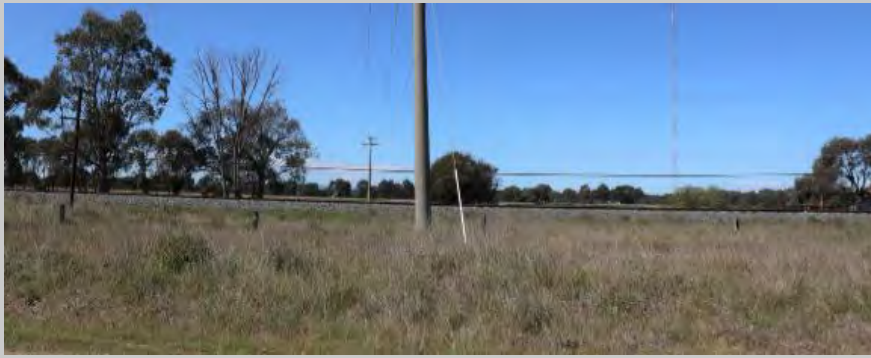
Powerline Project area	Chainage	Predicted threatened species (ABZECO 2019)	Observed Threatened species	Predicted TEC (ABZECO 2019)	Potential TEC	Image
103	240.78	N/A	No threatened flora species were observed	GBGW WBYBBRGGW	No threatened ecological recorded within the project area.

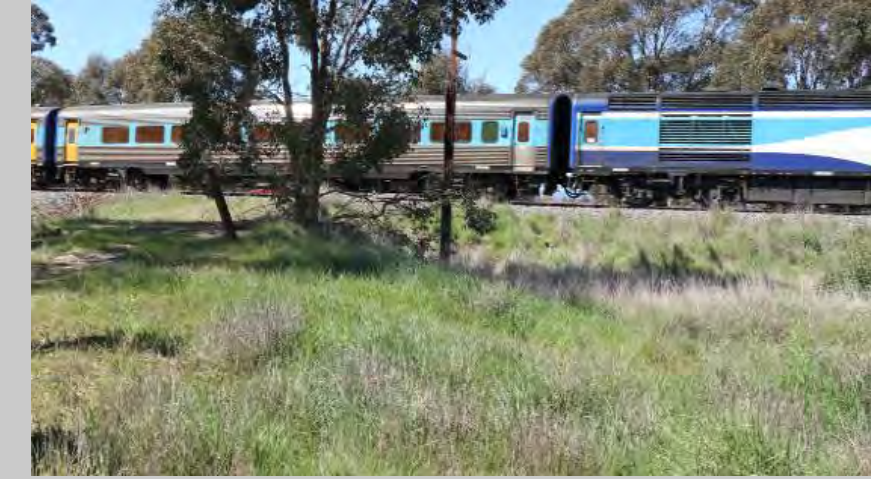
104	244.93	N/A	No threatened flora species were observed	GBGW WBYBBRGGW

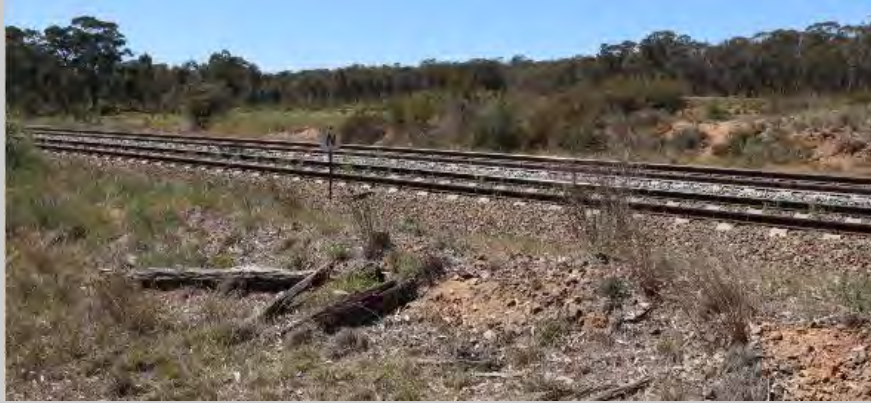
112	272.22	Crimson spider orchid Deane's wattle Cottony cassinia	No threatened species were identified	GBGB VTWBC WBYBBRGGW	No threatened ecological recorded within the project area.

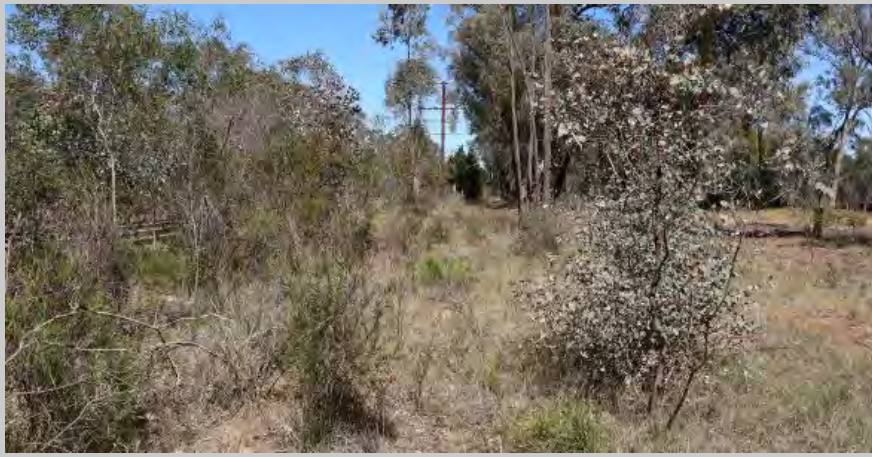
Powerline Project area	Chainage	Predicted threatened species (ABZECO 2019)	Observed Threatened species	Predicted TEC (ABZECO 2019)	Potential TEC	Image
113	273.69	Crimson spider orchid Deane's wattle Mountain swainson-pea Hooded mosquito-orchid Dookie daisy	No threatened species were identified	GBGB VTWBC WBYBBRGGW	VTWBC recorded adjacent.
